# Implementing Geological Disposal Technology Platform IGD-TP EF4

### Recent experience with the use of DIC and AE to monitor surface cracking in a cylindrical concrete buffer

Lou Areias, Sokratis Iliopoulos, Lincy Pyl, Jun Gu  
[lareias@sckcen.be](mailto:lareias@sckcen.be)

29–30 October, 2013  
Prague

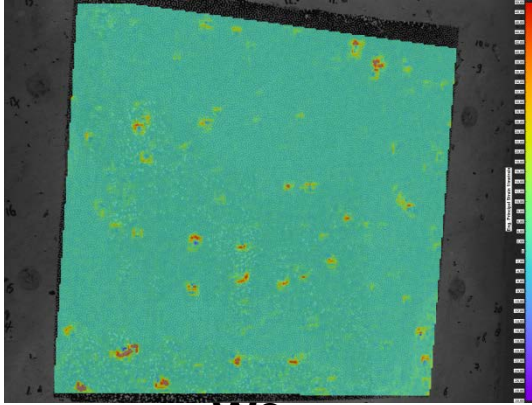
**W3**

**Overview of cracking**  
**No cracking in Phase 1 [left]**

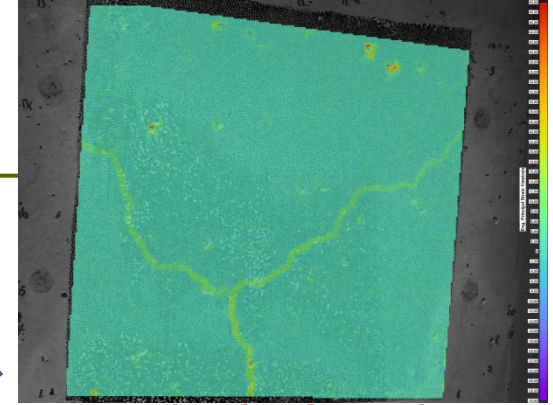
**W3 (14/06/2013)**

**Cracking initiation in Phase 2 [right]**

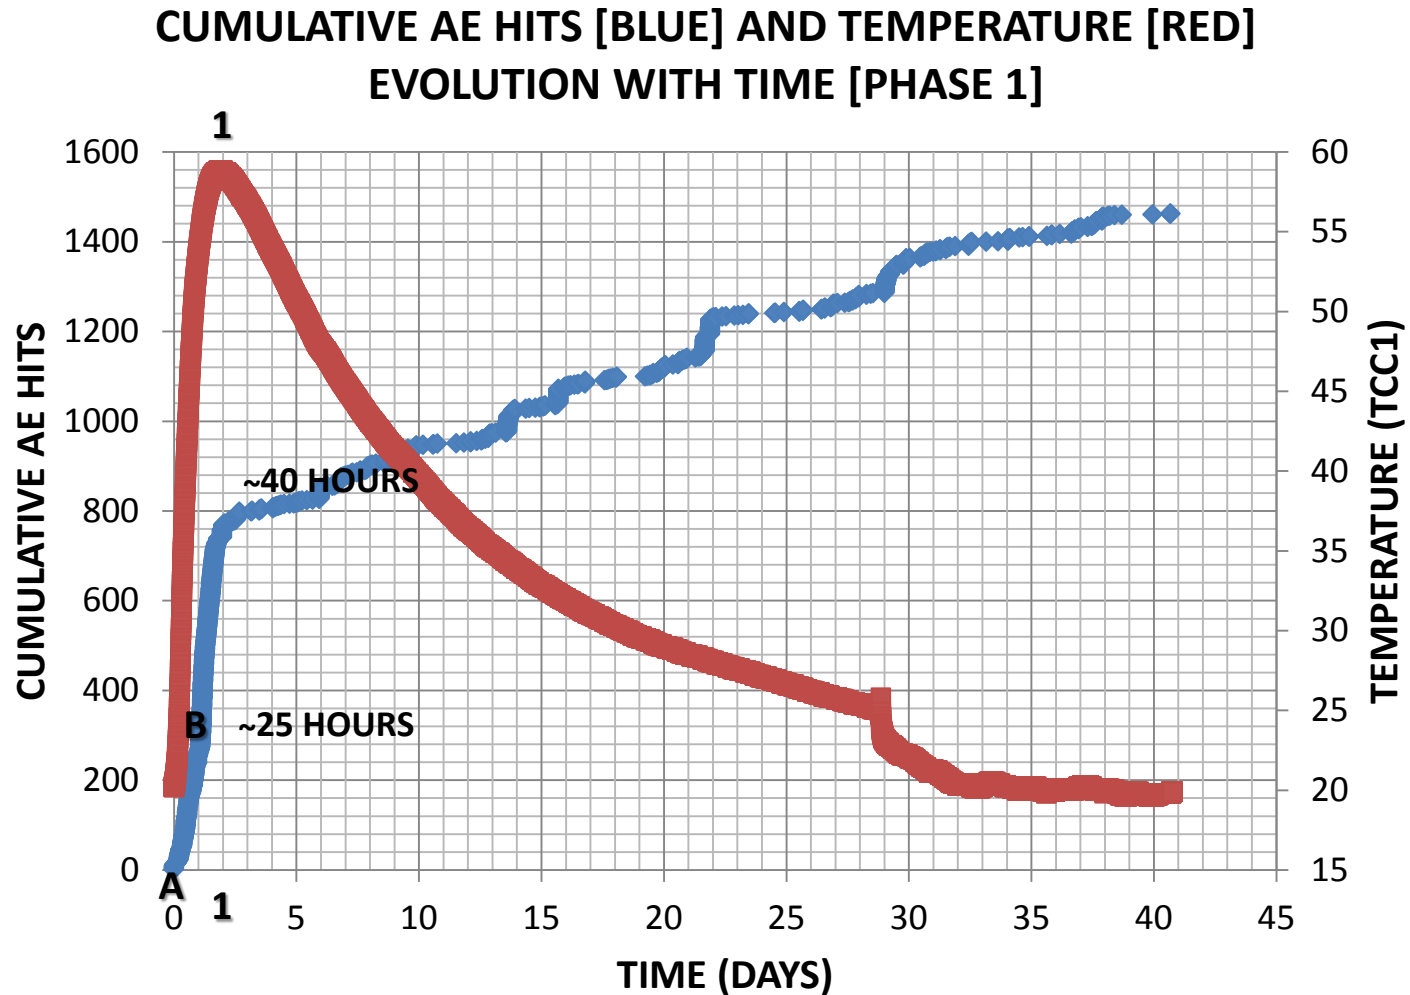
# Results DIC/AE – Phase 1 no cracking

- ❑ The high number of AE hits (~800) recorded in the first 2 days of Phase 1 represent segregation of aggregates after casting, migration of gas and water and start of hydration process. No cracking was observed either visually with the naked eye or with DIC /AE for the whole of Phase 1

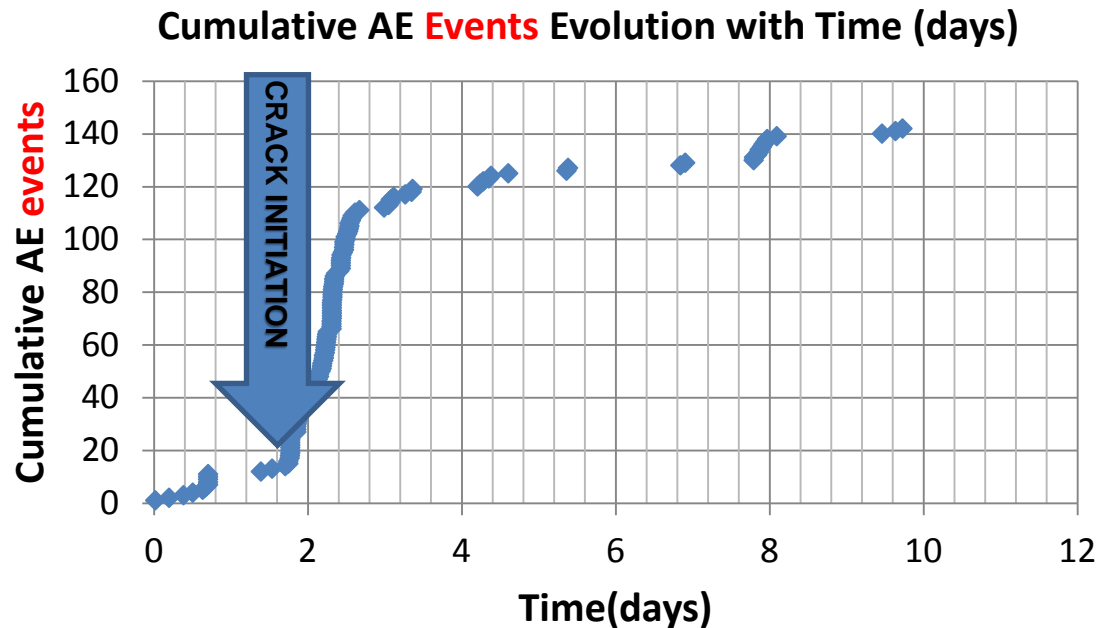
# Results DIC/AE – Phase 2 cracking

- **START OF AE MONITORING**  
11/06/2013 15:54 (Day 0)
- **FIRST CRACK INITIATION IN WINDOW 2**  
**12/06/2013 ~ 08:40 AM (Day 1)**  
**CONFIRMED BY DIC IMAGE CAPTURED ON 11:30 AM**
- **INDICATION OF CRACKING**  
**RAPID INCREASE OF AE EVENTS**

- ❑ The maximum rate of AE hits coincides with the peak temperature of hydration in Phase 1 (~ 40 hours after casting)
- ❑ Crack initiation was detected less than one day after the start of the heating phase in Window 2 AE at 08:40 AM on 12/06/2013. This was confirmed by DIC images in Window 2 the same day at 11:30 AM. The initiation of cracks in Window 2 is consistent with the location of the maximum stress and temperature distribution in the ½-scale test at this window

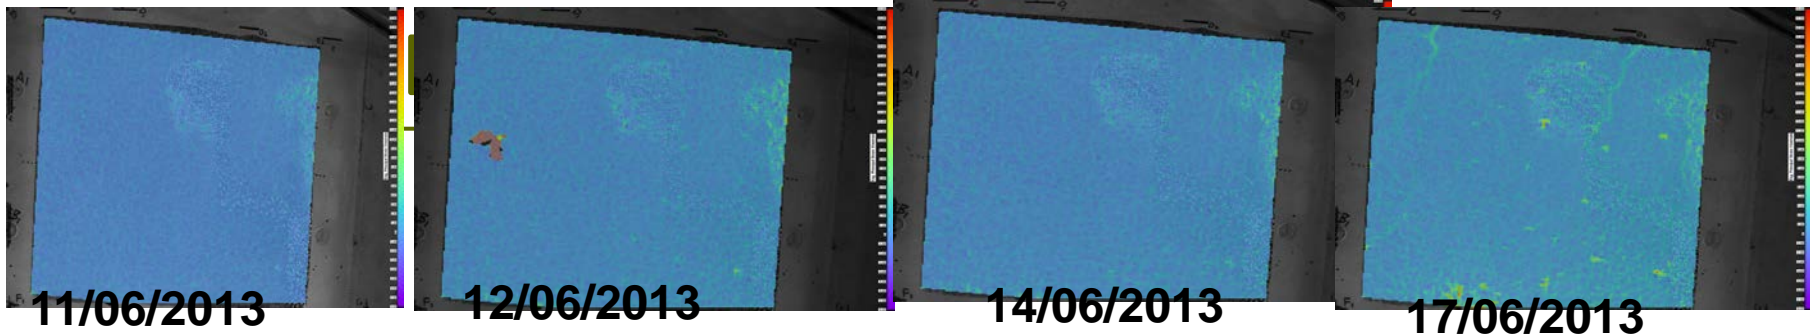
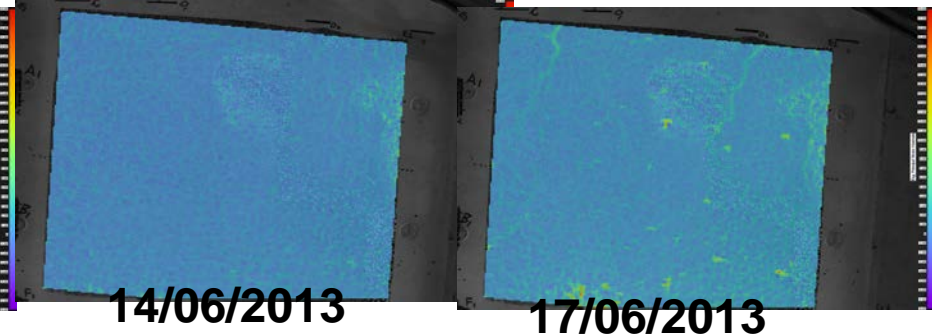
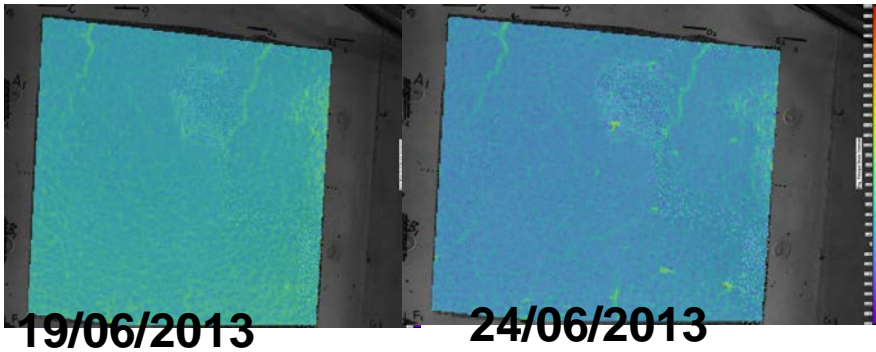
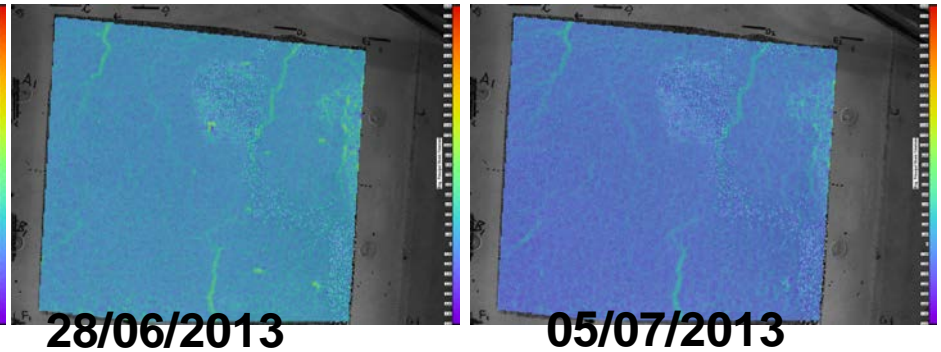
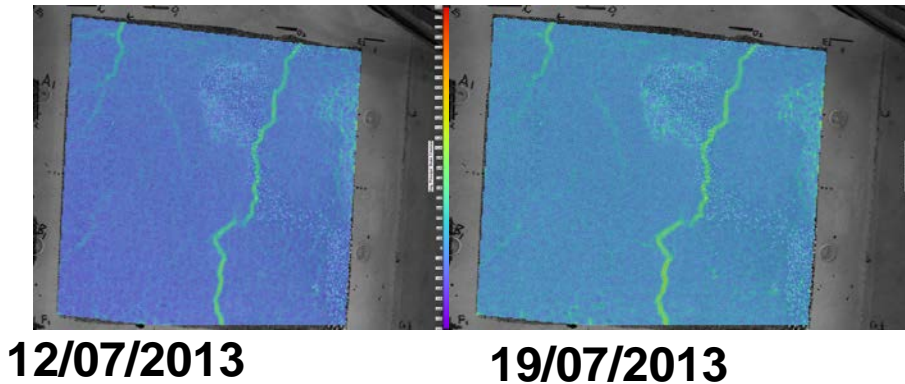
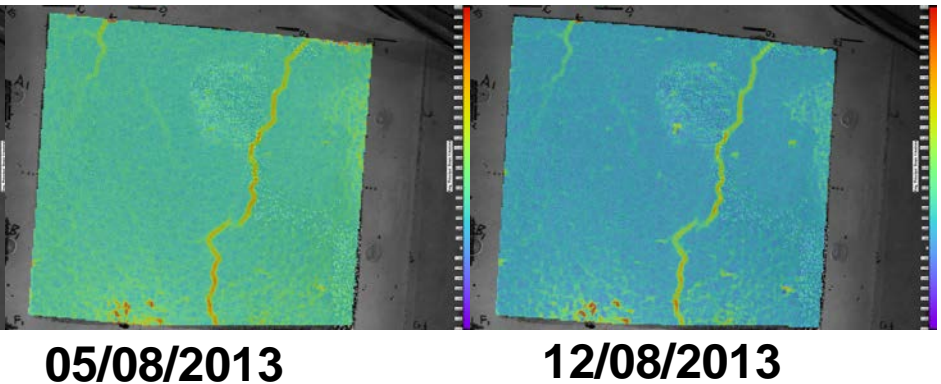
## W2 crack evolution

- 12/06 crack initiation

**Crack evolution in Window 1:  
First cracks on 17/06**
