## DELIVERABLE 8.1 OF MODULE 4 WORK PACKAGE 3.2

### Report on Short Plug Test Results

Mod4-WP3.2-D8.1– Report on Short Plug Test Results

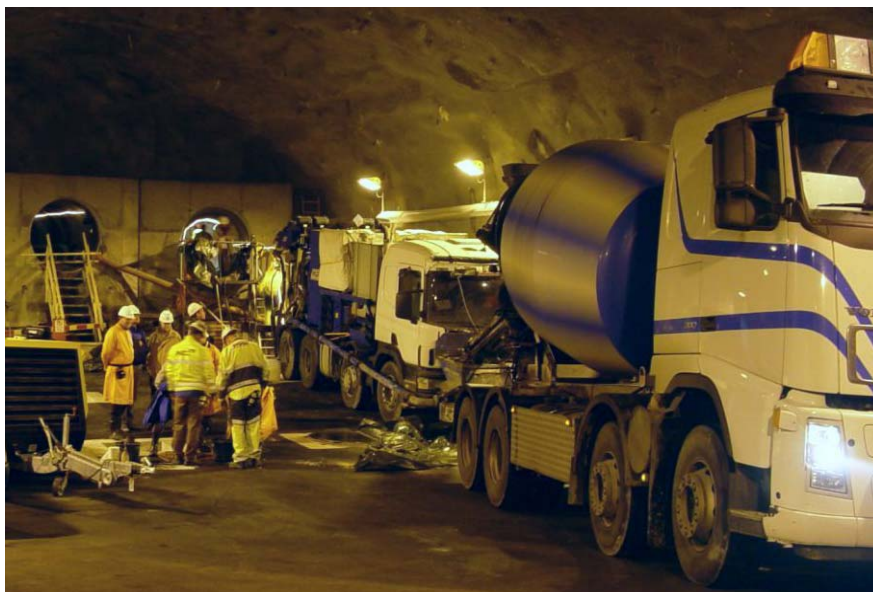
An attempt to construct the short plug at the -220m niche was made the following day using the equipment described above but with a different configuration - steel pipe at the pump outlet with a 90° elbow, followed by a reduction, a flexible hose and the nozzle - due to the lack of sufficient space in the niche to properly house the mixer and pump trucks (Figure 7). Several attempts were unsuccessfully made to pump the concrete. Time after time the concrete became stuck at different points along the pump line, as a result of which it was not possible to construct the plug.

*Figure 7: Arrangement during the failed spraying attempt*

After analysing the problems encountered it was decided to perform a new attempt on November 2, 2005, but this time using the same stand-alone Meyco SUPREMA pump and arrangement used in the preliminary test at Tumba. The mixing of the concrete was improved by using a mixer truck with a lower capacity drum and a higher rotation speed.

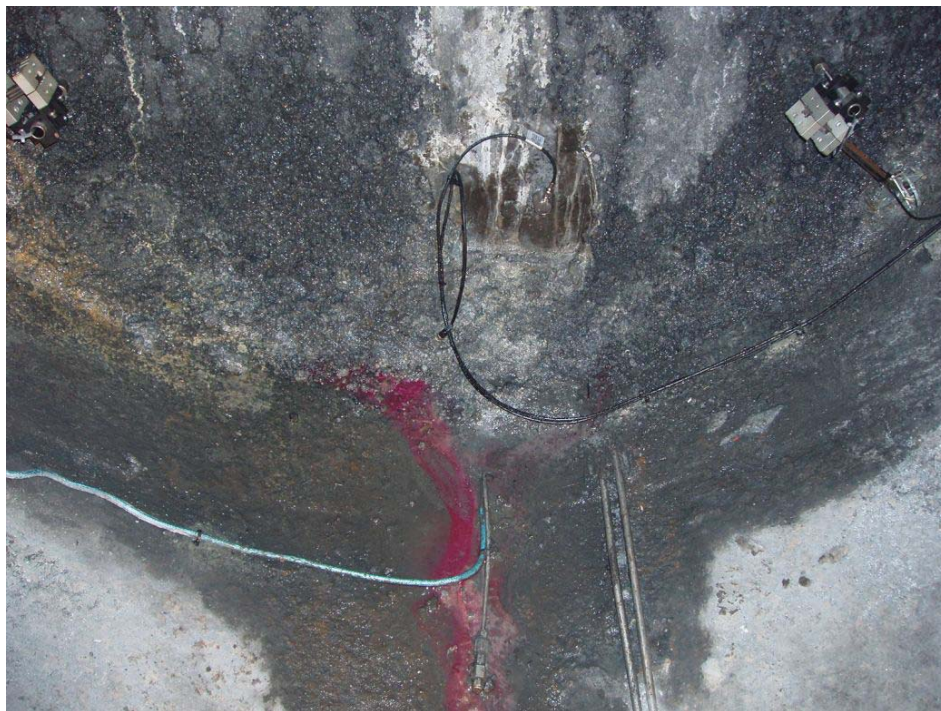
- After a pressure release down to 7.3 bar, with a deformation recovery from 0.170 mm to 0.120 mm, the pressure was increased once more, now with the doped water being injected through the inflow pipe. With the HPLC pump at its full capacity of 1 l/min, only 17.5 bar was reached. The doped water was seen to be coming only from a narrow zone at the very bottom of the plug (Figure 13). The leakage was roughly measured as about 1 l/min.

*Figure 13: Red doped water flowing out from the plug base*

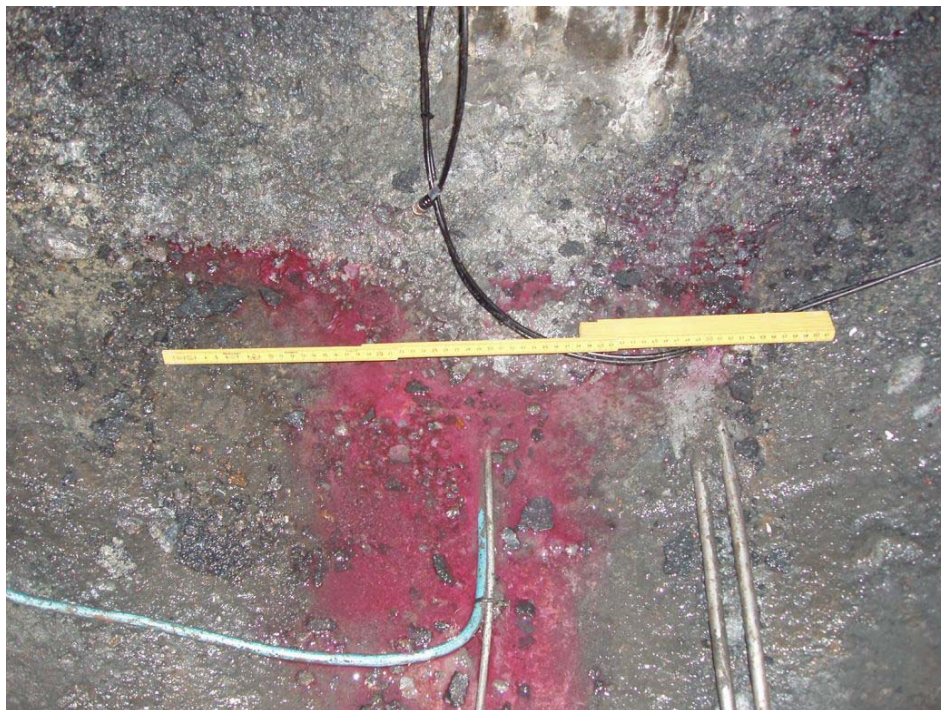
During this episode with the larger pump the water leakage in the bottom part of the plug increased significantly, which led to reasonable doubts regarding the capability of the inflow system to reach the expected “failure” pressures (at least 30-40 bar). Since this was critical for the test performance, it was decided to continue checking the system pumping capacity. It is also worth mentioning that all the testing performed up to this point seemed to indicate that the system was far from the “failure” point. The test continued as follows:

*Figure 14: Maximum extent of doped water flowing out from the plug base*

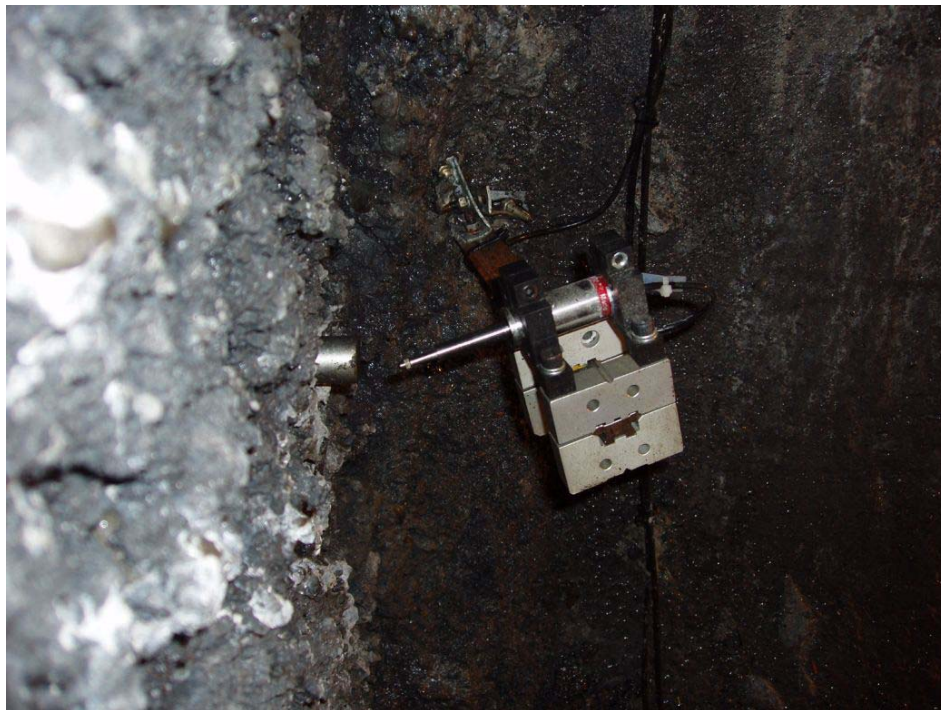
A visual inspection of the plug face revealed no cracks in the plug mass. The only cracks observed were located (outside the plug itself) in a thin film of shotcrete that was adhered to the rock walls in the 15 cm to 25 cm closest to the plug face. The movement of the plug pushed this thin film, which bent the support of one of the displacement sensors (Figure 15).

*Figure 15: View of the displacement sensor bent by the plug movement*

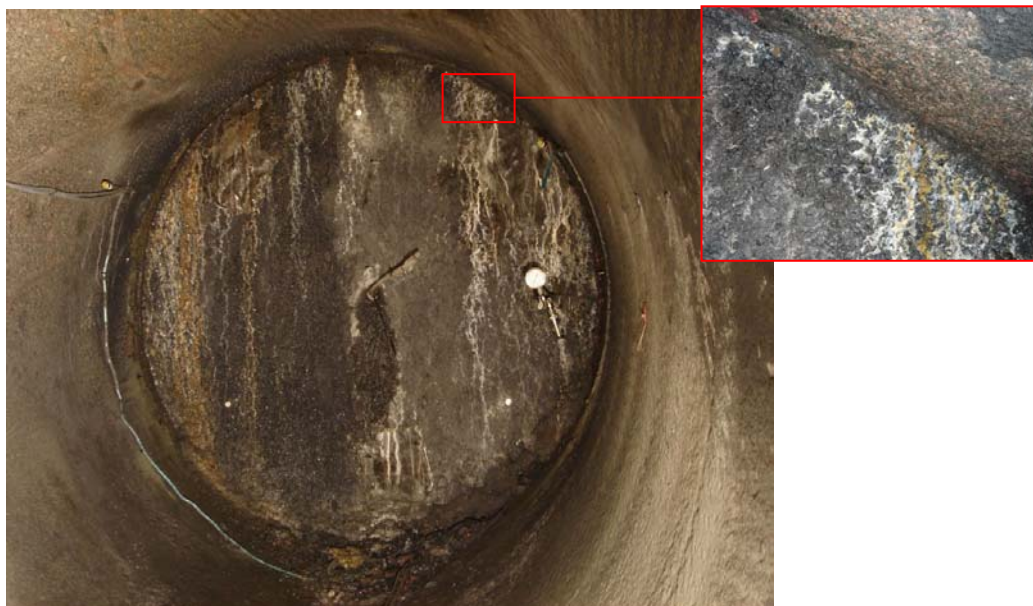
The plug sampling and dismantling process started with a detailed inspection of the plug face (Figure 17). The thin layer of shotcrete adhered to the rock at the border of the plug was removed in order to better observe the shotcrete-rock contact along the plug perimeter. No evidence or sign of any gap between the shotcrete and the rock was observed.

*Figure 17: Initial status of plug after failure test*

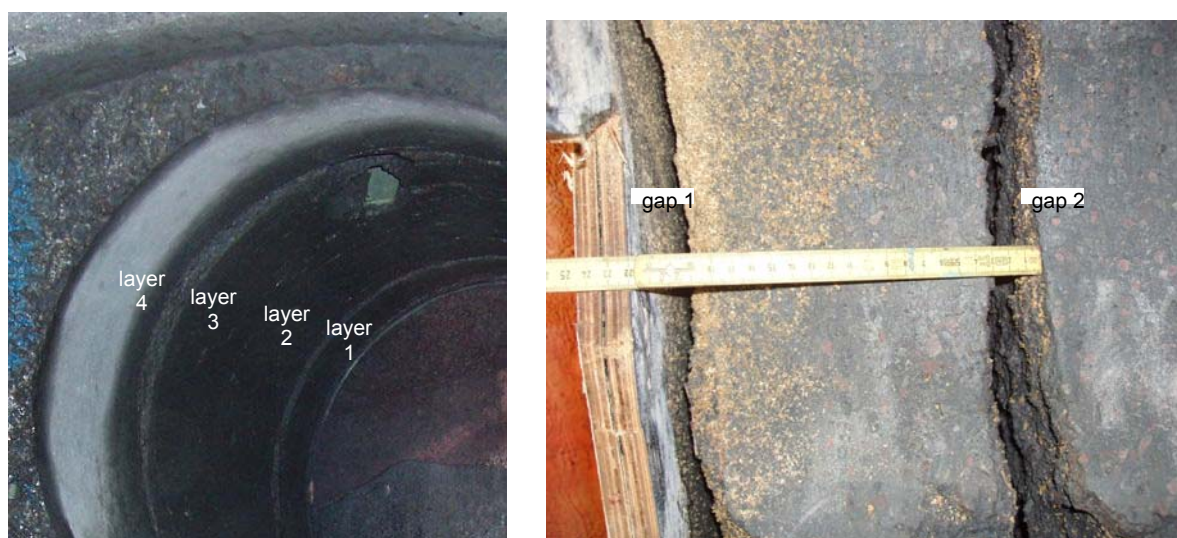
A gap measuring some 20 mm in thickness was found between the wooden support and the concrete (gap 1 in Figure 19). It is not possible to state when this gap might have occurred, either during the loading of the plug or the drilling of the horizontal boreholes, since (for reasons of design) the wooden frame had the potential to move forward during pressurisation of the water chamber and, therefore, might in this case have also moved backwards during the drilling of the entry to the water chamber. Another gap measuring between 20 mm and 40 mm in width was found along the surface of the penetration at a distance of about 200 mm from the rear end of the plug, approximately at the contact between concrete layers 1 and 2 (gap 2 in Figure 19). From visual inspection this gap appears to extend across the entire surface of the plug. The concrete in the layers 2 and 3 is very homogeneous and the contact between them difficult to observe.

*Figure 19: Appearance of shotcrete layers (left) and detail of gap between layers 1 and 2 (right)*

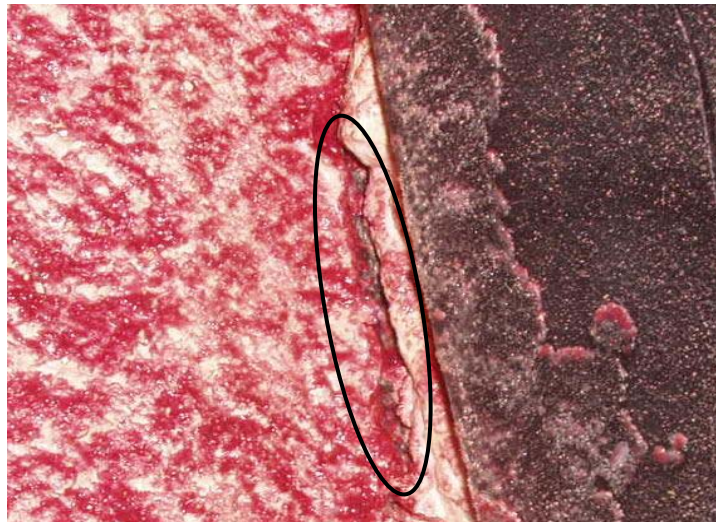
- The contact between the wooden support and the watertight membrane seemed to be intact, except for the lower left-hand part facing towards the entrance. In this zone the membrane presented a fissure (Figure 21).
- No signs of displacement could be observed at the anchoring points of the four beams that supported the wooden frame when these were removed.
- The membrane seemed to be intact and well bound along the entire rock surface of the chamber.

*Figure 21: Detail of fissure in the water membrane (lower left section facing towards the entrance)*

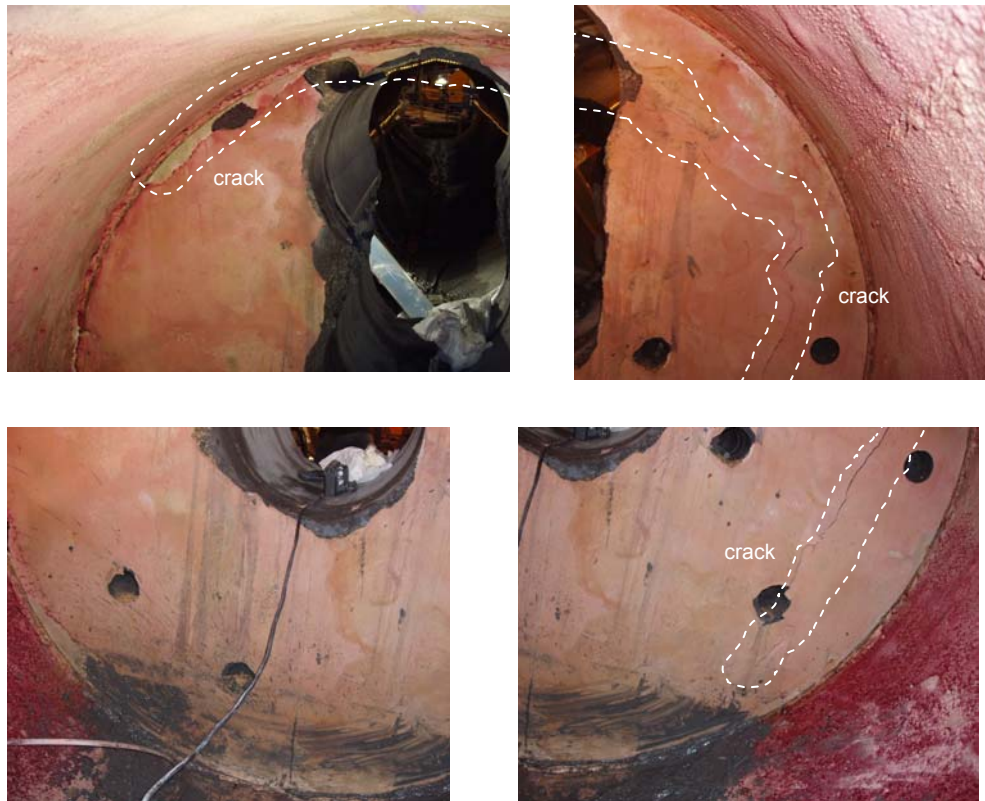
After removal of the wooden support, the membrane at the rear end of the plug was left exposed (Figure 22). In general, it presented a homogeneous appearance across the entire concrete surface, with a thickness of around 5 mm. A crack in the membrane that extends into the concrete (Figure 21) was observed almost along the whole surface (Figure 23).

*Figure 22: Appearance of membrane after removal of the wooden support*

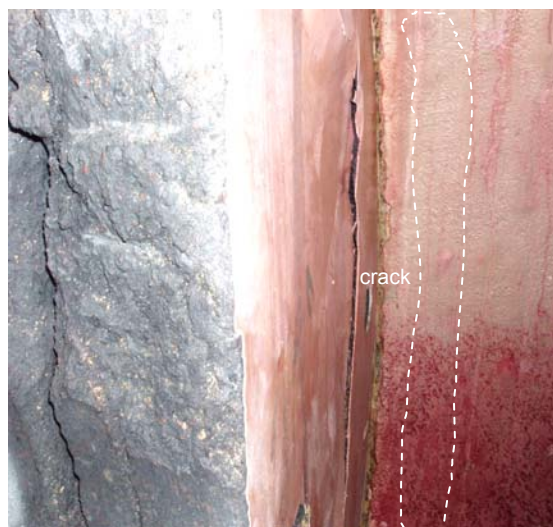
*Figure 23: Detail of the crack (side view from penetration)*

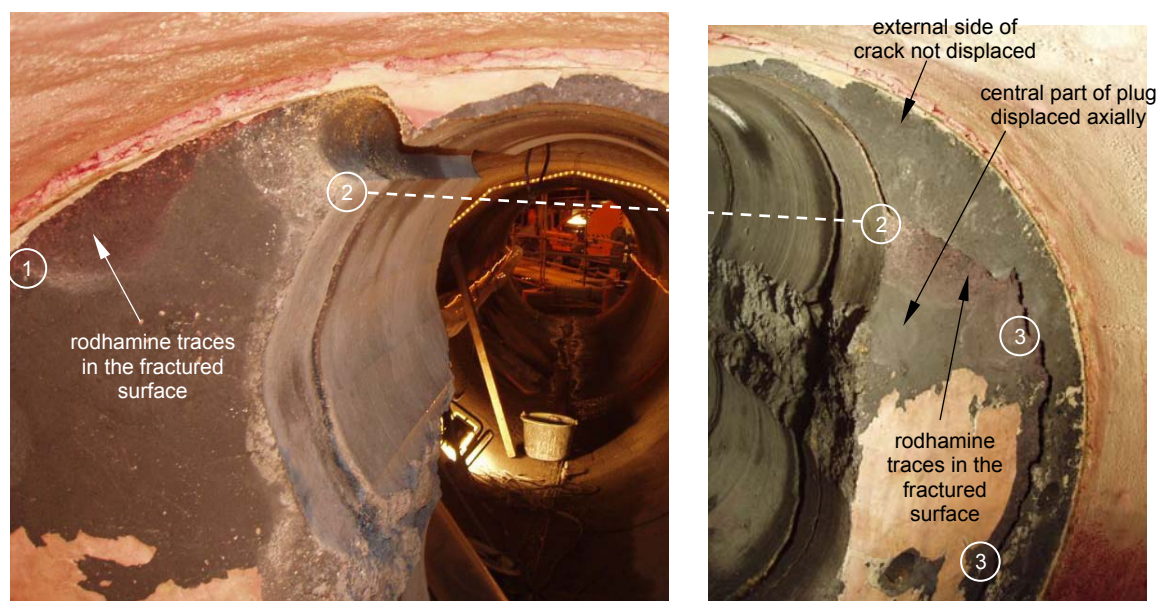
The inspection continued with the removal of the membrane. The concrete at the rear end showed a solid appearance, without pores. The crack could now be clearly seen, starting close to the rock, at 45° upper-left side (1 in Figure 24) facing the entrance, running through the pass-through (2 in Figure 24) and down to the lower right-hand side along the perimeter of the section (3 in Figure 24). A gap of 15 mm to 20 mm was measured in the axial direction of the gallery between the two sides of the crack. It was noticed that the side of the concrete on the crack in contact with the rock had not undergone axial displacement, so this gap was due to a displacement of the central part towards the entrance. The fractured surface of the concrete of

the crack was coloured with Rodhamine, so it is clear that the water penetrated through this crack into the gap between layers 1 and 2.

**Figure 24: Concrete appearance, crack and traces of Rodhamine on fractured surface**

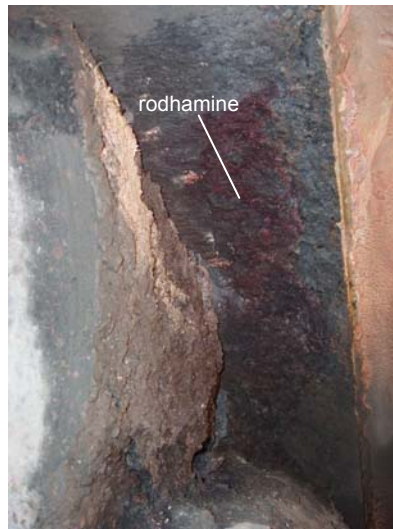
The inspection finished with the removal of a concrete piece from layer 1 (Figure 25). The penetration of the Rodhamine doped water may be clearly observed in the rock (Figure 26), as well as on the exposed surface of the concrete.

*Figure 26: Detail of Figure 25; side view of the rock surface following removal of the rock piece showing the penetration of Rodhamine*

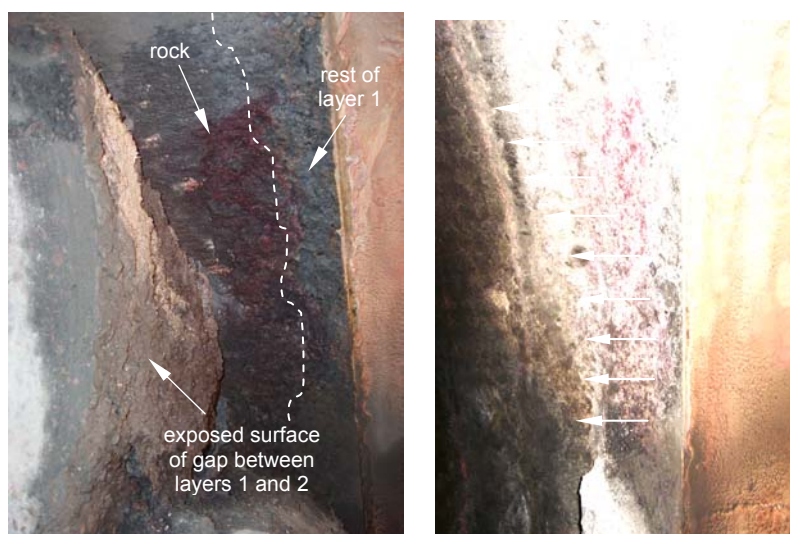
After dismantling concrete layer 2, it was observed that the penetration of rodhamine affected the fractured zone in layer 1, but it did not progress further along the concrete-rock contact, indicating that there was no gap between concrete and rock beyond layer 1 (Figure 28). This was observed more clearly along the entire periphery after the completion of the demolition (see 6.2.5.2).

*Figure 28: View of penetration front before (left) and after (right) demolition of layer 2*

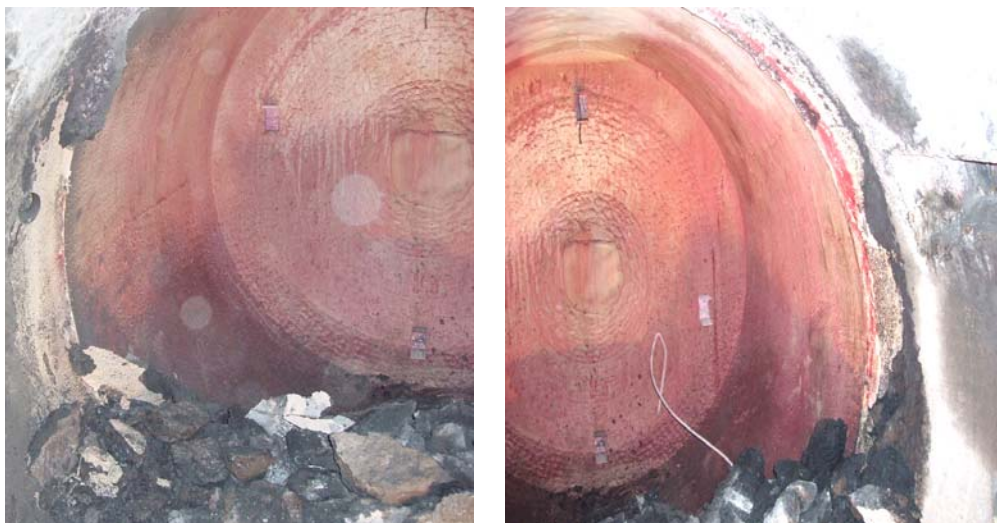
No noticeable variations in the porosity or noticeable heterogeneities in the bottom part of the concrete were observed either during breaking with the splitter or upon close inspection of the pieces of concrete removed. No clear signs of flow paths with Rodhamine were observed in the bottom part of the plug. Figure 30 shows the marks of Rodhamine along the entire contact between layer 1 and the rock, which did not progress through layer 2.

*Figure 30: View of rodhamine marks, along only the layer 1-rock contact*

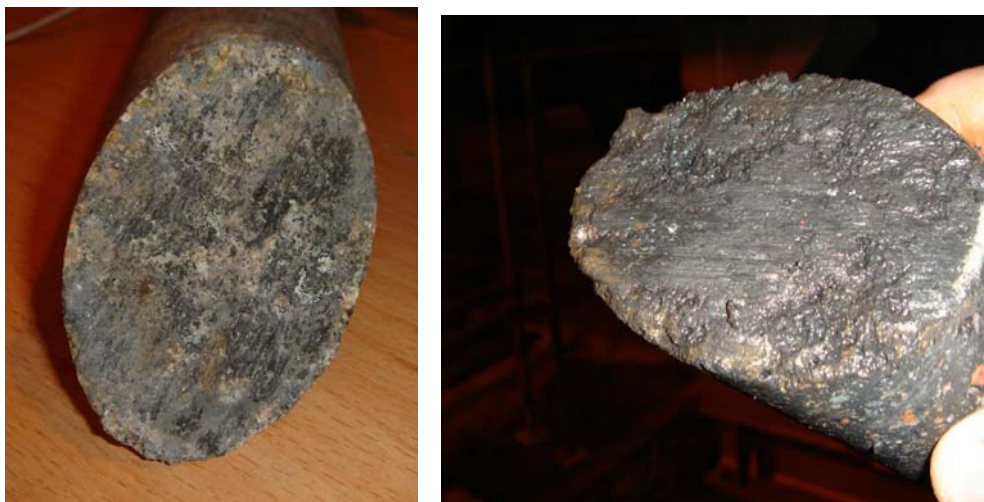
The core extracted from the top of the plug showed slickensides both in the concrete and in the rock (Figure 36). This is a clear indication of the tight contact existing between the concrete and rock, at least in the central part of the plug.

*Figure 36: Detail of core 3.I from the top of the plug; rock core (left) and concrete core (right) both with slickensides*

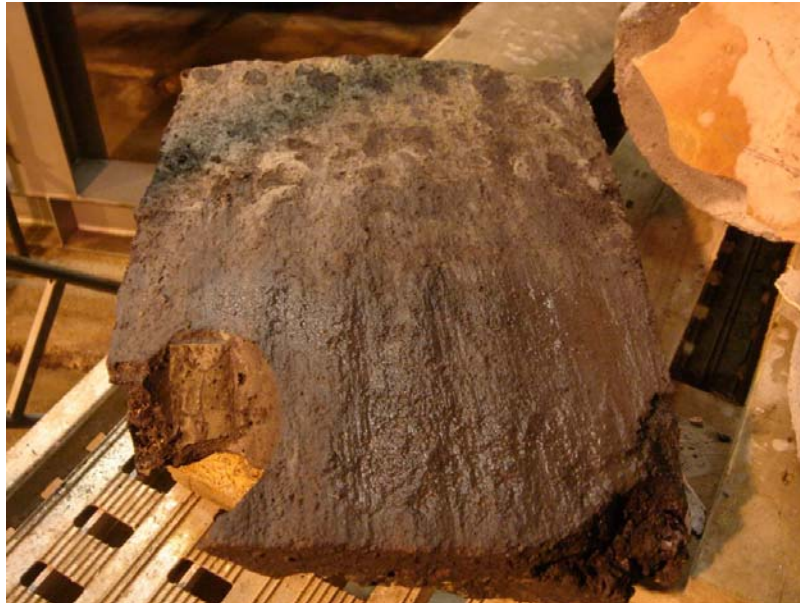
The contact between the rock and the concrete above the penetration was studied by cutting a rectangular piece of the concrete (600 mm long by 400 mm wide) using a saw. Again, the entire surface of the concrete in contact with the rock showed slickensides (Figure 39).

*Figure 39: Concrete in contact with rock at top of the gallery*

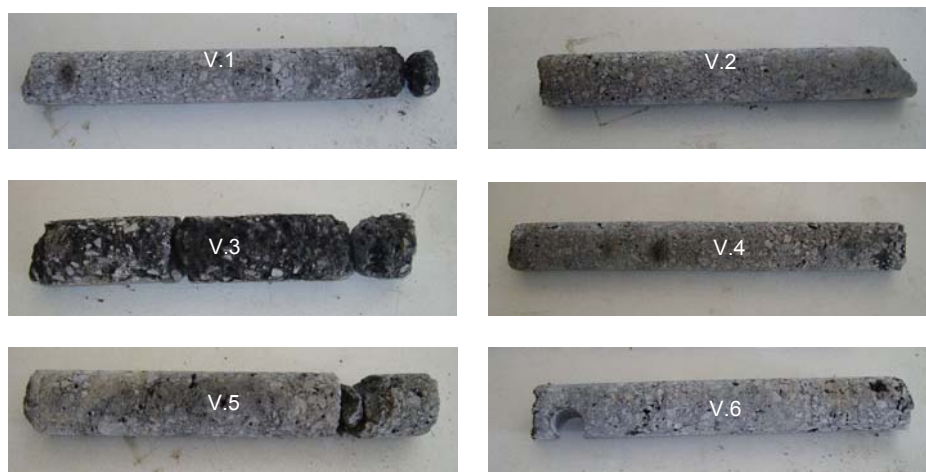
Boreholes V.1, 3 and 5 were drilled in concrete layer 3, while V.2, 4 and 6 were drilled in concrete layer 2. In the cores from layer 2 a more heterogeneous and porous zone was observed at a few centimetres from the rock. Apart from this, no significant variation may be observed between the bottom and top parts of the cores.

*Figure 41: Vertical cores*
