DOPAS

Deliverable no. 3.20

EPSP plug test installation report

The EPSP plug has been designed as a prototype plug for a future Czech deep geological repository. It is expected, therefore, that similar plugs will be required to function throughout the whole of the operational phase of the repository, i.e. 150 years with an expected over-pressure of up to 7MPa.

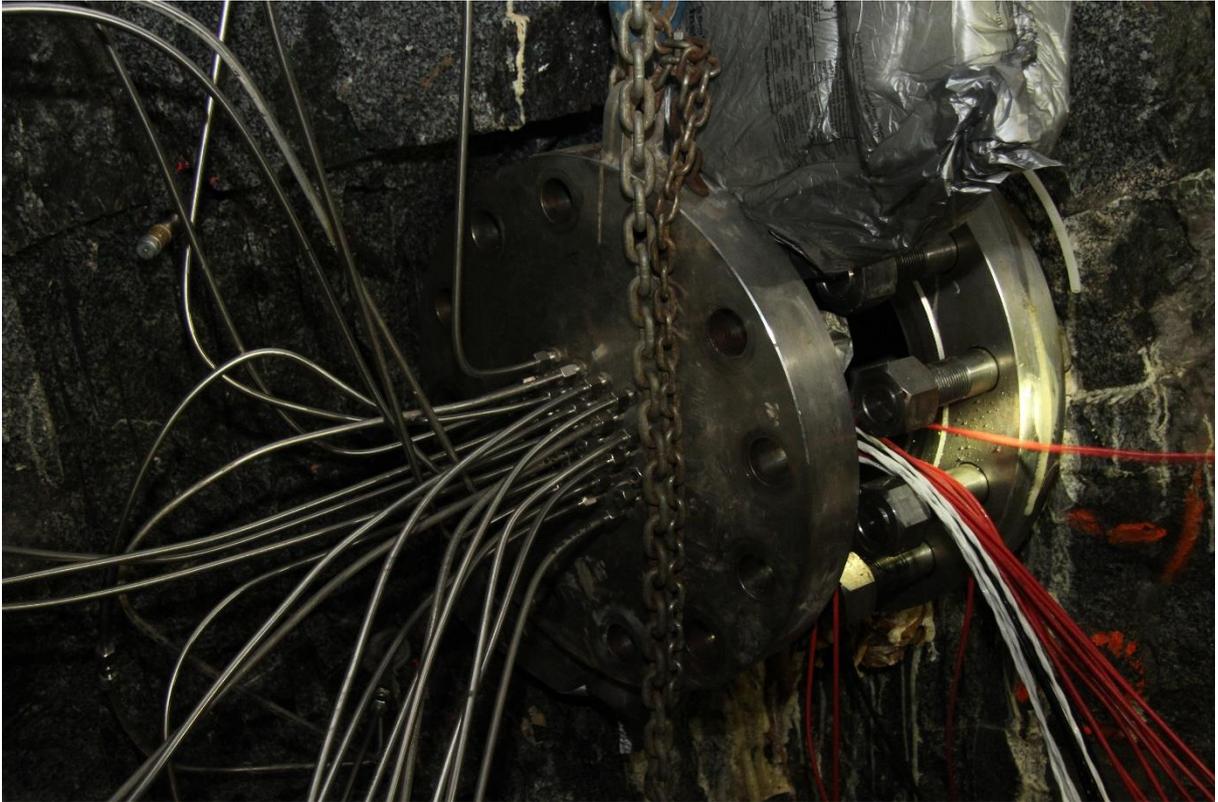
Figure 5 - Cable head before leading the cables through the borehole (29 August 2014)

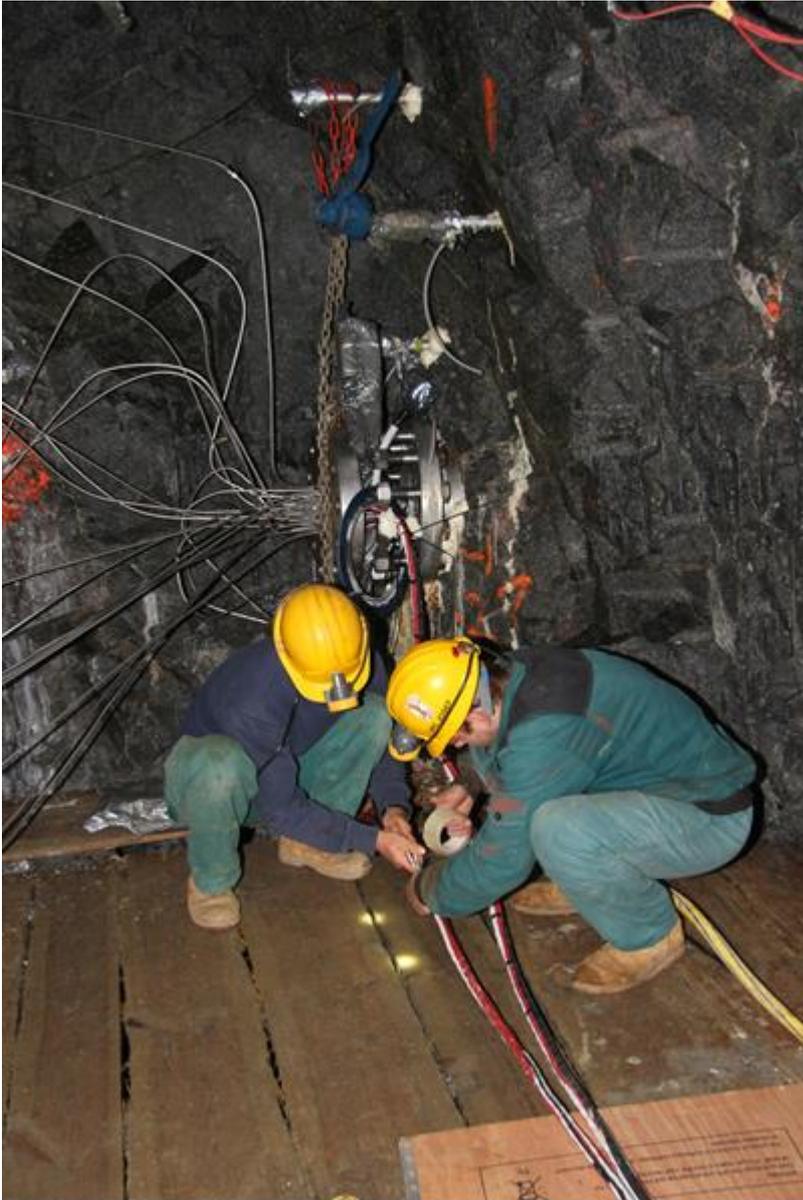
Figure 6 - Preparation for the leading of the cables

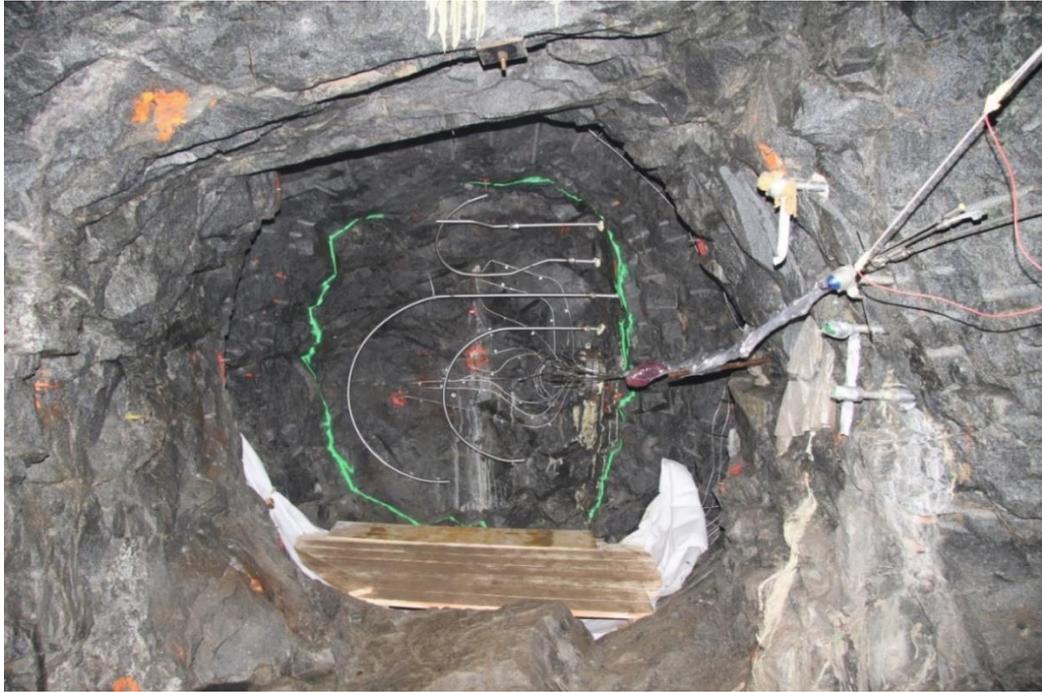
The walls and floor of the pressurisation chamber were treated using shotcrete and SikaTop-122SP (www.sika.com). The thickness of the profiling was such that there was a gap of 100mm between the remodelled chamber surface and the next structure (the first concrete separation wall). The surface of the remodelled chamber was treated with a 3mm-thick waterproofing finish of SikaTop Seal 107 (www.sika.com). The instrumentation for the monitoring of the shotcrete filling (temporarily stored at the side of the plug space) was installed between the application of individual batches of shotcrete and once shotcreting was completed.

Figure 9 - Pressurisation chamber prepared for shotcreting (24 October 2014)

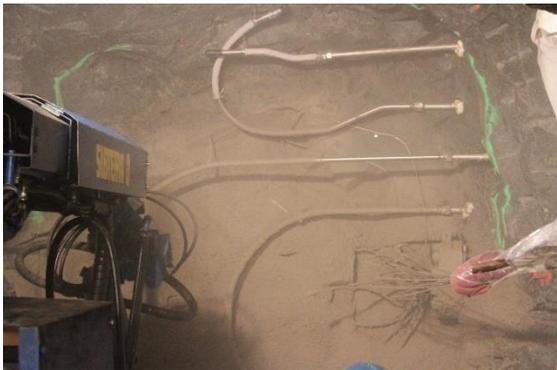
The shotcreting process also served as the ultimate test of the technological setup for plug erection (the same machine setup was used).

Figure 10 - Shotcreting of the chamber (27 October 2014)

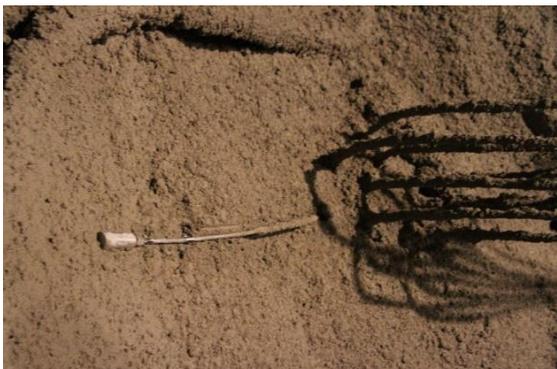
Figure 11 - Sensor installation within the shotcrete (27 October 2014)

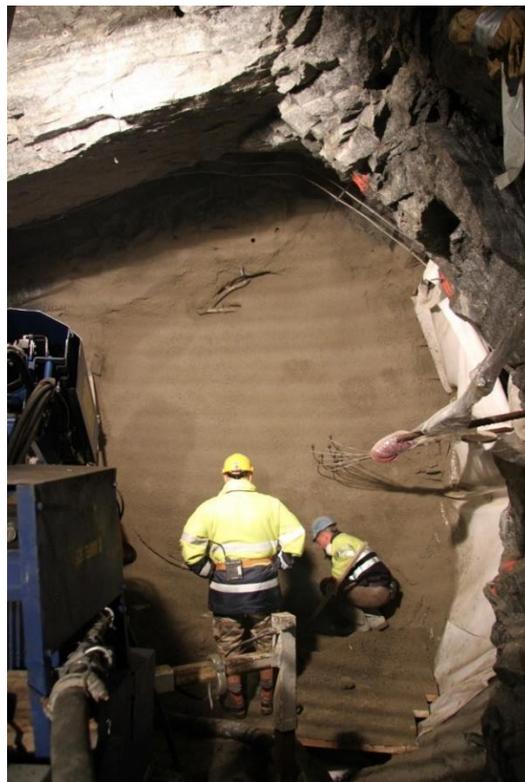
Figure 12 - Completed shotcreting (27 October 2014)

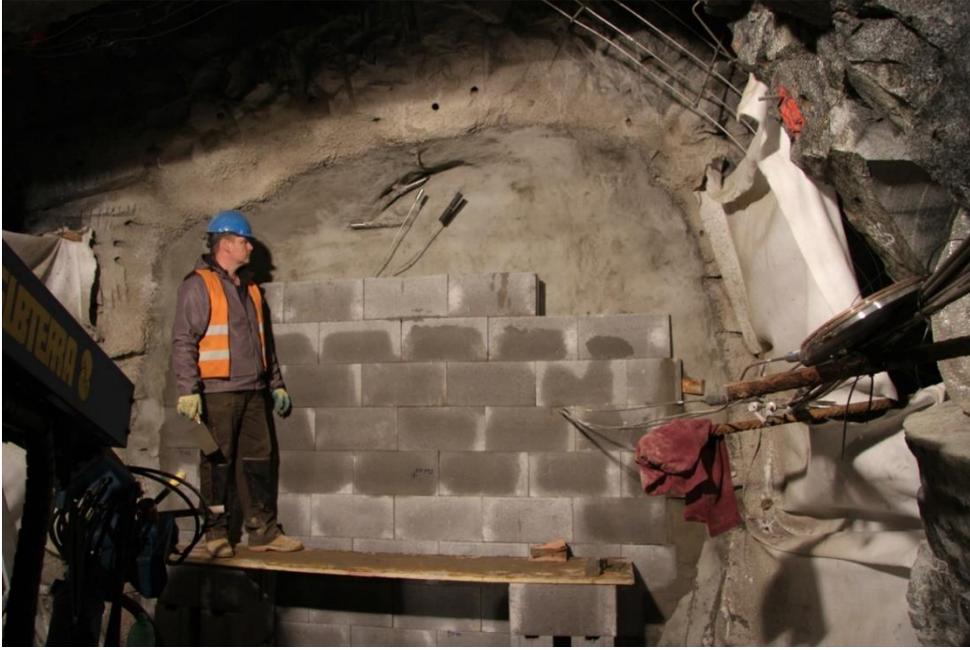
Figure 13 - Separation wall erection (4 November 2014)

The separation wall was made of prefabricated hollow blocks (in the form of a lost formwork) which were filled with concrete. The spacing of the blocks was intentionally “loose” so as to allow for free water flow through the wall.

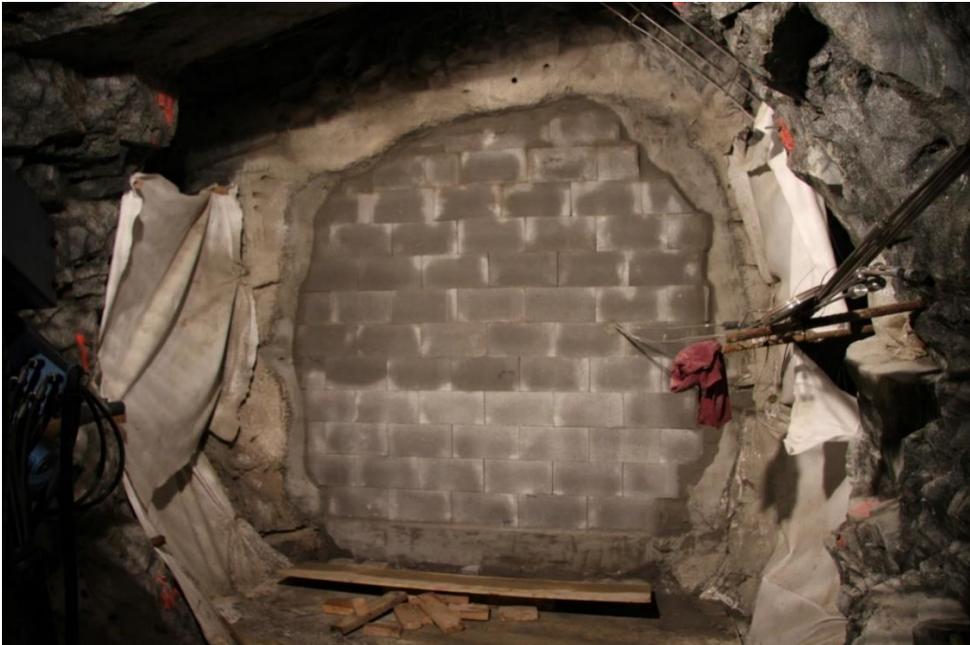
Figure 14 - Completed separation wall (5 November 2014)

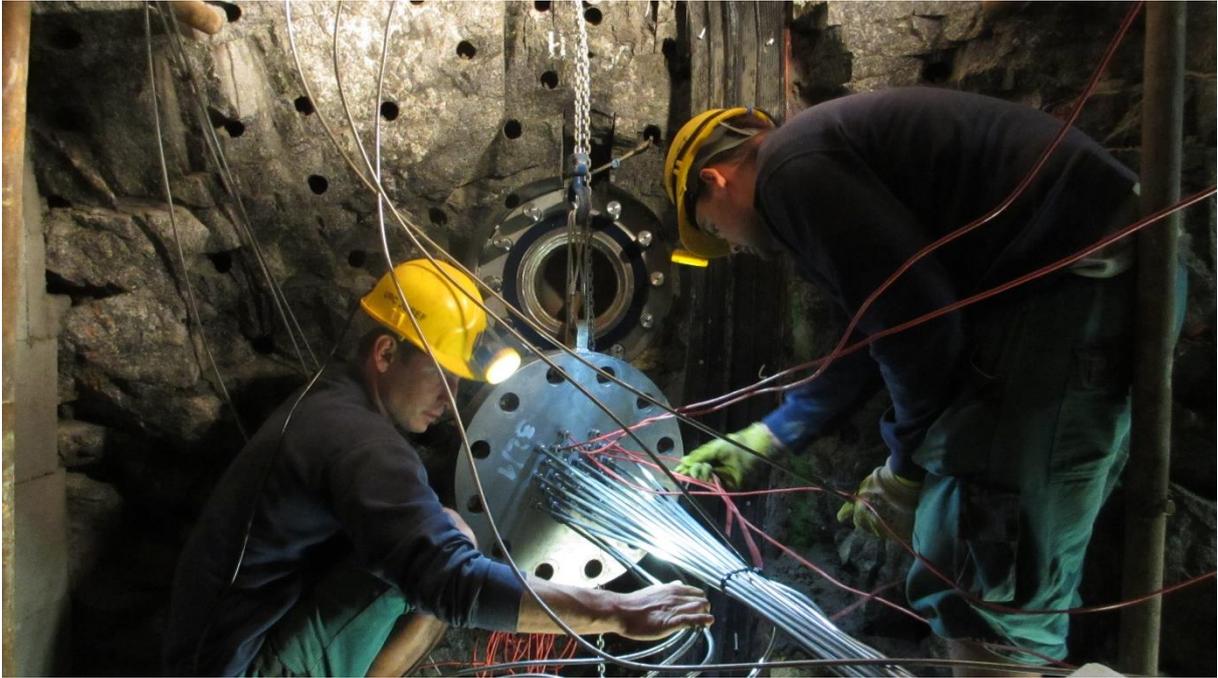
Figure 15 - Cable head preparation (outer plug, 17 June 2015)

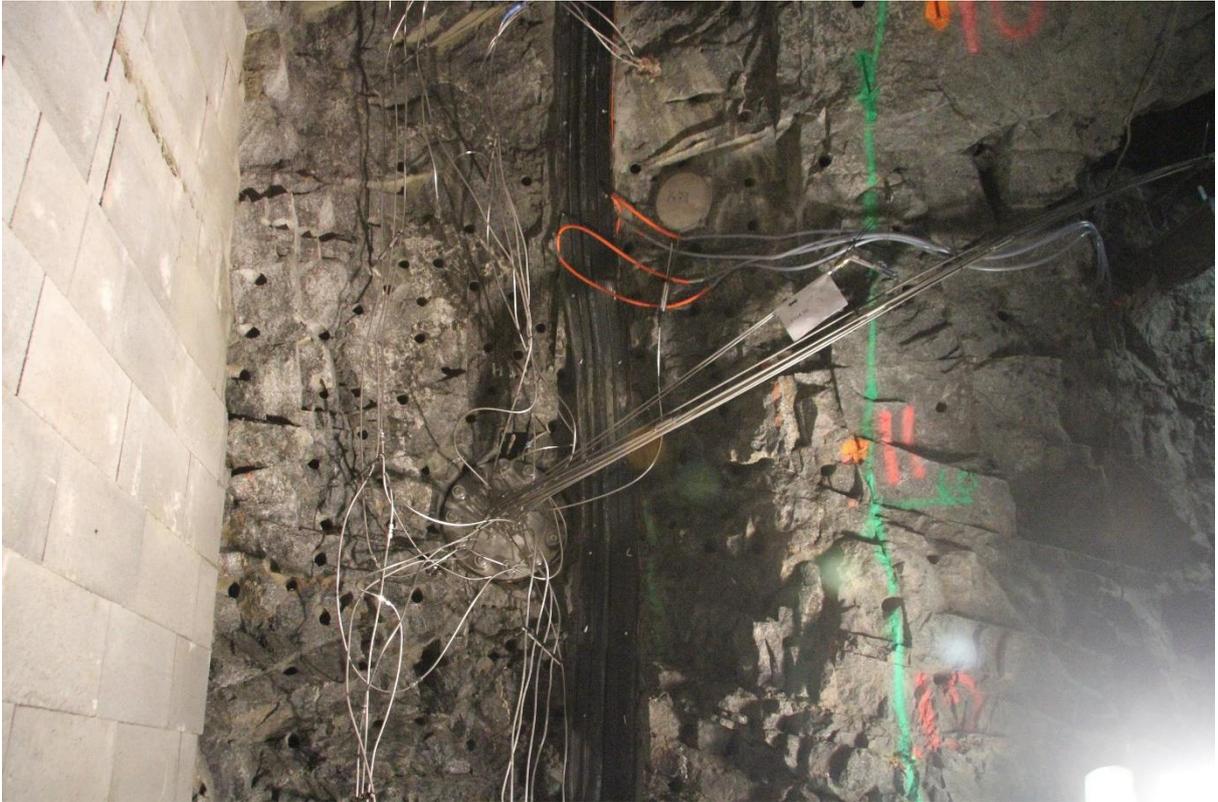
The fourth step involved the fixing of the cabling (in protective tubing) to either the rock mass or to so-called “ladders”. The cabling was arranged in such a way as to minimise its impact on the shotcreting, i.e. to avoid the creation of shadows by the spreading of the cables.

The instrumentation destined to be positioned in the shotcrete plug itself was temporarily stored at the sides of the plug space. It was positioned later as the shotcreting of the plug progressed.

Figure 16 - Cable head and instrumentation before shotcreting (outer plug, 19 June 2015)

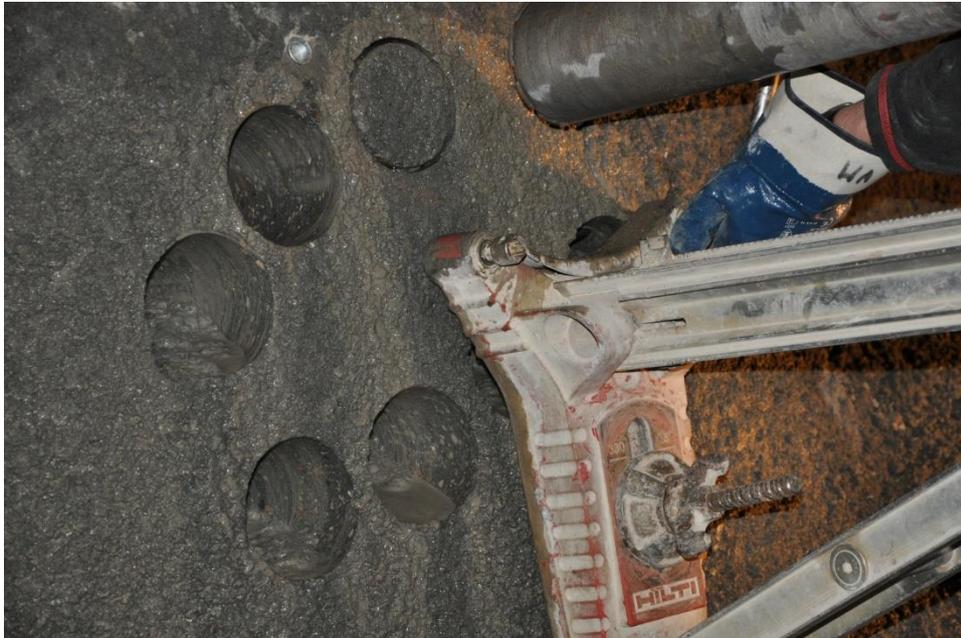
Figure 17 - Core sampling in-situ (material qualification test)

Two mixes were tested and their suitability assessed based on a consideration of pH, compressive strength, rheology and other parameters (Table 1). The two mixtures were also subjected to mock-up tests in a testing niche in the Josef URC underground laboratory (Figure 17).

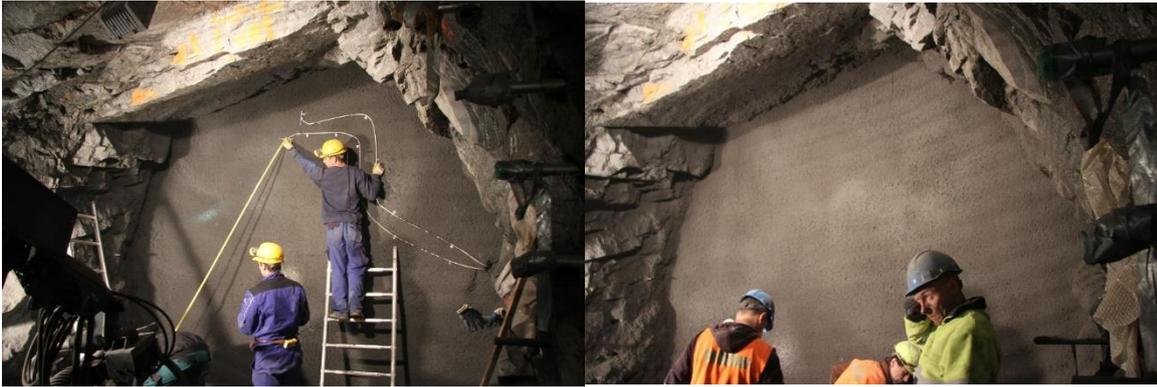
Figure 18 - Inner plug erection and sensor installation (12/13 December 2014) – reloading of the concrete mix, offloading the mix into the pump, shotcreting machine, first batches sprayed, instrumentation installation, finished plug

Once the plug had cured, a pressure test was undertaken using water and air. Measurements and observations taken during the test demonstrated that contact grouting would be necessary between the plug and the rock mass so as to ensure water tightness.

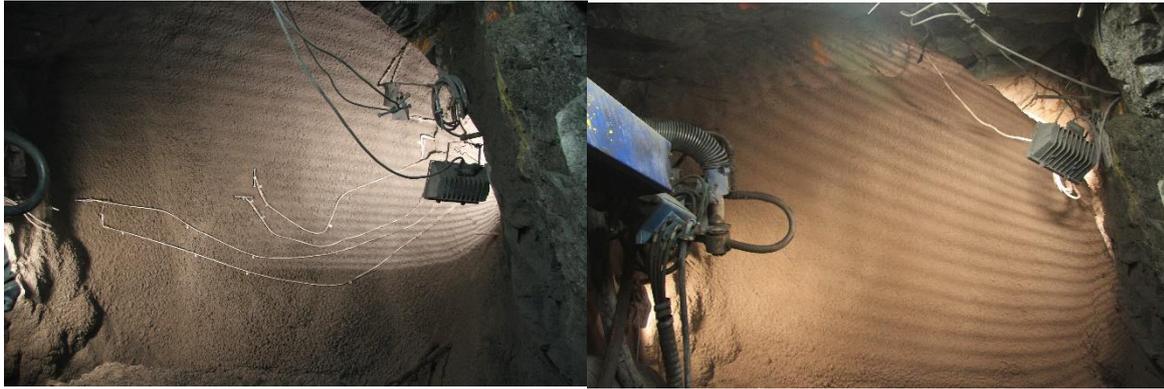
Figure 19 - Outer plug erection (19/20 June 2015)

Once the plug had cured, grouting was undertaken using the preinstalled tubes. The initial pressure testing of the EPSP demonstrated that this grouting was insufficient and additional grouting was employed in a similar way as with the inner plug.

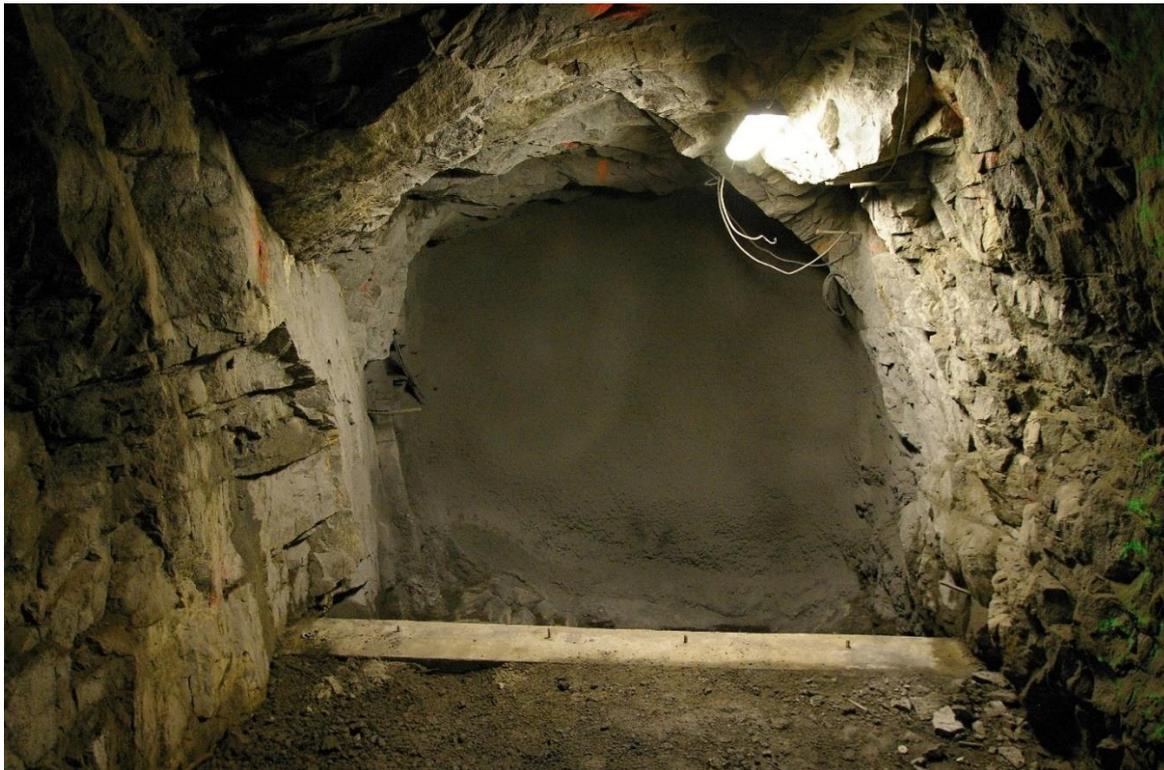
Figure 20 - Finished outer plug

The shotcrete plugs behaved very well during the curing period. The maximum temperature reached inside the plug was approximately 55°C, thus presenting no danger to the concrete. No shrinkage (or other) cracks were detected on the bodies of the plugs. The only cracks detected were located between the shotcrete sprayed on the sides of the niche (outside of the plug) and the bodies of the plugs which would tend to indicate that the body of each plug shrank in one piece while probably separating to some extent from the rock surface.

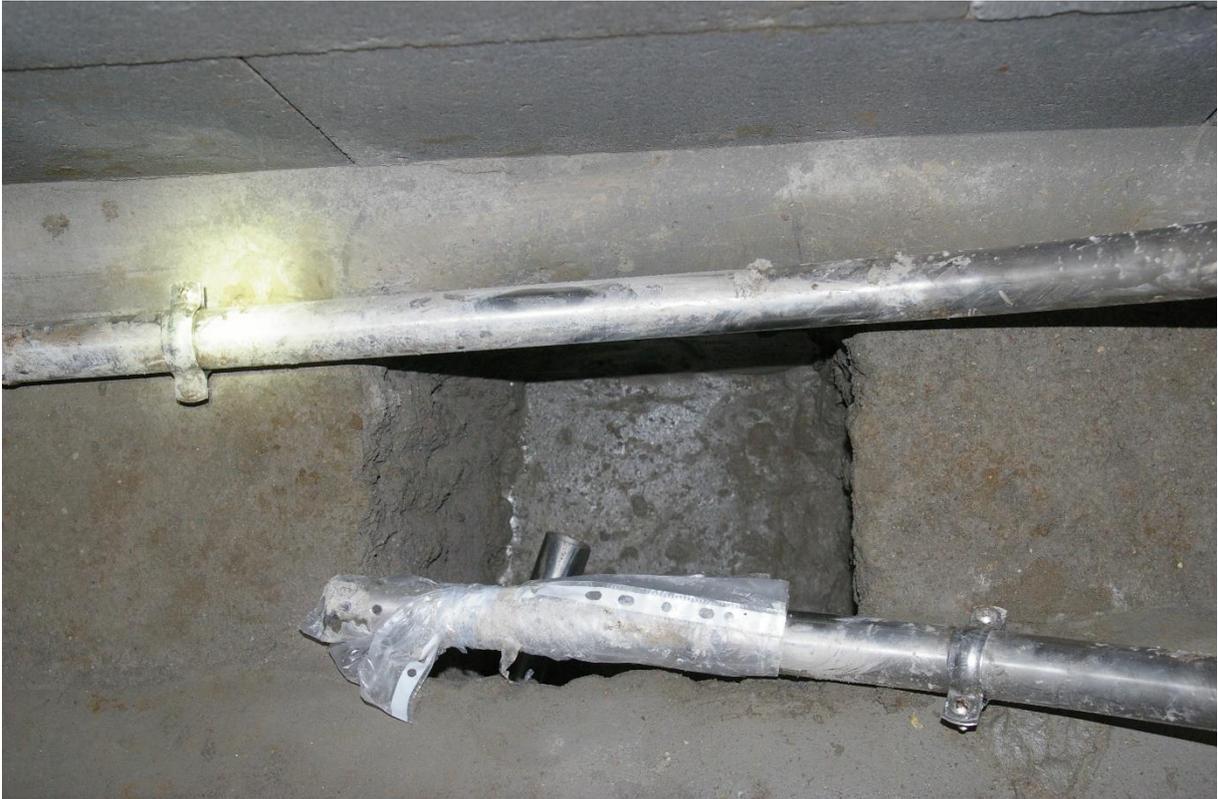
Figure 21 – Bottom drain of the filter (pressurisation tubes with temporary protection overlying the drain)

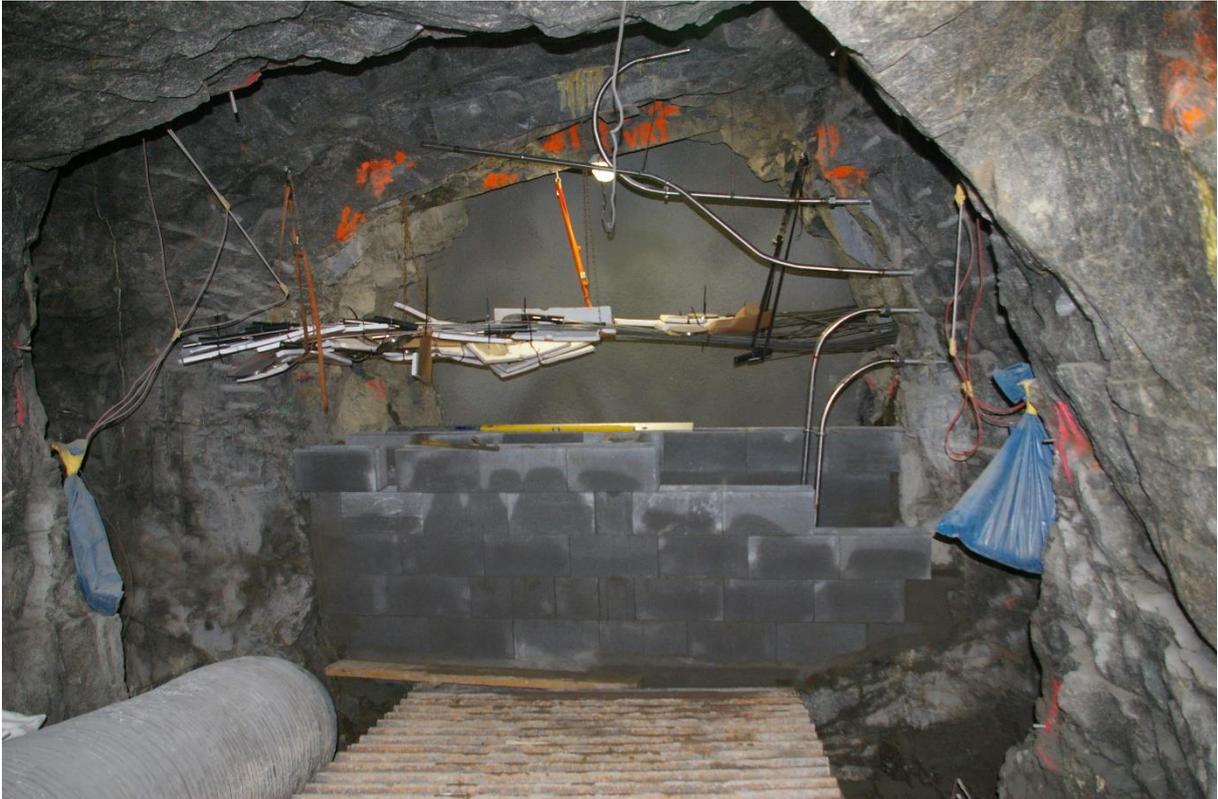
Pressurisation tubing similar to the tubing in the pressurisation chamber was installed in advance prior to the erection of the filter. The piping, which is able to serve as pressurising media in/outlets is connected via boreholes to the technological niche. The piping consists of four welded stainless steel (DIN 1.4571) tubes of a diameter of 38mm. One end of each tube was fixed to the head of the piping leading to the technological niche. The other end was left open into the filter. Two of the pipes ended at the top of the chamber and two at the bottom (Figure 22). The tubes were fixed in place by clamps on stainless steel rods.

Figure 23 - Lower part of separation wall erection with the installed pressurisation piping (5 December 2014)

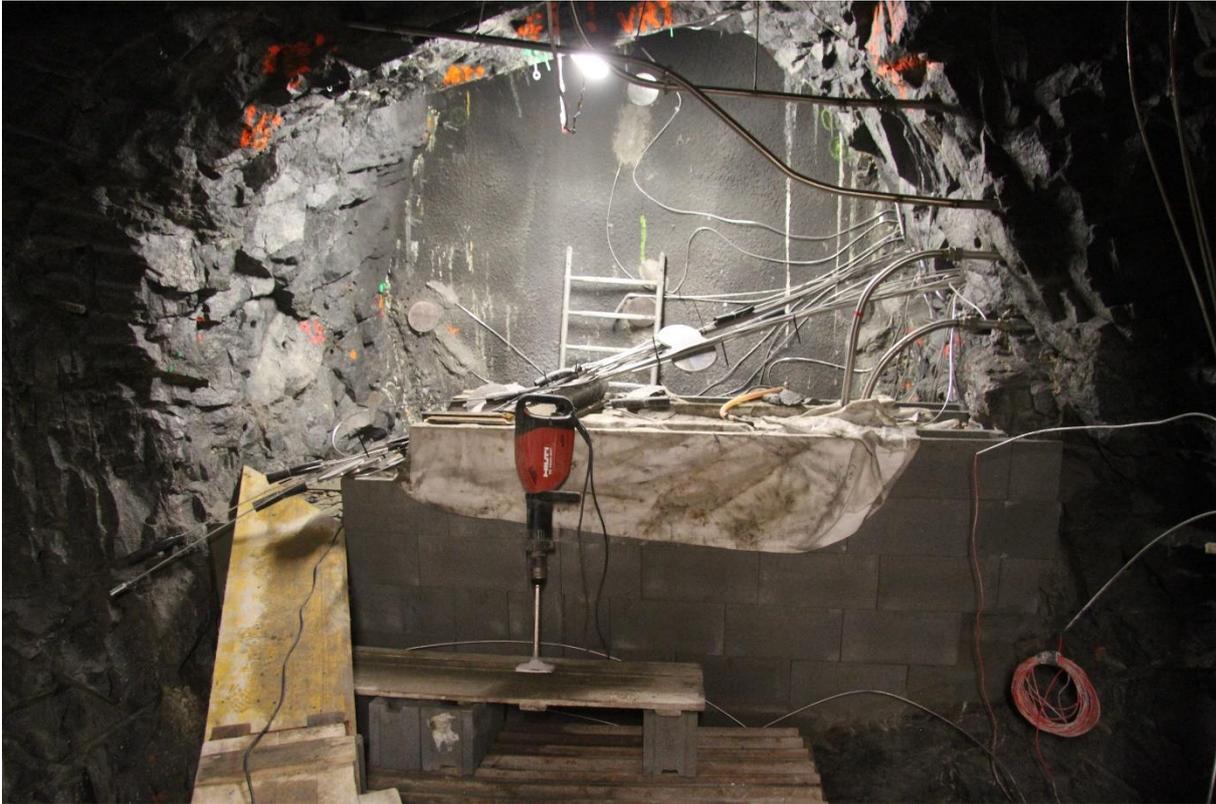
The bottom drain formed a part of the base of the separation walls, therefore it formed the first part of the filter structure to be erected. It was fitted with a stainless steel outlet tube at its lowest point leading through the outer plug and ending with an outlet valve. A water collection device can be fitted below the valve thus allowing for the measurement of outflow water if required.

Figure 24 - First part of the filter erected (photo taken at the time of the start of bentonite installation, 5 June 2015)

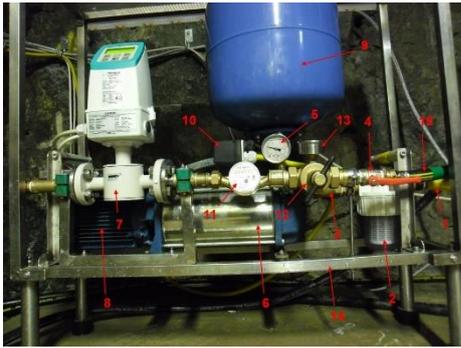
Water is supplied from the reservoir to the low pressure unit which consists of a PLURIJET 6/90 pump, valves, a mechanical pressure regulator on output and a flowmeter. The unit is designed to operate at up to 0.5MPa and at 35l/minute. The output from the low pressure unit is either directly connected to the EPSP (via heads and borehole piping) or to the high pressure unit.

Figure 26 - Low pressure unit

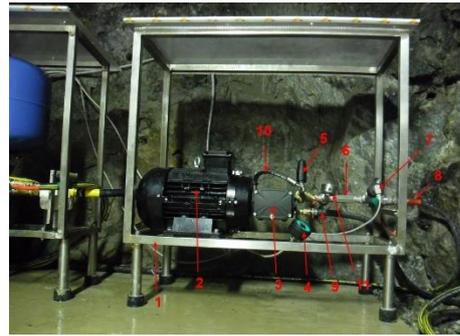
Figure 27 - High pressure unit

The high pressure unit features an Interpump E 21.21/9,2 kW pump capable of attaining up to 20MPa and delivering 20l/minute. The unit allows the electronic measurement of pressure and is equipped with a back flow prevention valve.

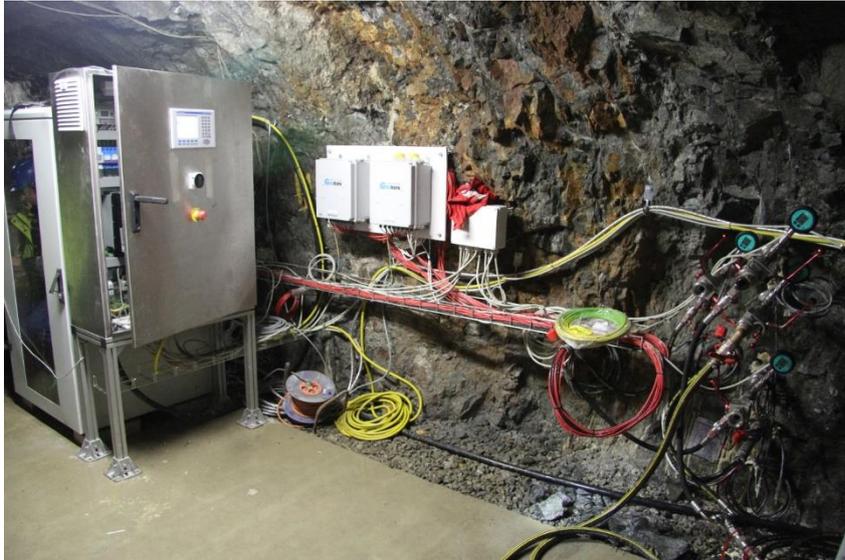
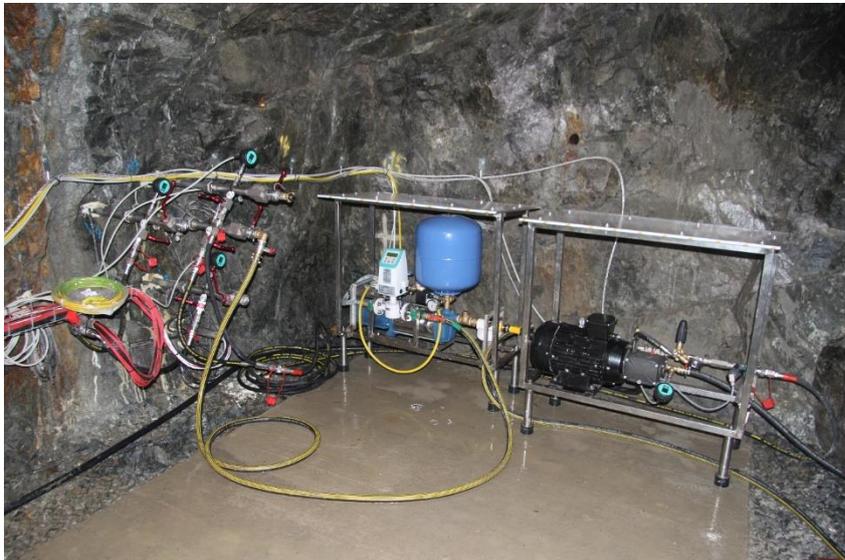
Figure 28 – Technological equipment installation in the niche (24 February 2015)

Figure 29 - Technological equipment installation in the niche (24 February 2015)

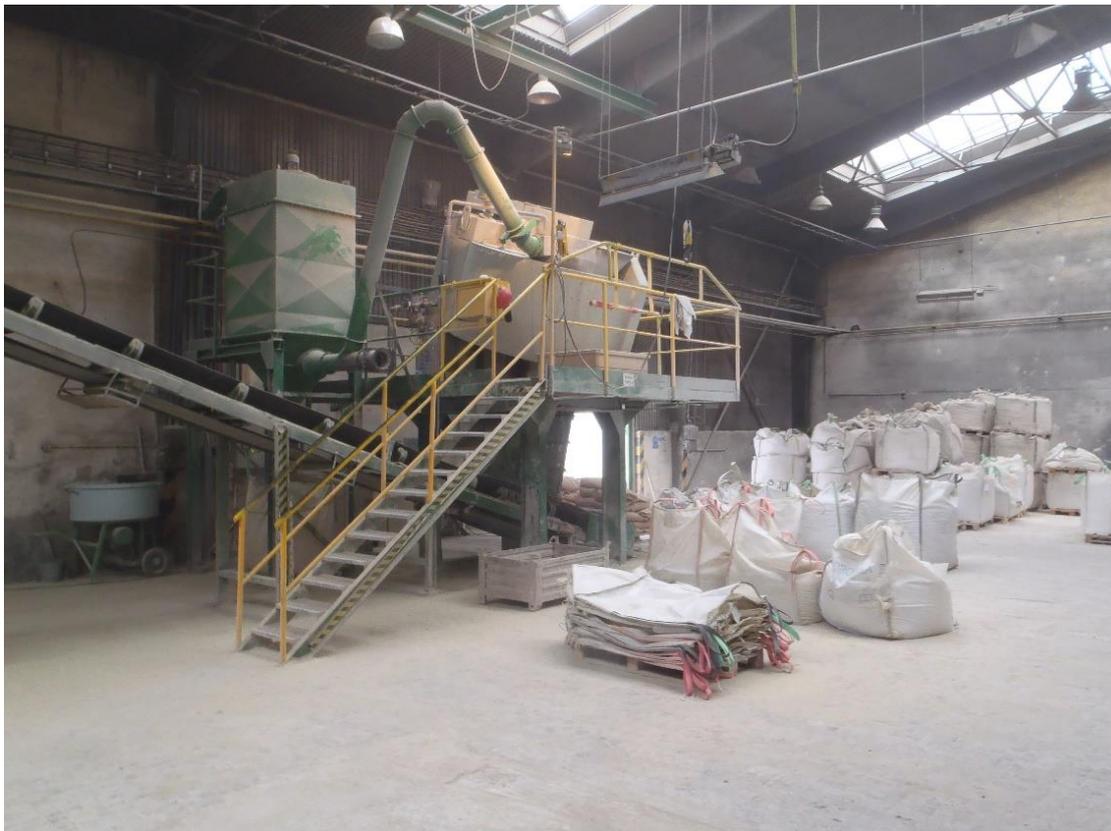
Figure 33 - Mixing machine for adjusting water content in the dry bentonite (from $w=8\%$ to approx. 19%)

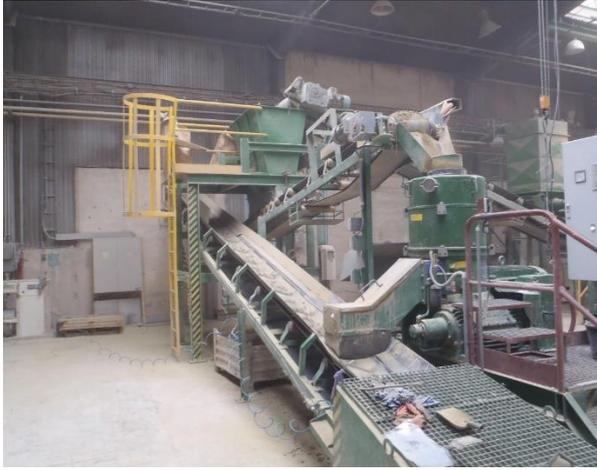
Figure 34 - Roller compaction machine

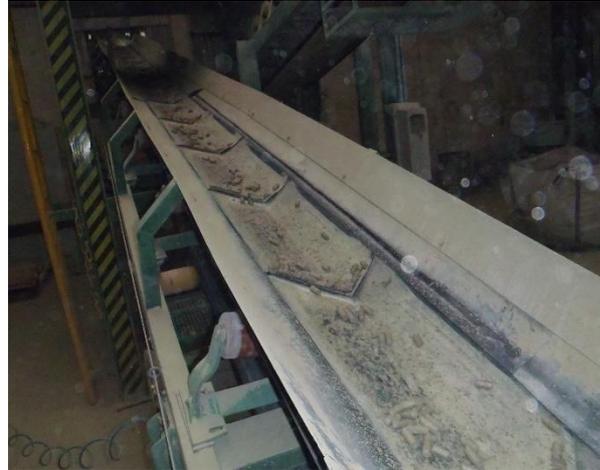
Figure 35 - Transport of the pellets from the roller compaction machine

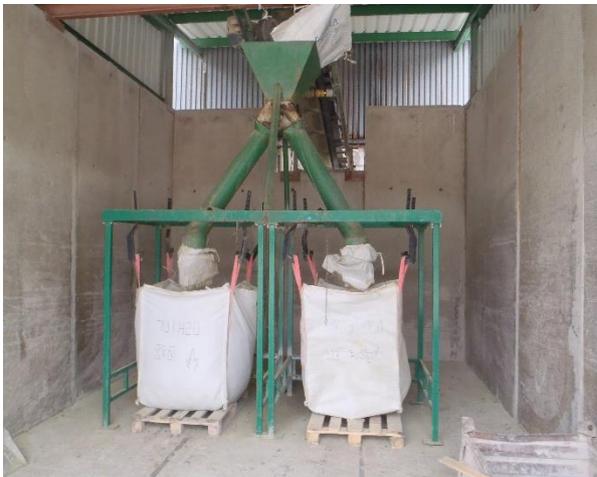
Figure 36 - First stage of packing

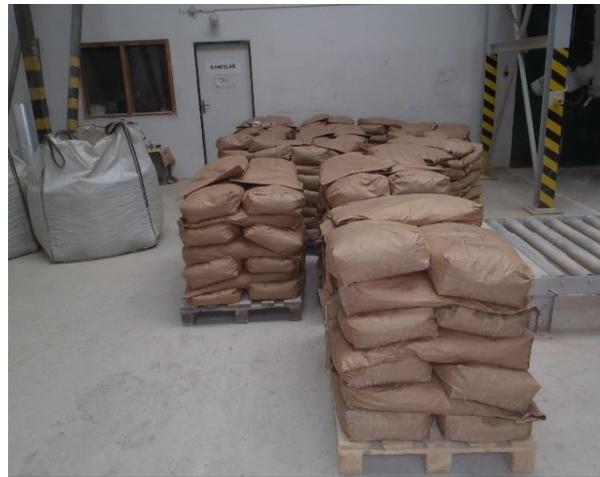
Figure 37 - Final product in bags

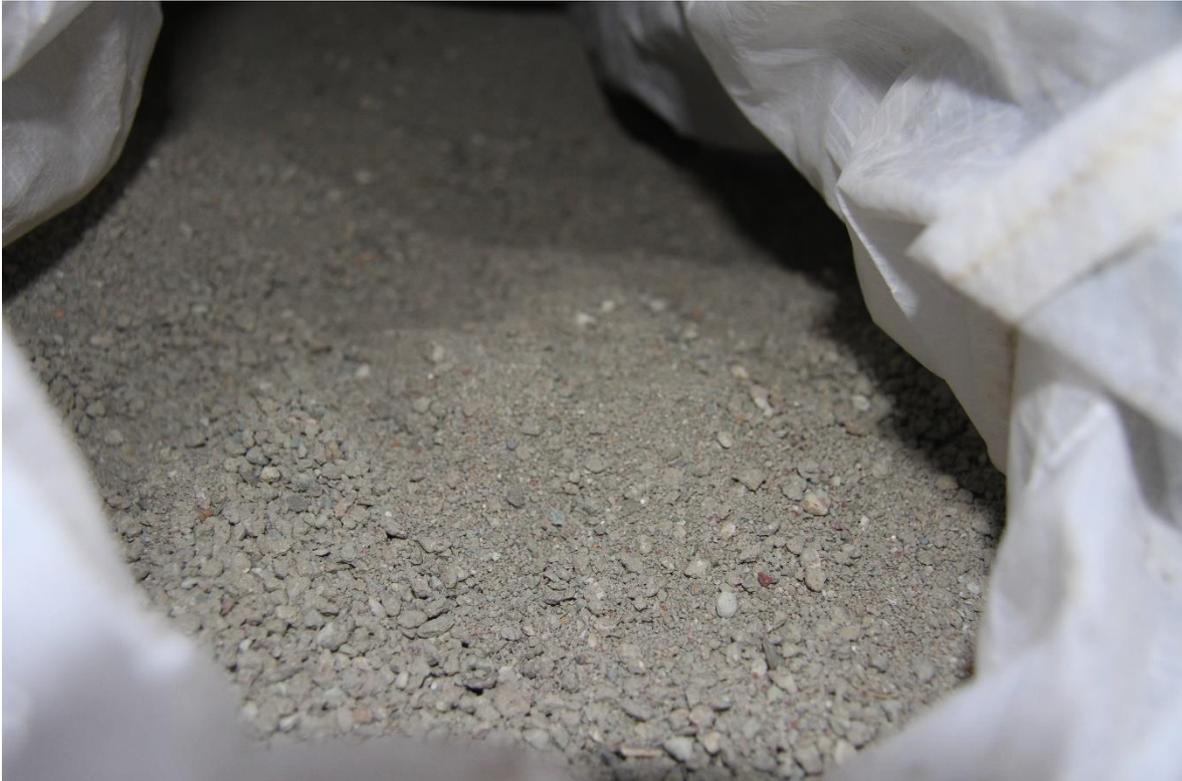
Figure 38 - B75 REC

This material originated as the result of negotiations with a Czech bentonite production company. The pellets (fragments of highly-compacted bentonite plate) are not available commercially but they do represent an intermediate stage of the industrial process employed by the company. Laboratory testing revealed a good level of compaction (dry density 1.70-1.98g.cm⁻³) with a relatively low water content value. The advantage of this technology consists of the production of pellet fragments of various sizes, i.e. it allows for the mixing of various grain sizes in order to achieve the best grain distribution curve which helps in terms of achieving a sufficient level of dry density within the emplaced material. The resulting material was code-named B75 REC. Following pilot testing, B 75 REC 0,8-5 was selected for spraying application (Vašíček et al., 2016).

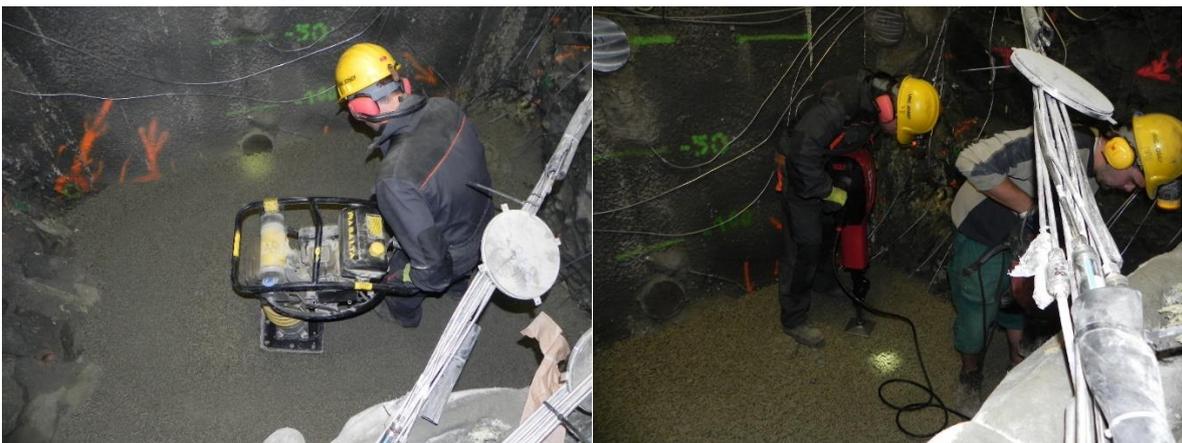
Figure 39 - Vibration compaction

Electric hammer drills (HILTI TE 3000-AVR and HILTI TE 1500-AVR) fitted with plates were used for compaction purposes around the measurement sensors, in the vicinity of the drift wall and in the upper part of the drift.

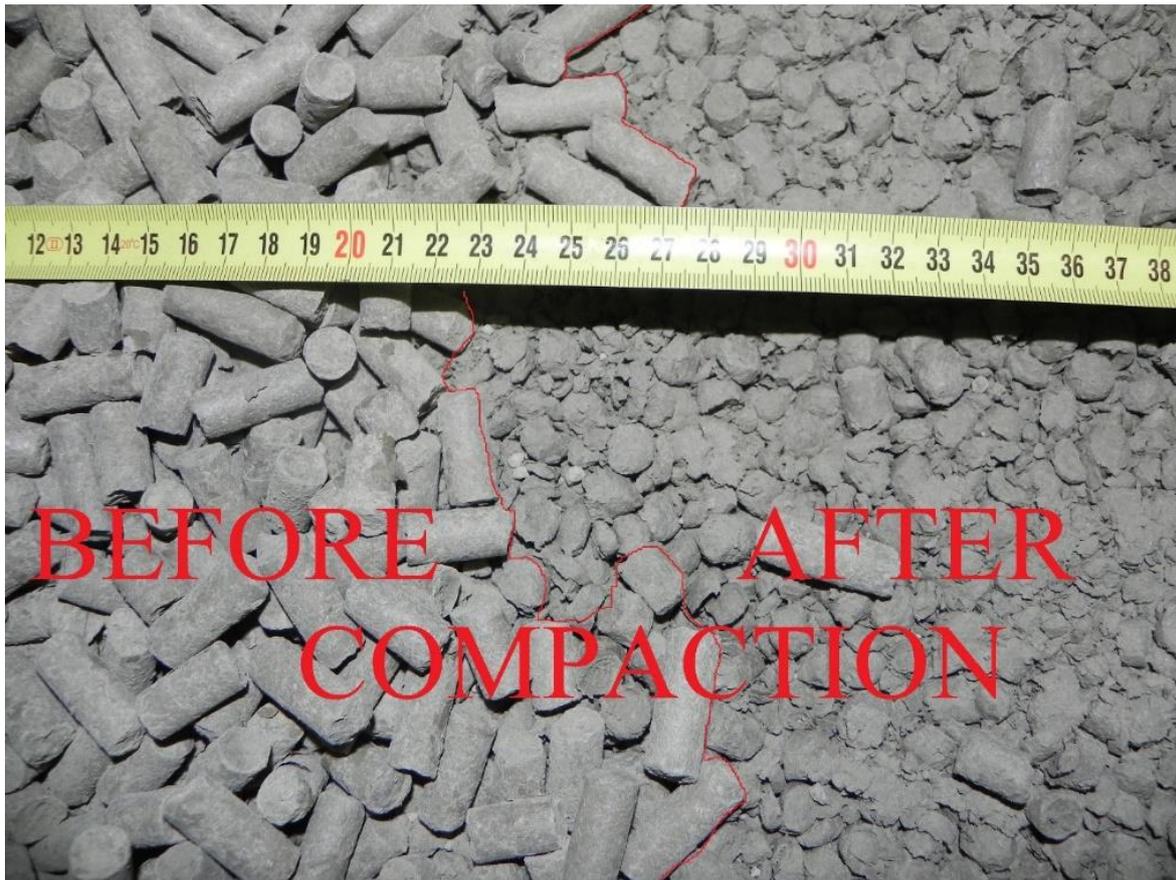
Figure 40 - Emplaced pellets

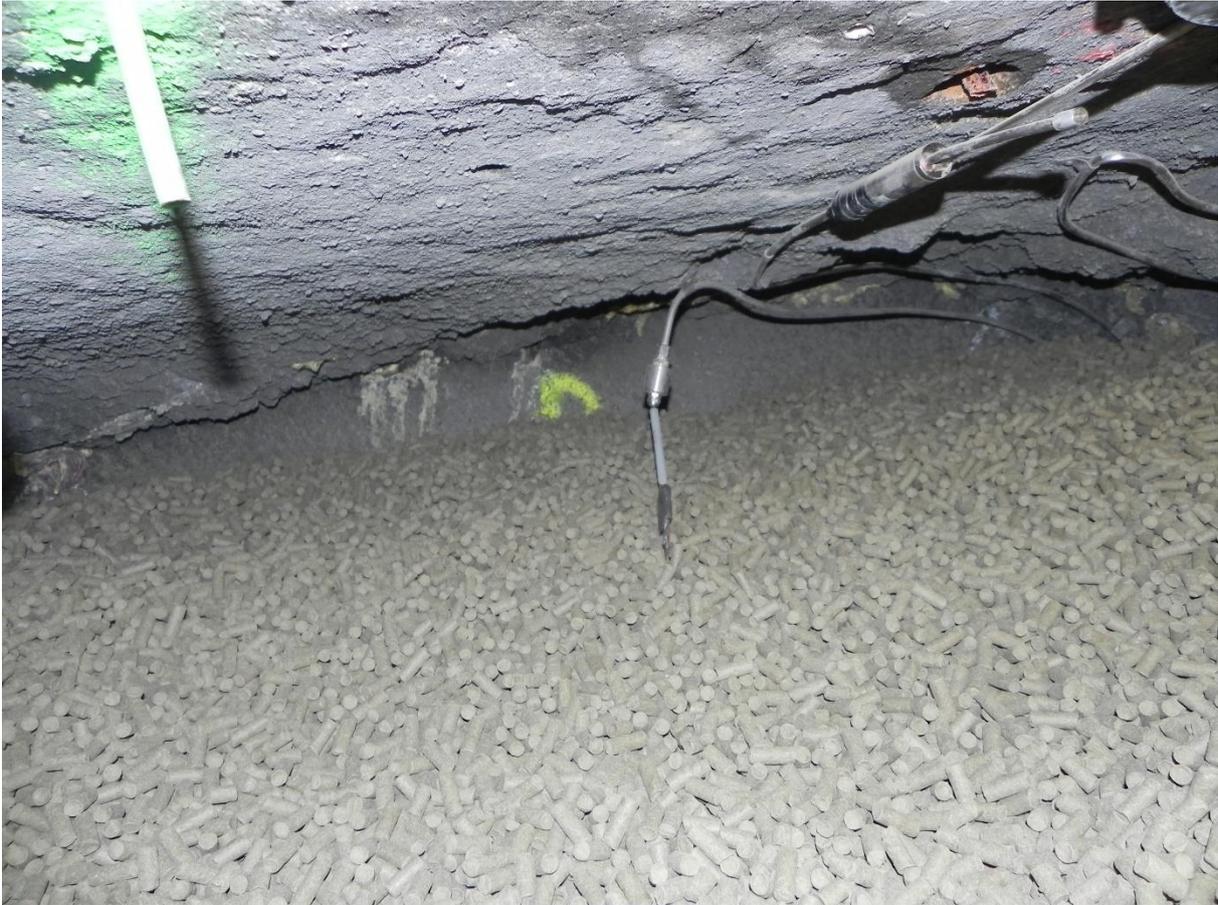
Sprayed clay technology was used for the backfilling of the upper part of the drift. Approximately 5% (1.5m³) was backfilled using sprayed B75 REC 0.8-5. The spraying machine selected consisted of an SSB 14 DUO (Filamos Ltd.) machine with an Atlas Copco electric air compressor (working pressure 10 bar, air capacity 350m³/h). Both machines were pilot tested before the construction phase commenced.

Figure 41 - Upper part of the drift – space to be filled by spraying

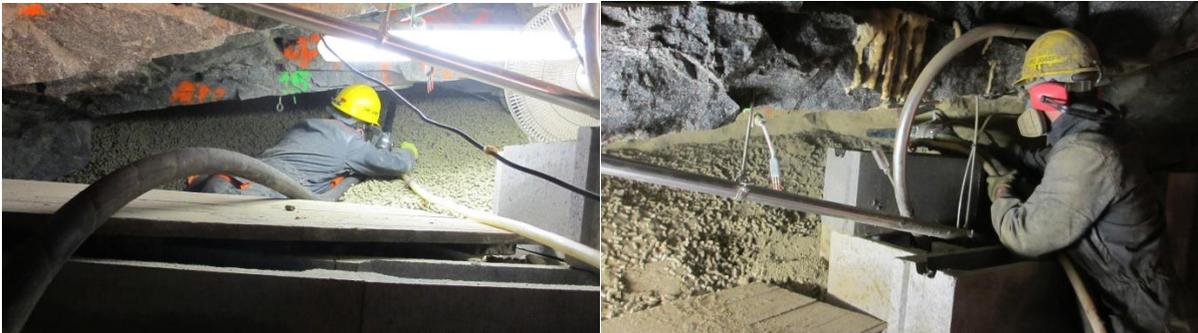
Figure 42 - Spraying of the bentonite

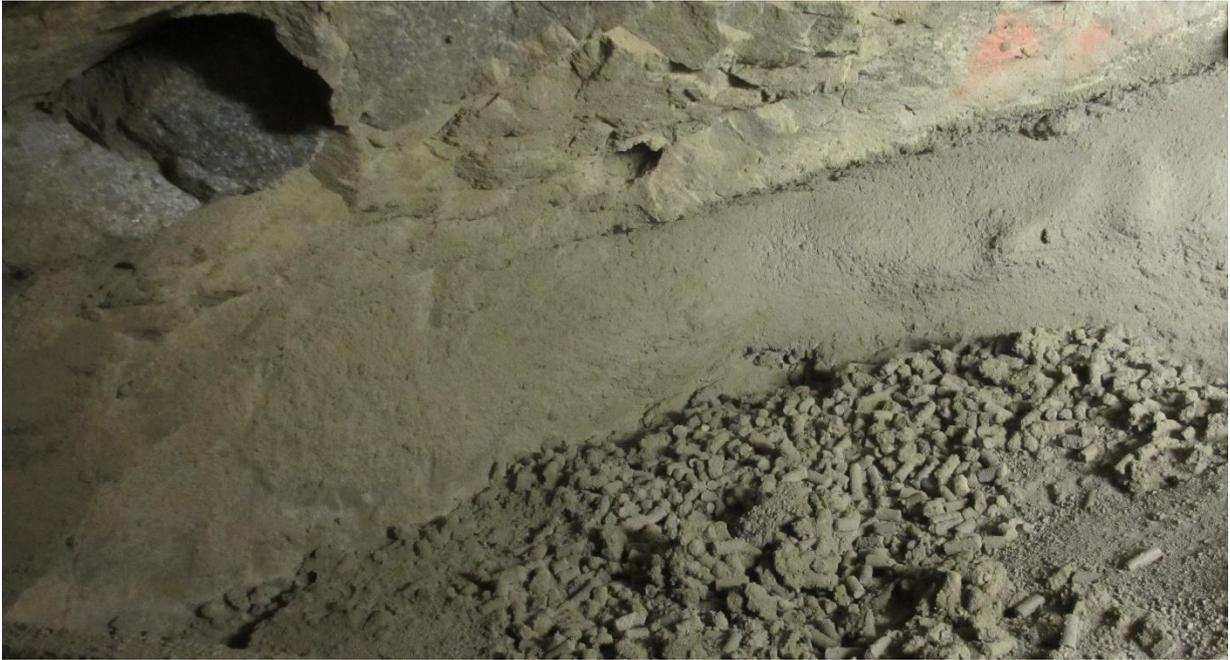
Figure 43 - Sprayed bentonite

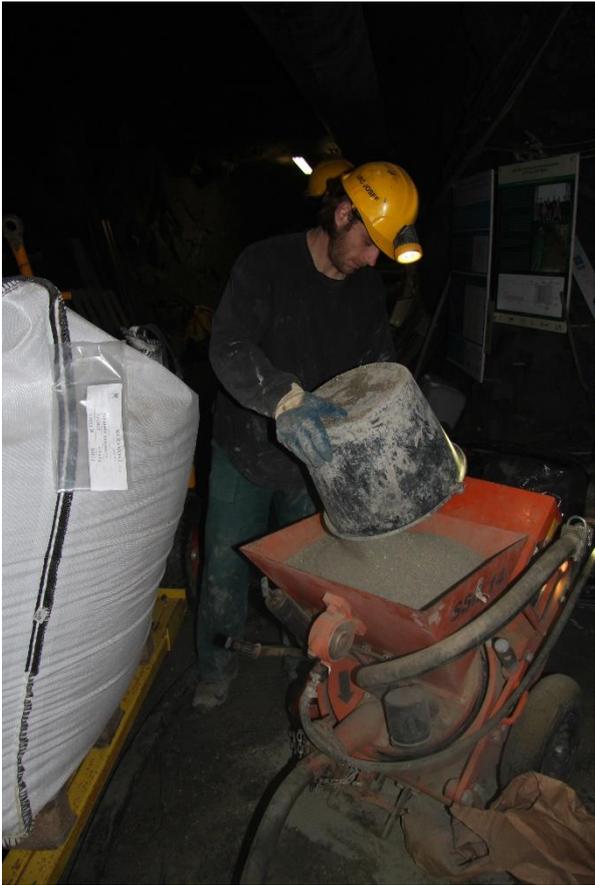
Figure 44 - Spraying machine
