DOPAS

Deliverable no. 3.20

EPSP plug test installation report

The EPSP plug has been designed as a prototype plug for a future Czech deep geological repository. It is expected, therefore, that similar plugs will be required to function throughout the whole of the operational phase of the repository, i.e. 150 years with an expected over-pressure of up to 7MPa.

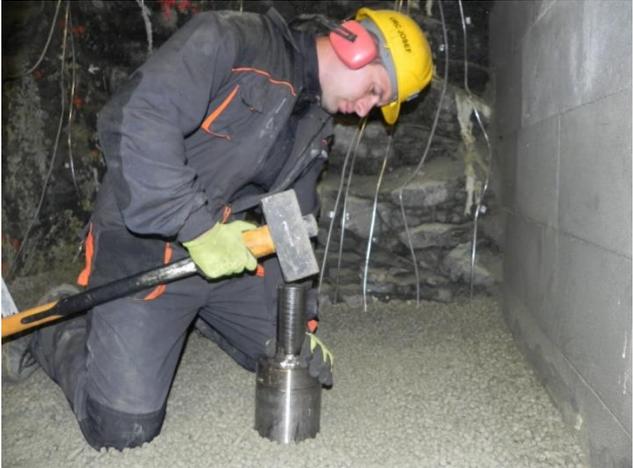
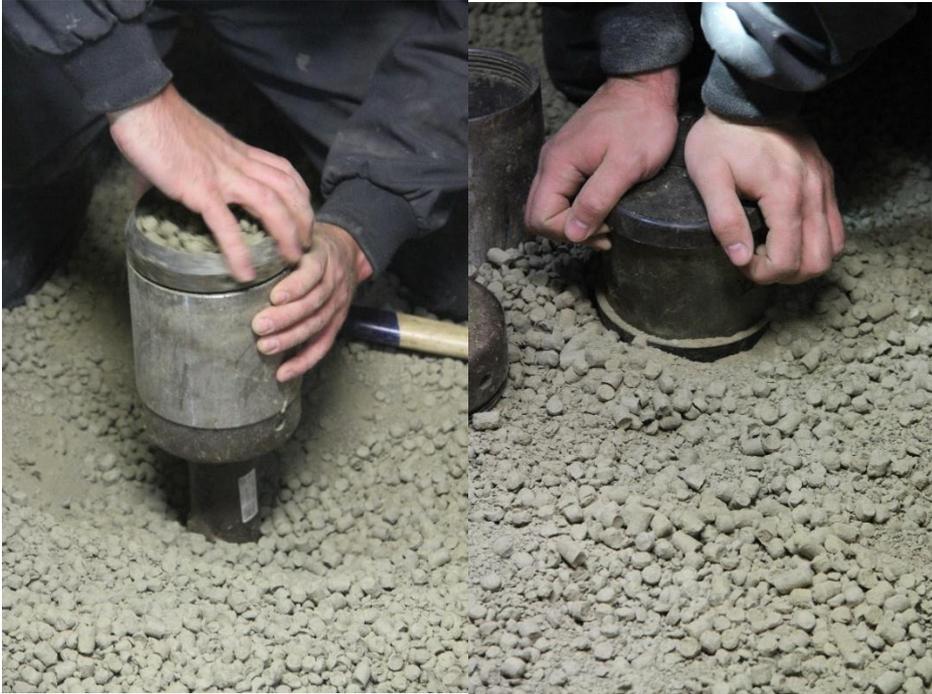
Figure 45 – Sampling

Figure 46 - Sampling

Mass water content	Dry density $\rho_d - \text{kg/m}^3$
Bottom profile	18.7%	1399
	17.8%	1416
	17.6%	1205
	17.6%	1346
Middle profile	17.2%	1518
	16.6%	1517
	18.4%	1471
	19.0%	1346

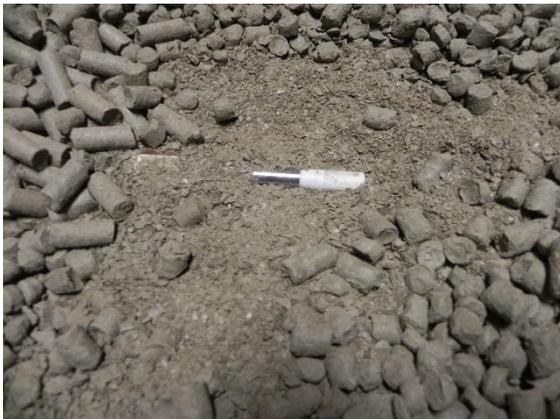
Figure 47 - RH sensor installation (7 June 2015)

Special precautions were in place so as to avoid damage to the sensors during the compaction process. Bentonite pellets were compacted above the level of the sensor to be installed. A hole was then excavated, the sensors positioned in the hole and the space surrounding the sensor was finally backfilled using crushed material (Figure 47).

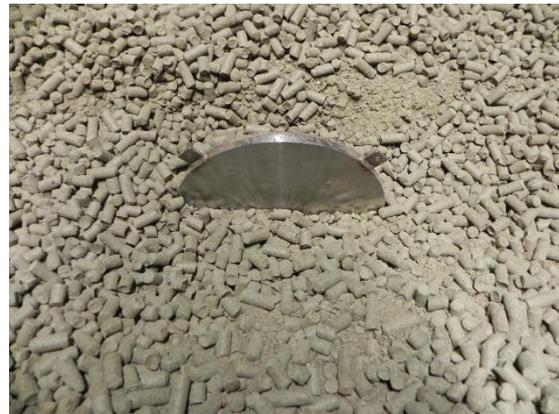
Figure 48 - Pressure cell (8 June 2015)

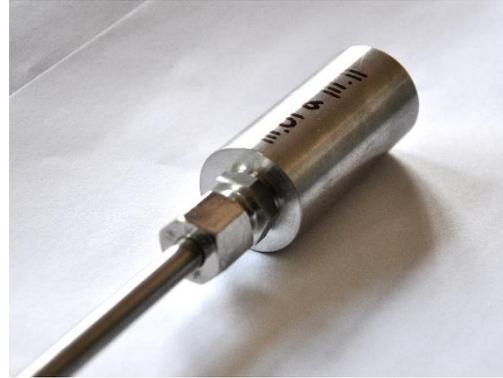
The thermometers were connected to the cabling and subsequently the stainless steel protective cap was fitted. The sensors were fixed in the cap using resin (DENTACRYL). The cap was equipped with a cutting ring fitting for the connection of the protective stainless steel tube (Figure 52 - Temperature sensors (analogue and digital)). Generally, both an analogue and digital sensor were installed into the same cap in case of the malfunctioning of one of the sensors (redundancy).

Figure 53 - Temperature probe

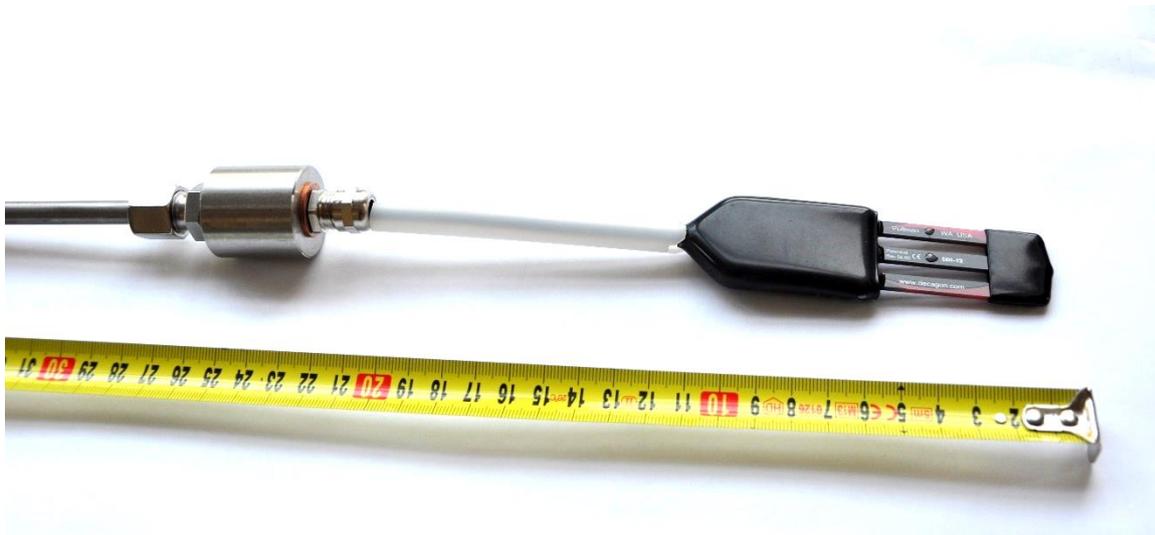
Figure 54 – TDR water content probe

The TDR sensors were factory calibrated. The correlation between permittivity measured by means of the sensors and water content was measured by the CTU for B75 bentonite as part of the laboratory experimental programme.

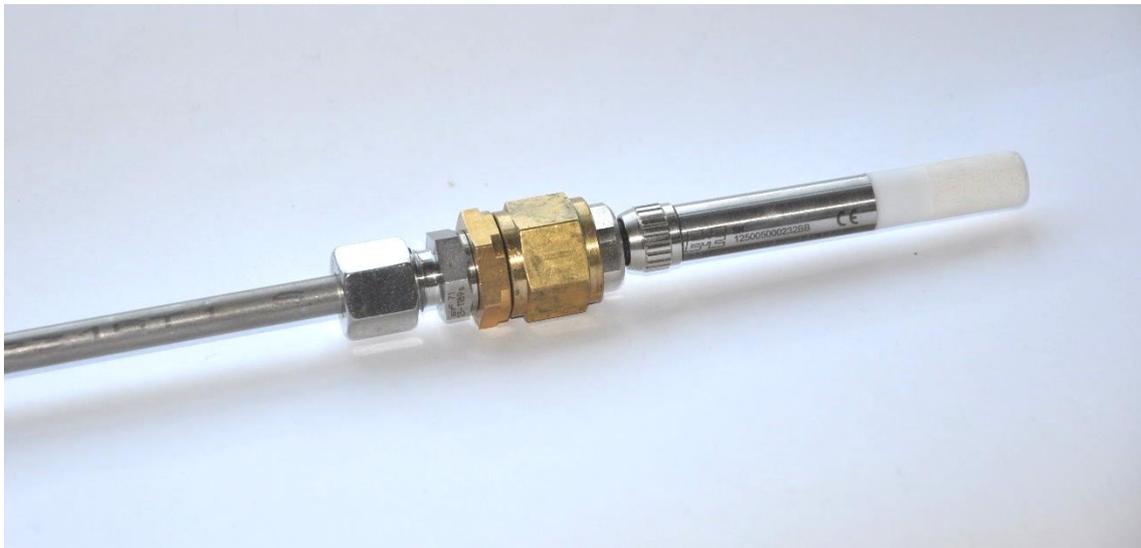
Figure 55 – Relative humidity probe

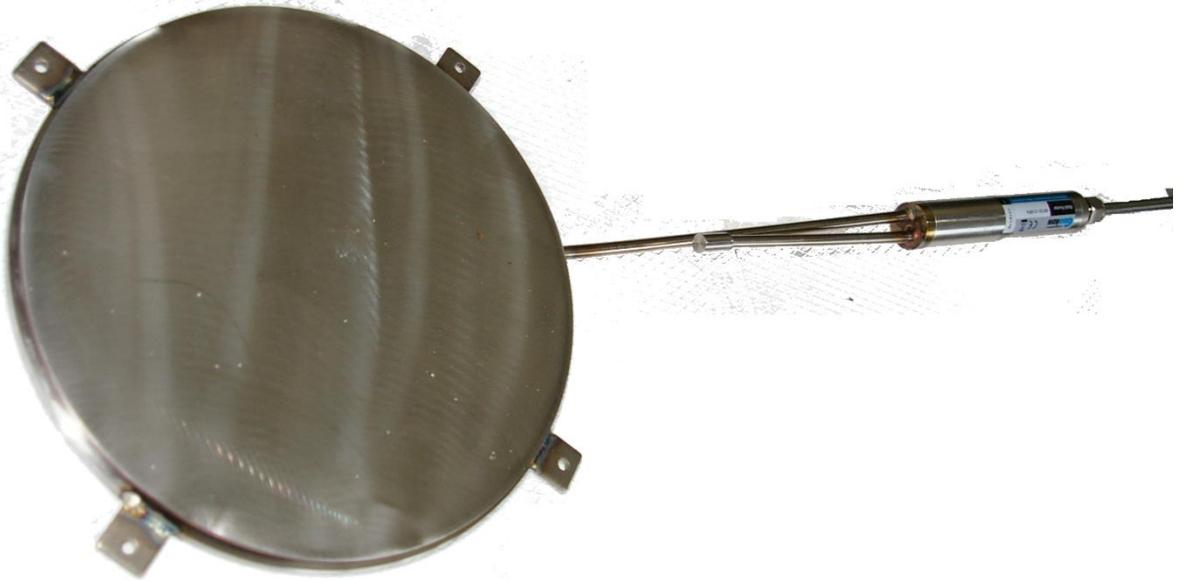
Figure 56 - Pressure cell

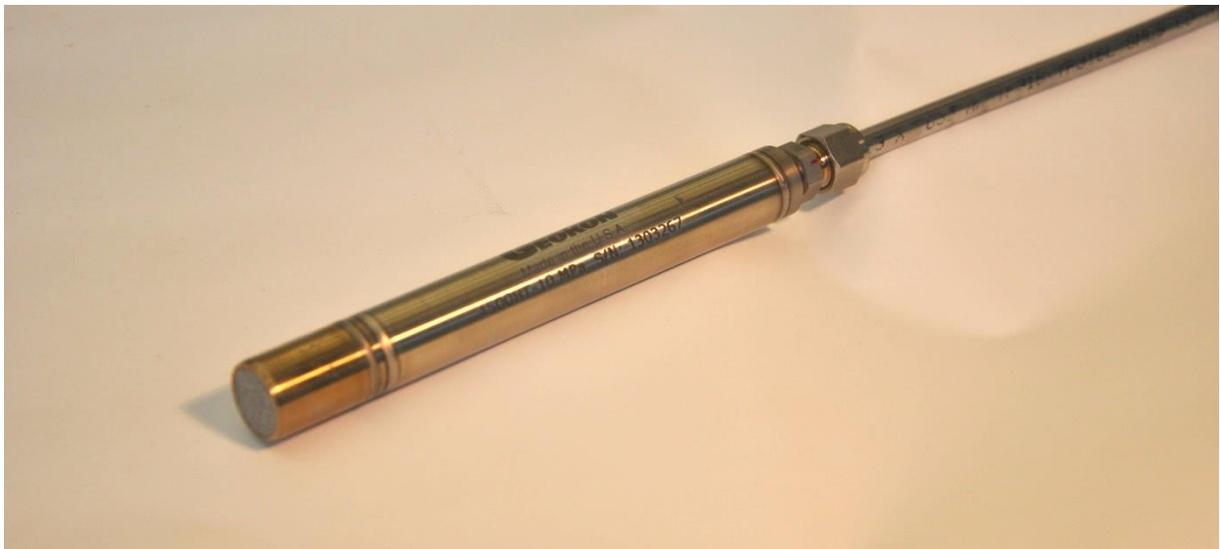
Figure 57 - Piezometer (VW)

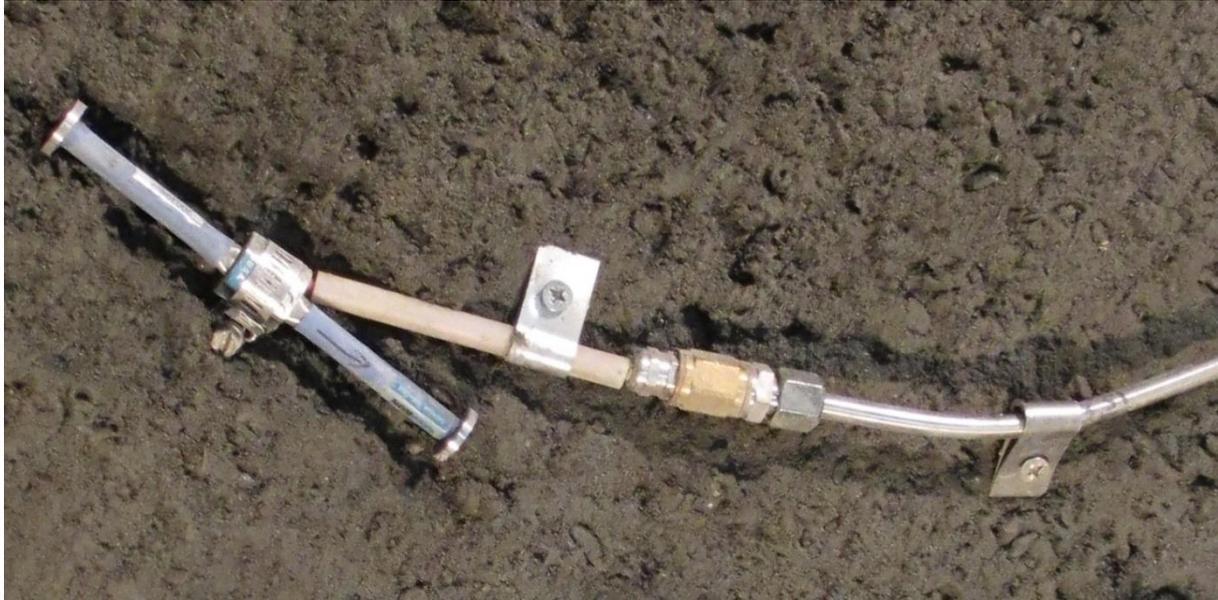
Figure 58 - Strain gauge

in the form of a fully-sealed package including the cabling. The sensors were, however, equipped with protective tubing in the Josef workshop consisting of a number of parts, including HDPE plastic tubing serving for the mechanical protection of the cable while allowing a certain degree of flexibility and, subsequently, a cable gland for sealing the entry of the cable within the stainless steel protective tubing assembly. The complete assembly consisted of the cable gland, a cutting ring fitting and protective stainless steel tubing. The sensors were factory calibrated.

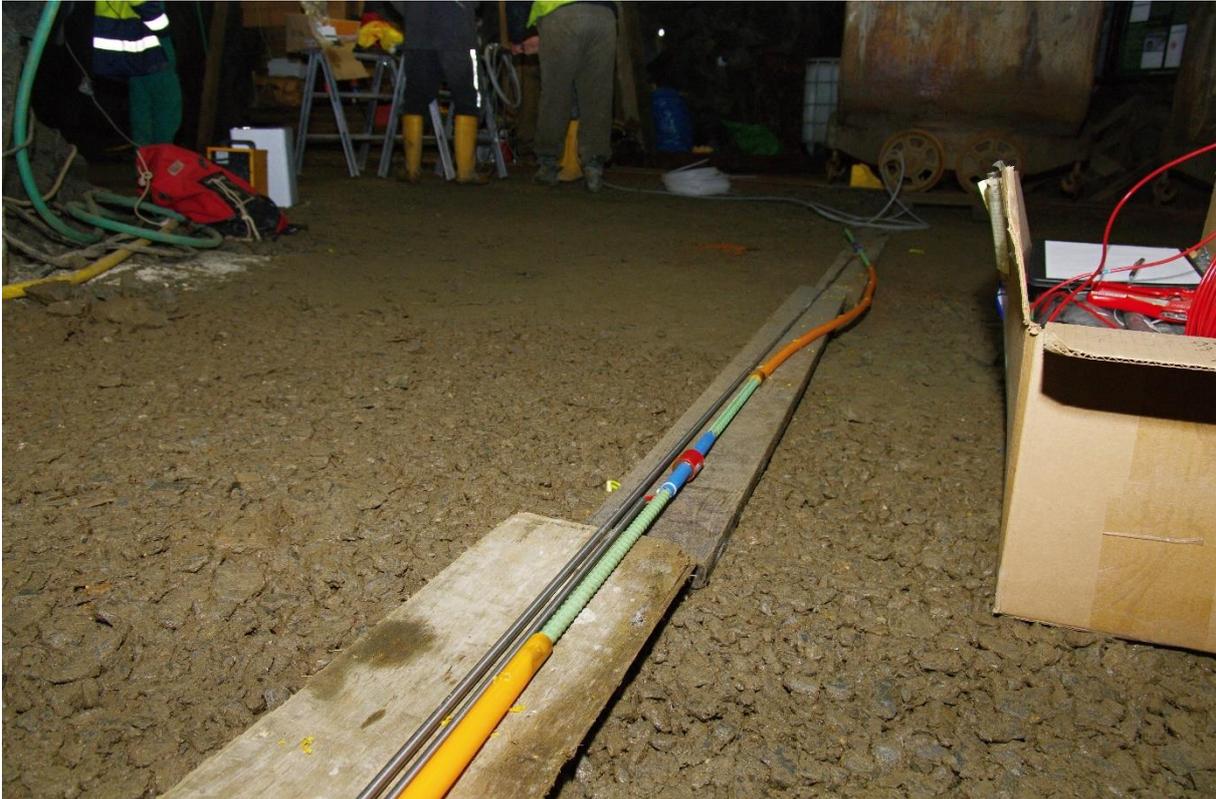
Figure 59 - Rock bolt assembly prior to installation

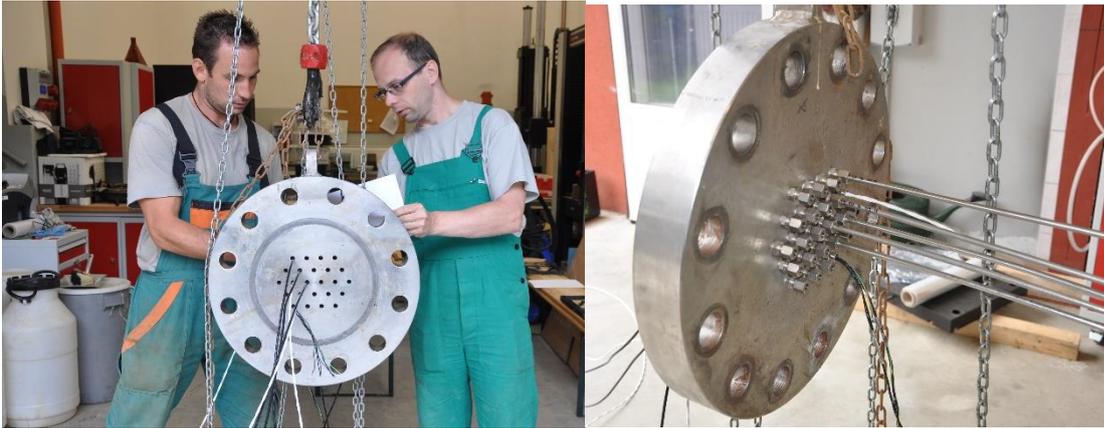
The sensor probes were grouped into sensor assemblies according to their assigned cabling boreholes. The assemblies were put together by means of the cables of the probes being pulled through the cable head plate and by the subsequent fixing of the protective tubing into the cutting ring fitting on the cable head plate. Each sensor assembly contained up to 32 probes.

The completed assemblies were then packed and transported into the underground complex where they were fitted to the corresponding cable head at the end of the borehole. In total 5 assemblies were installed in the EPSP experiment.

Figure 60 - Sensor assembly preparation

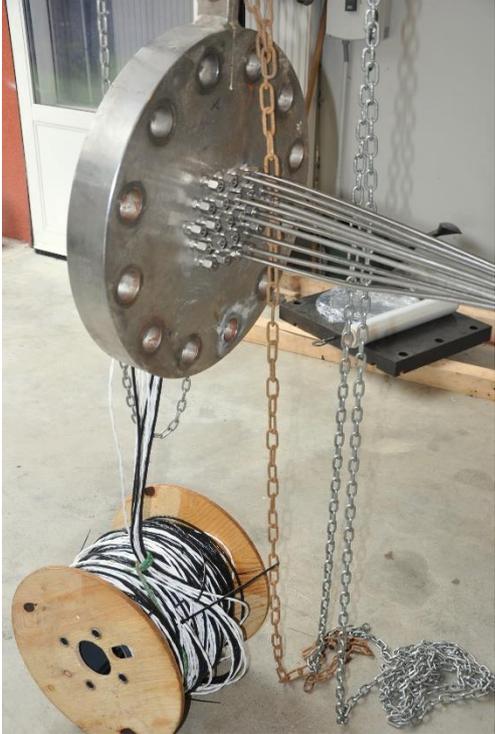
Figure 61 - Sensor assembly

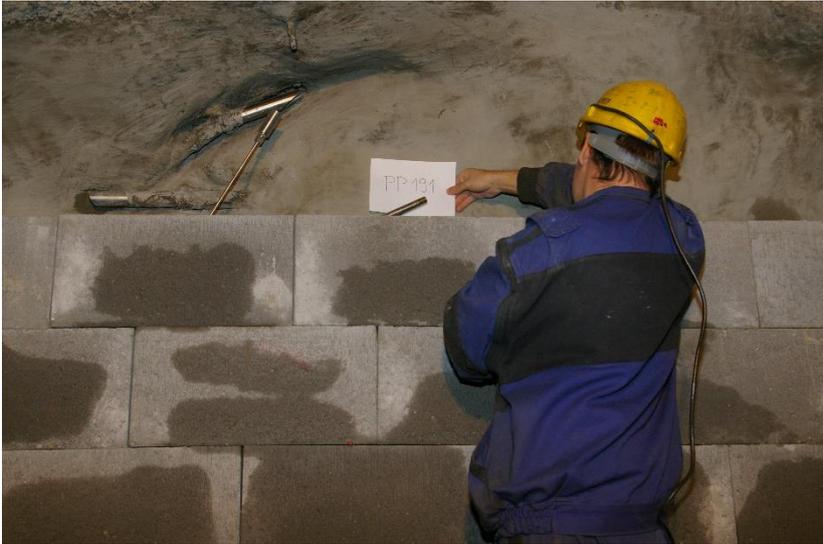
Figure 63 - Piezometer installation in the pressurisation chamber

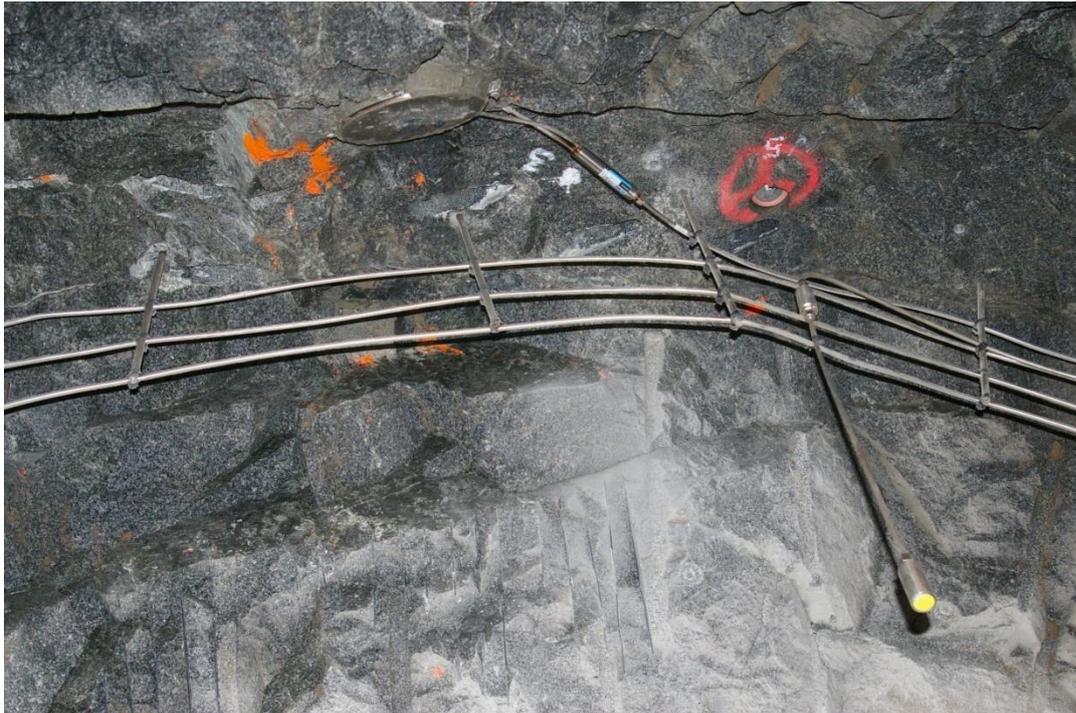
Figure 64 - Pressure cell on the rock face; cabling in protective tubing on “ladders”, thermometer

The first step involved the installation of four pressure cells in their final positions on the contact zone between the rock mass and the shotcrete (applied later). Subsequently, the protective tubing of the sensor cabling (of the pressure cells and rock bolts) was attached to supporting rods. The cabling was widely spaced in order not to create obstacles to the shotcreting process.

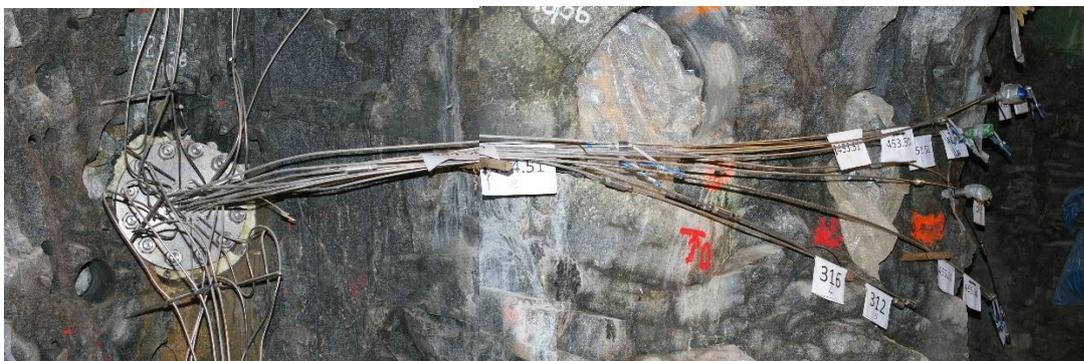
Figure 65 - Sensors temporarily stored on the side of the niche

The rest of the sensors were temporarily attached to the side of the chamber. These sensors were installed one-by-one during the shotcreting process in the intervals between the delivery of individual batches of shotcrete.

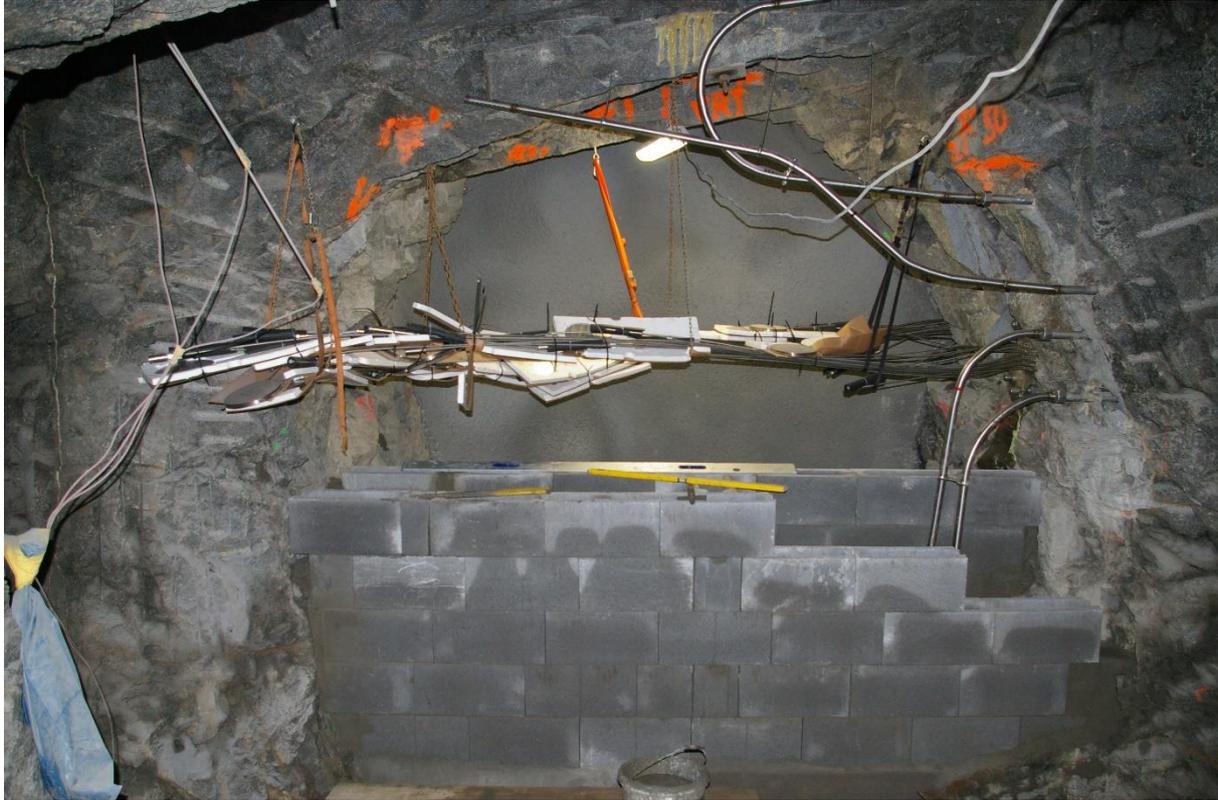
Figure 66 - Cable head assemblies installed, 1st part of the filter separation walls erected, pressurisation tubing into the filter installed (December 2014)

The bentonite sealing section of the EPSP experiment houses two cable connecting boreholes. Cable head assemblies D4 and D1 were installed in November and December 2015. The sensors were not installed immediately (they were stored temporarily on the side of the chamber) in order to allow for the testing of the inner plug and grouting.

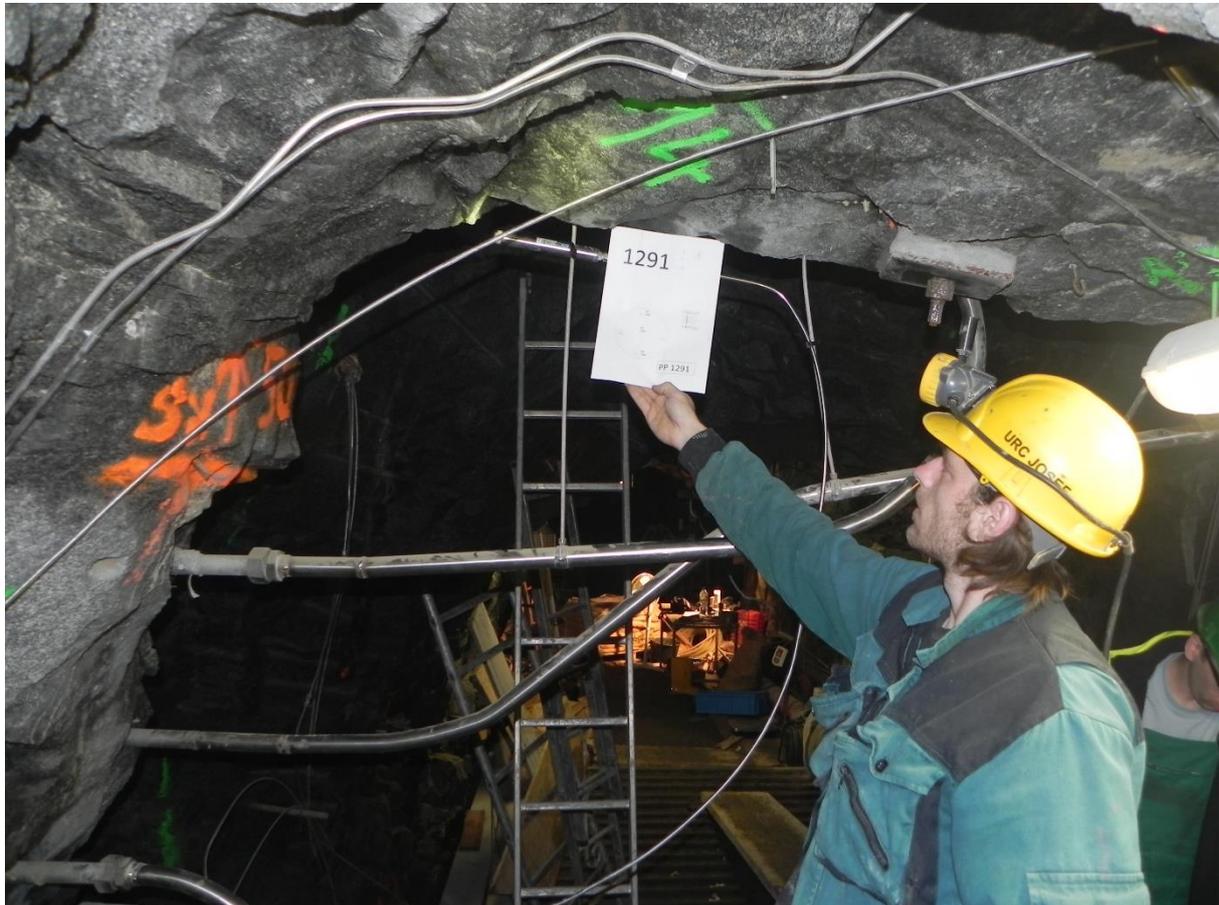
The filter houses no connecting cabling borehole; the associated cabling uses borehole and cable head D1 which is located at the end of the bentonite section. The relevant sensors were therefore installed at the same time and in the same manner as the sensors in the bentonite. Moreover, the filter structure served as support for the bentonite; therefore, it was raised gradually as bentonite emplacement progressed.

Figure 68 - Piezometer in the filter area

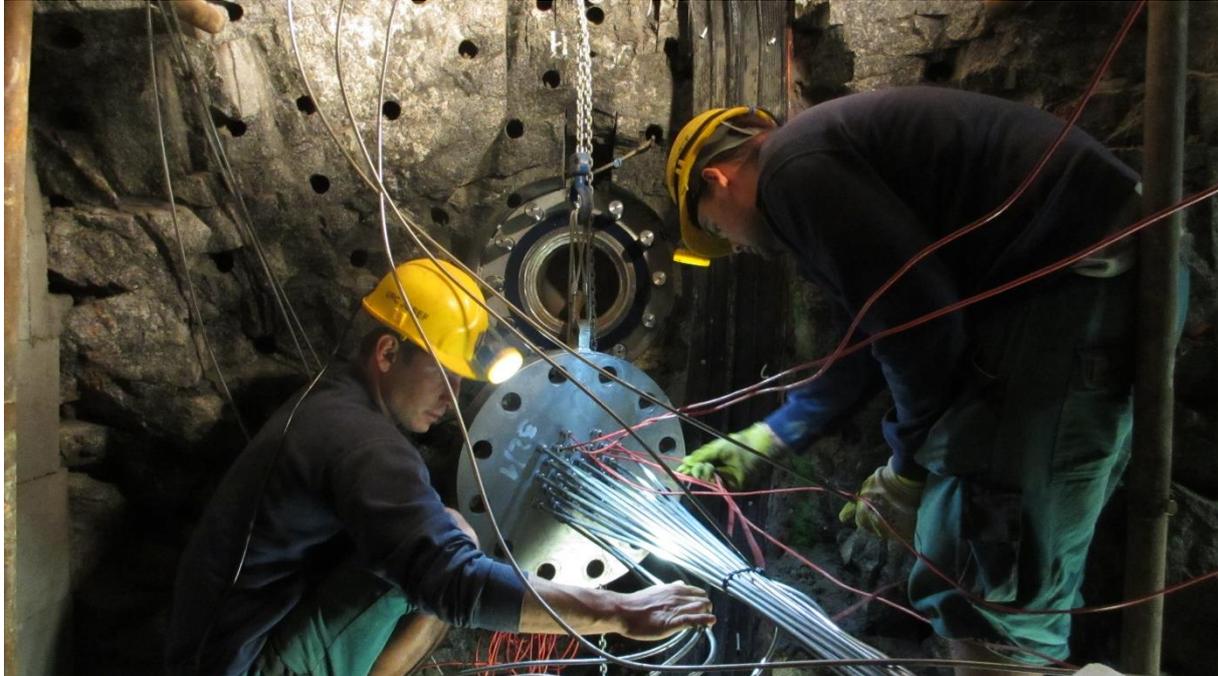
The outer plug houses a second connecting cabling borehole. The cable head B assembly was installed in June 2015. This cable head also provides space for the cabling of four of the instrumented rock bolts (part of profile G) which were attached during the installation of the cable head assembly.

Figure 69 - Installation of cable head assembly B (June 2015)

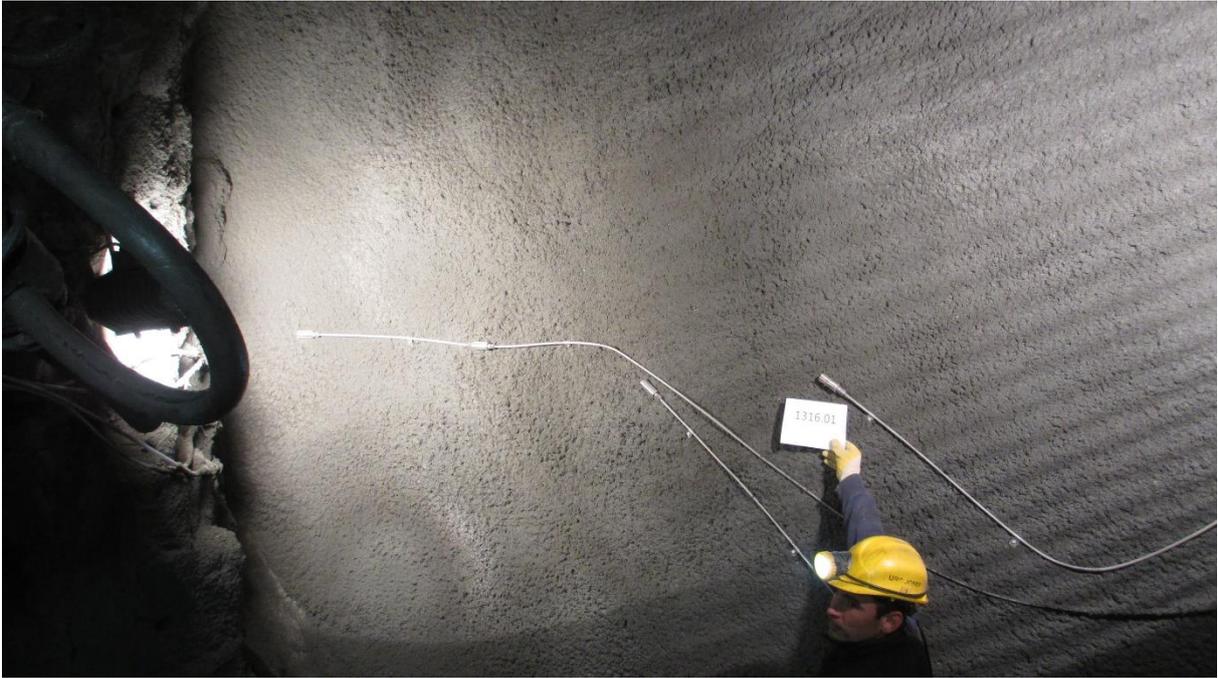
The first step involved the installation of four pressure cells in their final positions on the contact zone between the rock mass and the shotcrete (applied later). Subsequently, the protective tubing of the sensor cabling (of the pressure cells and rock bolts) was attached to supporting rods. The cabling was widely spaced in order not to create obstacles to the shotcreting process.

The rest of the sensors were temporarily attached to the side of the chamber. These sensors were installed one-by-one during the shotcreting process in the intervals between the delivery of individual batches of shotcrete.

Figure 70 - Temperature sensor installation (20 June 2015)

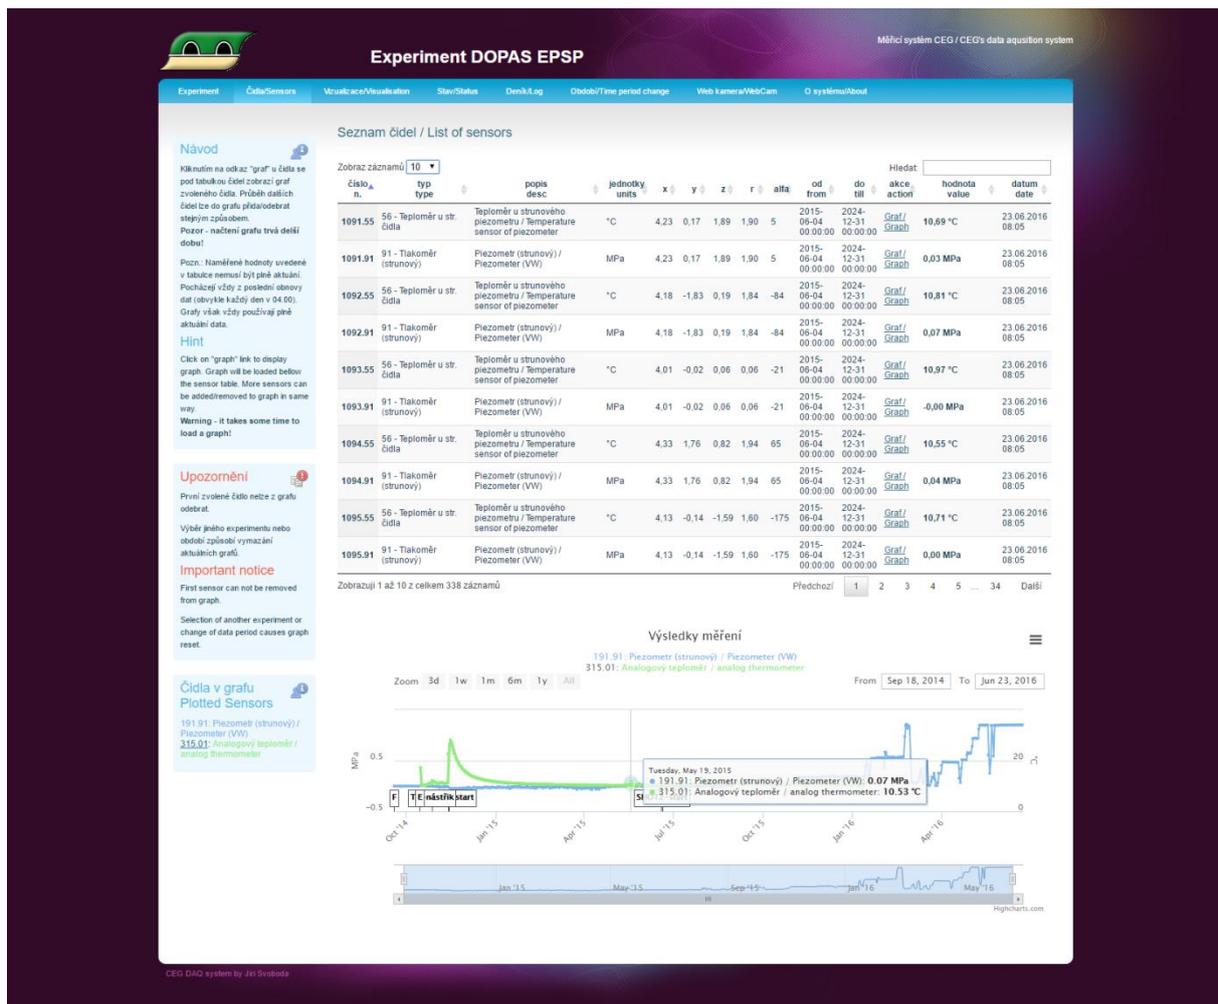
The frontend is the most visible part of the system since it is the part with which the user interacts. The frontend is web based and runs on an nginx (<http://nginx.org/>) web server; it consists of a specialised web site written in the php programming language and JavaScript. The system pulls all the necessary data from the backend database and presents it to the user. The system rapidly calculates results for the user from the raw data. The results of calculations are cached and held in a separate database in order to speed up the system and to reduce system processing power requirements; this significantly reduces system overheads. The website provides online information on the status of the experiment and the simple data visualisation interface (2D charting and 3D visualisation). For more comprehensive analysis purposes, direct data export is available using specialised URLs.

Figure 75 - EPSP measurement system web frontend UI
