# **Deposition machine upgrades during the Multi Purpose Test**

Author(s): Markku Ojala,  
Thomas Von Numers (Navitec Systems OY)

Date of issue of this report: **20/05/2014**

## **P-14-08 KBS-3H D 4.2. Deposition machine upgrades during the Multi Purpose Test**

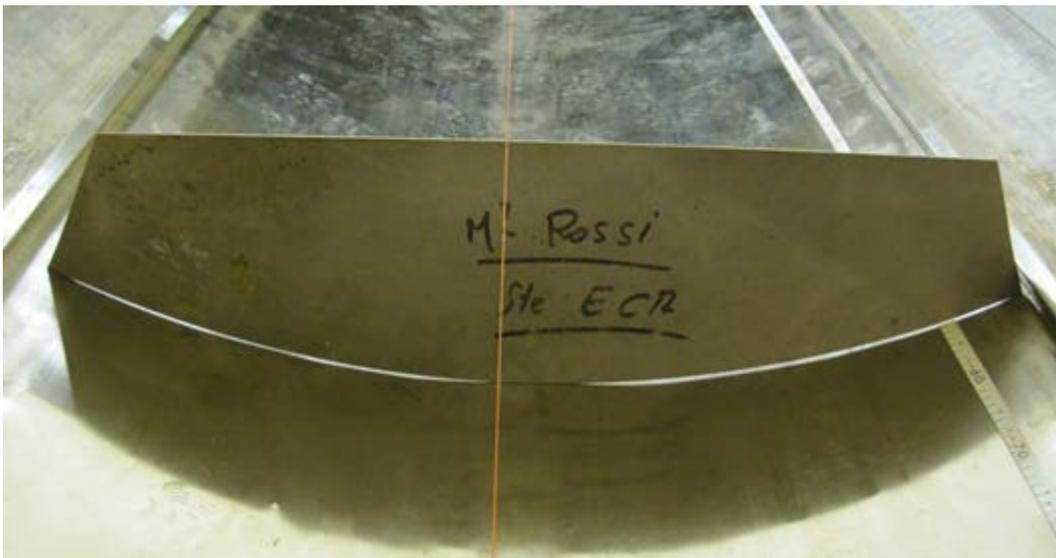
**Figure 3-2.** The sliding plate is deformed by the pressure from the cushions. The metal sheet is clearly stretched at the two cushion tracks.

The sliding plate is constantly dragged on the rock surface of the drift and then kind of rolled by the sliding Supercontainer. During every stroke the sliding plate is differently supported by the drift bottom and therefore the rolling forces deform the plate in different ways. Since the lifting cushions slide on the middle part and the sliding plate has stiff box type structures in each end the plate is slowly deformed into a hammock shape. Figure 3-2 shows the two cushion tracks on the plate. Since the front end of the sliding plate is a stiff box-type structure it keeps its' shape. As a result the sliding plate tends to lift its' front end from the drift bottom causing an extra space requirement between the drift bottom and the Supercontainer. Another result is that the front end of the sliding plate is not stably supported over its' whole width by the drift bottom and tends to wiggle somewhat depending on which side the main weight lies on. This is causing some inaccuracy in the angle detection of the front of the sliding plate. It was therefore planned that the sliding plate should be reshaped as part of the machine upgrade. However, the sliding plate is a very large structure and reshaping of the macro deformation could not be done at site. Instead some local deformations caused by stones or local bending caused by the step between the start tube and the transport tube were repaired, figure 3-3. To avoid excessive wear of the cushions scratches on the upper sliding surface of the plate were removed by polishing.

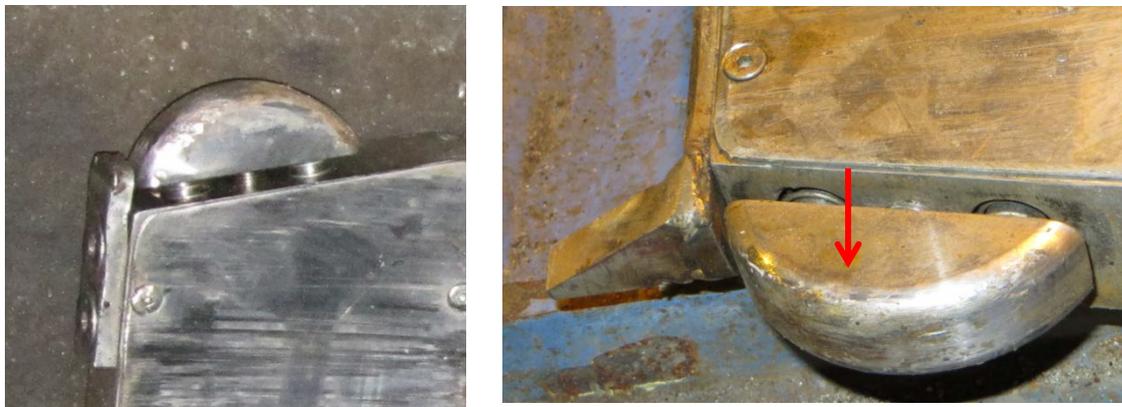
**Figure 3-5.** Guides forcing down the sliding plate to protect the collision sensors from vertical bending forces.

The design of the sensor was not changed, but the contact body was protected from vertical forces by

mounting triangular guides forcing down the sliding plate if in contact with the Supercontainer, figure 3-6.

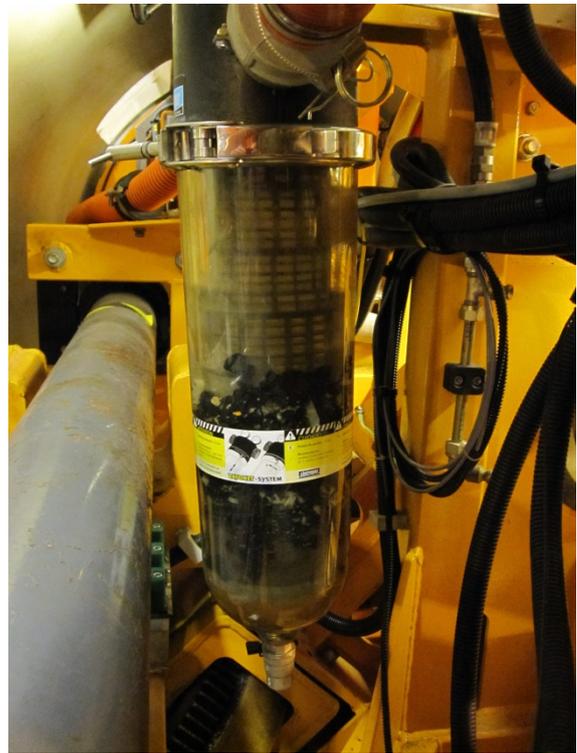
Wear between the guiding edges on the sliding plate and the pallet as well as abrasion of the concrete elements in the Supercontainer dummy have caused contamination of the water returning from the lifting cushions. Since the return water was not filtered, all particles have been able to circulate in the water system. The result has been clogging of lifting cushion valves leading to uneven lifting and sometimes very slow emptying of cushions causing excessive strains on cushions. Since the concrete blocks in the Supercontainer dummy were to be replaced by more brittle bentonite, it was assumed that the amount of particles would increase in real deposition.

**Figure 3-7.** *Black chips from the guiding edges of the sliding plate in the water filter.*

Two water filters were therefore mounted in the water return line before the main tank, figure 3-7. Clogging of valves has not been a problem after this arrangement.

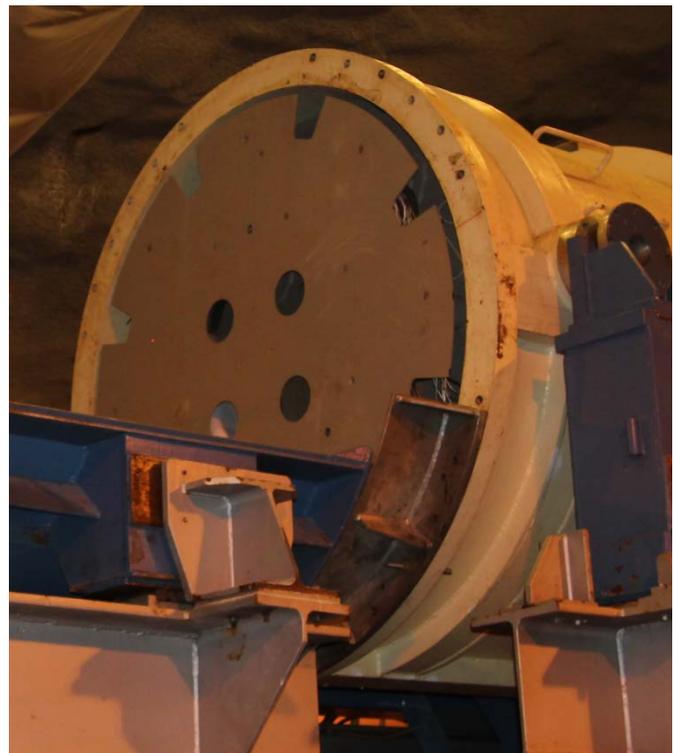
The transport tube can not be transported in the Äspö ramp tunnel with the gamma gates mounted due to the height limitation. In order to save time in the final MPT experiment, the use of gamma gates at the deposition drift was avoided by designing a replacement ring. By mounting this ring in one end of the transport tube the tube is lengthened about as much as the removal of the gammagates shortens it.

**Figure 3-8.** Left upper drawing shows the end of the transport tube with the frame of the open gammagate. Below the extension ring replacing the two gammagates. To the right a photo with the extension ring mounted to the transport tube and the end of the start tube adjusted towards the ring.

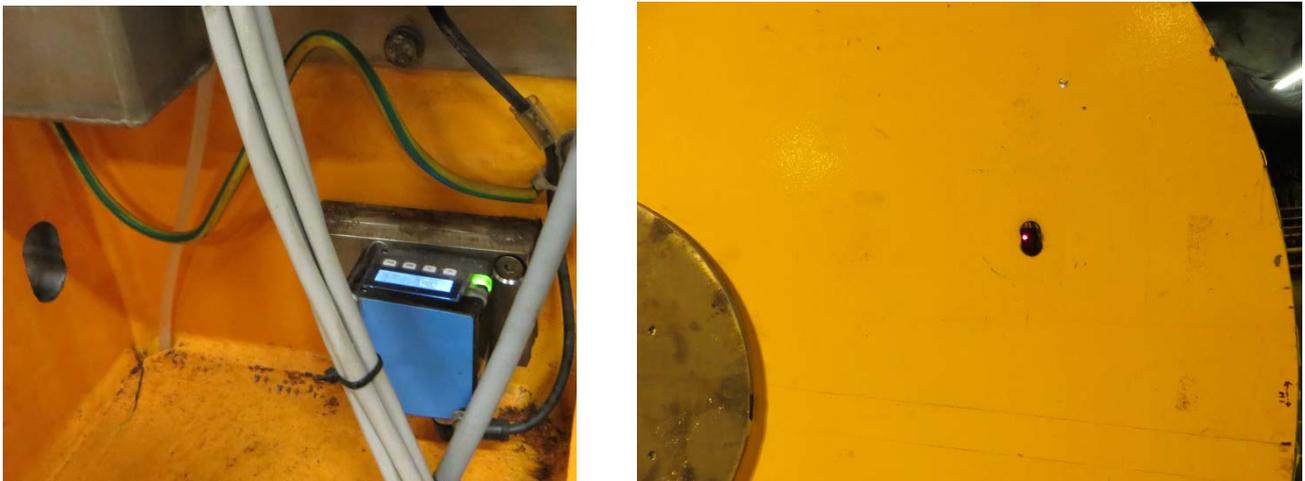
**Figure 3-11.** a) Laser distance sensor mounted behind the main plate of the radiation protection shield and the hole for the beam machined into the shield. b) The laser beam in the hole seen from the lifting pallet side.

A SICK DT50 laser distance meter was mounted behind the radiation protection shield and a hole in the shield was drilled for the laser beam, figures 3-11 a and b. Not a final solution in terms of radiation protection, but good enough for proof of concept. The laser is directed forwards and measures the position of the rear end of the distance block. If a Supercontainer has a perforated end plate the measurement varies somewhat depending on whether the laser beam hits the shell or the bentonite. This was considered a negligible error in this process but has been completely avoided now, as the reference design of the Supercontainer for other reasons has been changed to solid end plates.

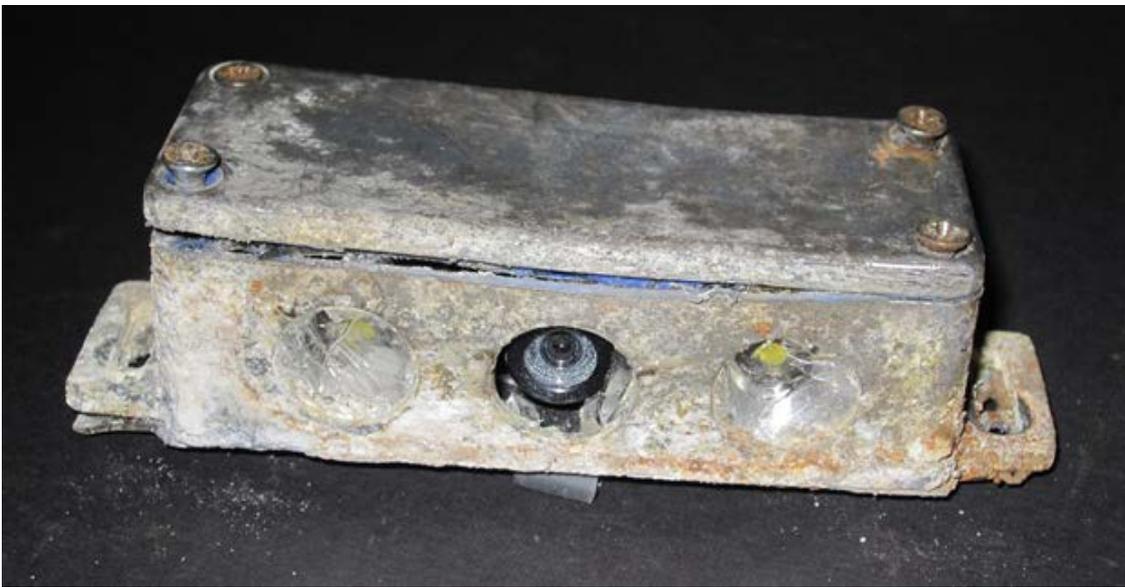
Though the right hand camera was unused it was still powered. As the deterioration of the camera housing reached a critical state, figure 3-14, it caused a short circuit destroying part of the powering system of the deposition machine. It was discovered that the power lines to the lights and cameras were not fused and therefore a whole multi output transformer unit was destroyed. The camera was removed and in conjunction with renewal of the powering system all sourcing cables were fused.

**Figure 3-14.** The camera unit with two power LED's for lighting and a camera in the middle. Protective glass cracked and fallen apart.

If testing shall continue for a longer time a new camera unit should either be purchased or built. If it is decided to build a new unit some attention must be taken regarding the heat from the lighting. The heat from the power LED's warms up the protecting glass which cracks when water is splashing on it, figure 3-14. When the glasses fall apart water penetrates into the casing causing oxidation.

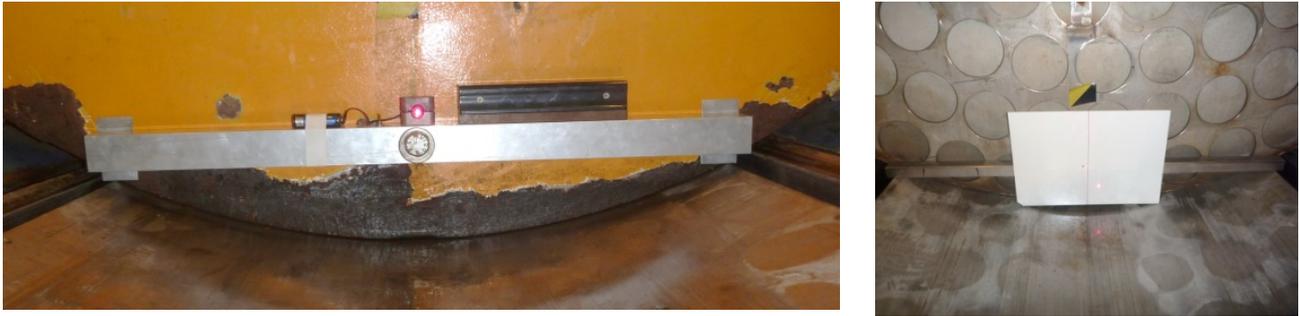
**Figure 3-19.** The calibration tool developed for aligning the lifting pallet with the machine. The ruler against the shield on the left and the target plate in front of the Supercontainer on the right.

The calibration method uses the radiation shield as base for aligning the pallet with the machine. A calibration tool consisting of a ruler with an attached laser transmitter and a target plate was developed, figure 3-19. The ruler is put against the shield surface and the target plate is centered over the far end of the lifting pallet. The position of the lifting pallet is then shifted until the laser beam hits the middle of the target plate before the lifting pallet is attached to the shield. In this way the lifting pallet is always centered and perpendicular to the shield. The calibration gave good, however not always lasting results, as described in the next chapter.

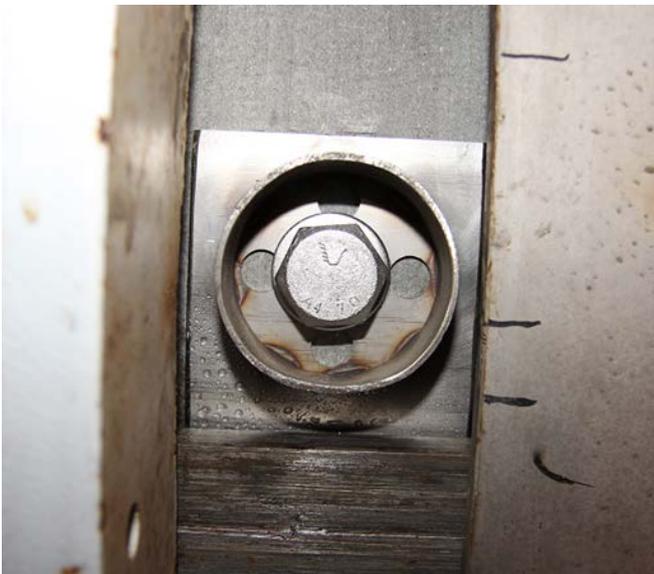
The tests revealed a minor issue with the machine. The distance block made of bentonite had a slightly different mass distribution than the previously tested concrete dummy which caused some longitudinal load balancing problems. These problems indicate that a lift balancing scheme based on the height measurement sensors might anyway be, if not necessary, at least very useful in the future.

**Figure 4-3.** Slight deformation of the distance block foot after the deposition test. No cracking in the bentonite and firm fastening after the test.

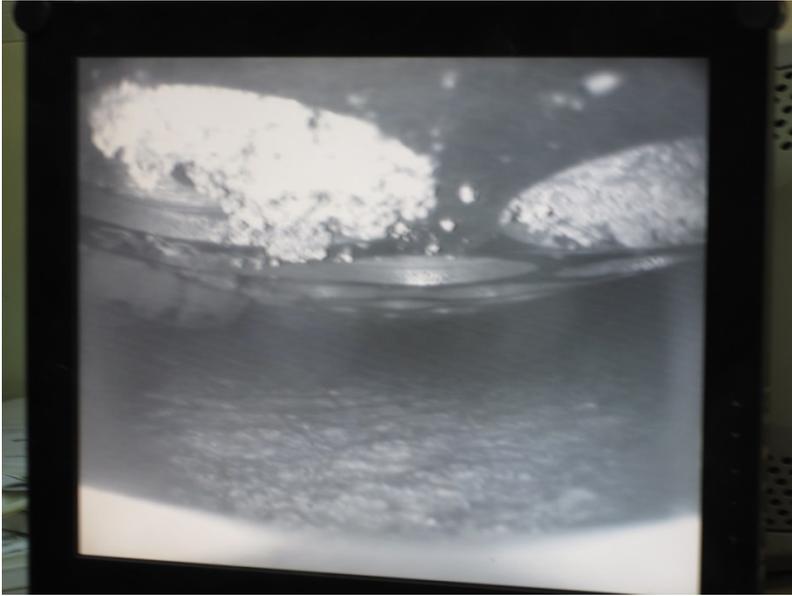
Splashing was not a problem with any of the distance or transition blocks, figure 5-4, even when the load was a bit unbalanced longitudinally. However, the big unbalanced load of the Supercontainer with the cable block caused rather severe splashing problems, figure 5-5 and 5-6. It is difficult to assess how big the influence of the greater load was compared to the imbalance, but splashing was remarkable especially in the rear of the lifting pallet where the cushions reached their maximum lifting height during the long lifting times.

**Figure 5-5.** The bottom of the Supercontainer after deposition. Splashing has wetted the bentonite so much that it is pouring out of the holes in the steel shell.

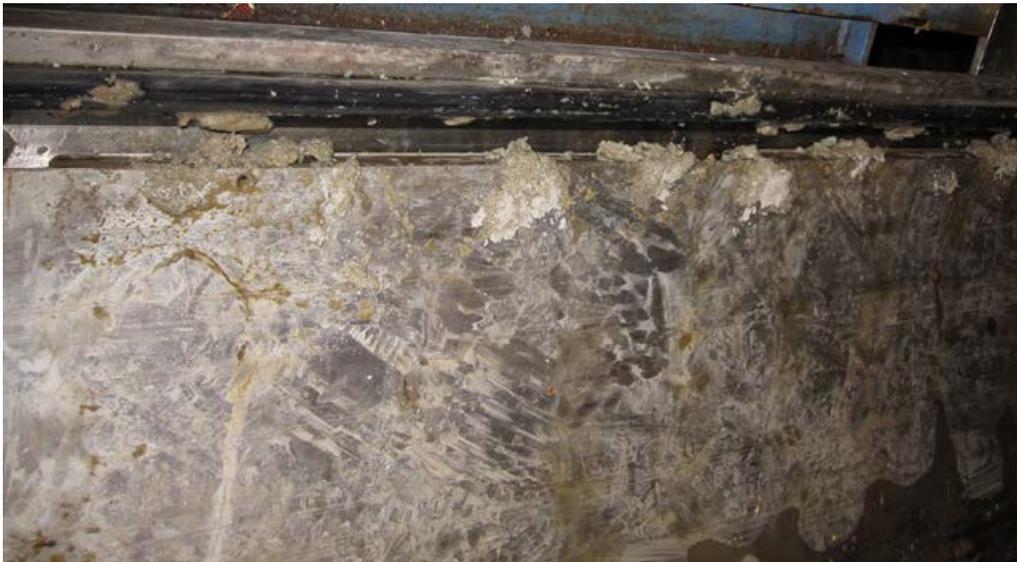
**Figure 5-6.** The lifting pallet after deposition of the Supercontainer. Wetted bentonite was left on the pallet.
