New materials and innovative monitoring for safe sealing structures in underground repositories

Vera Lay, Franziska Baensch, Detlef Hofmann, Frank Mielentz, Patrick Sturm, Prathik Prabhakara, Sergej Johann, Hans-Carsten Kühne, Ernst Niederleithinger

Overall, the project SealWasteSafe aims at optimising the construction material, multi-sensory monitoring concepts and ultrasonics for quality assurance applied at sealing structures.

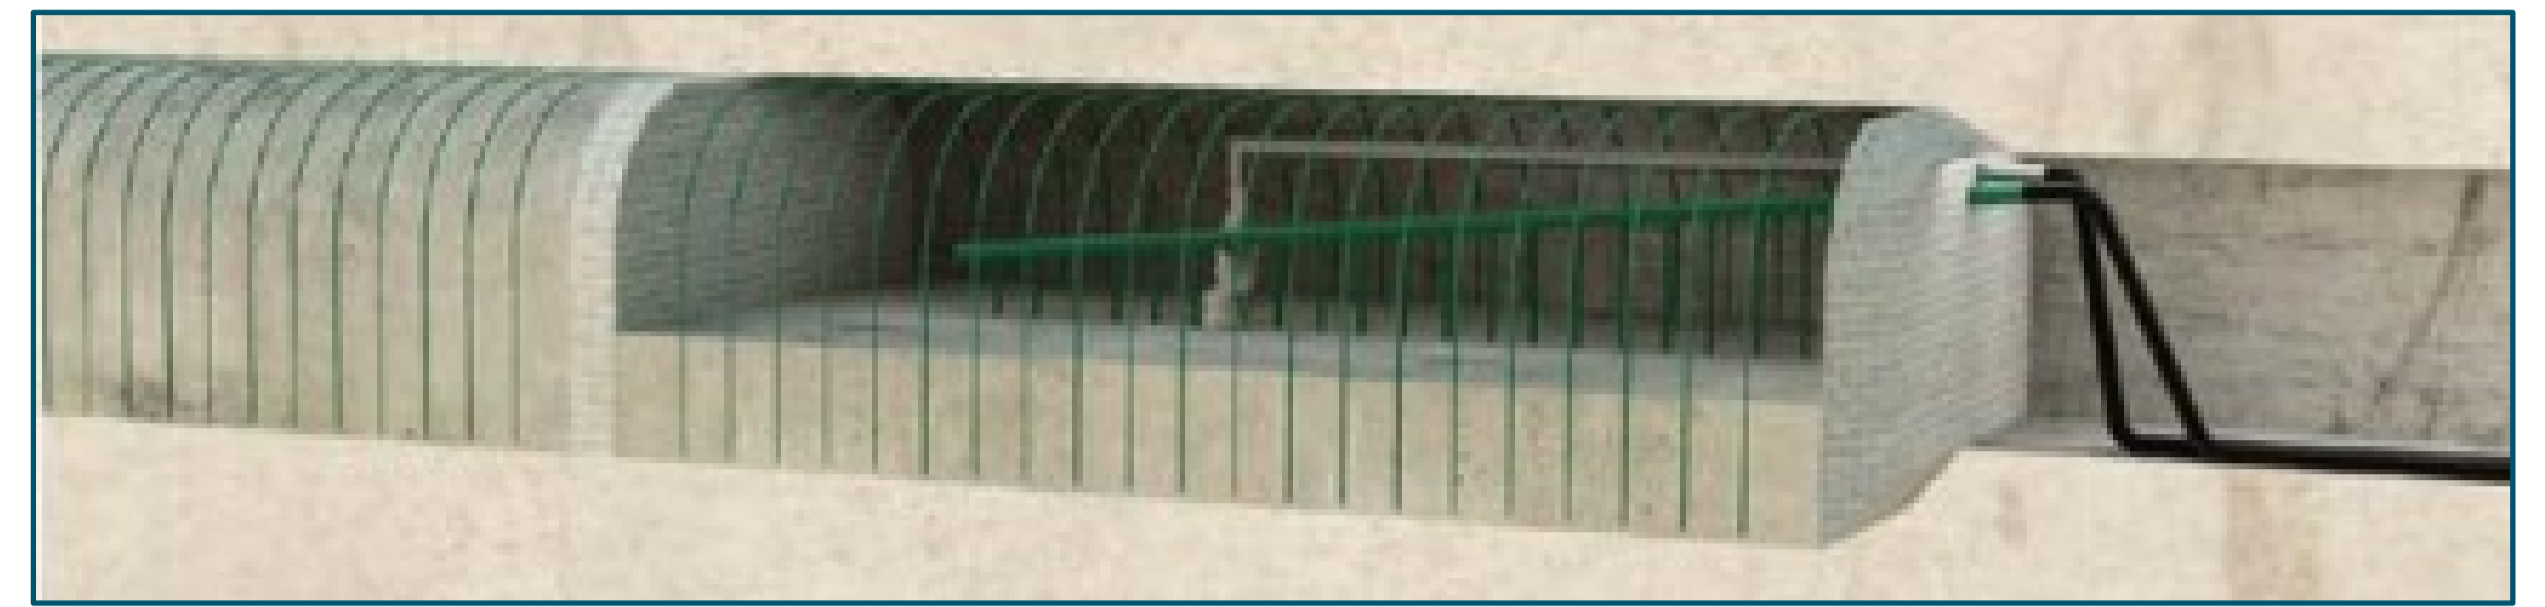
Concept of an engineered barrier system (source: BfS, 2015)

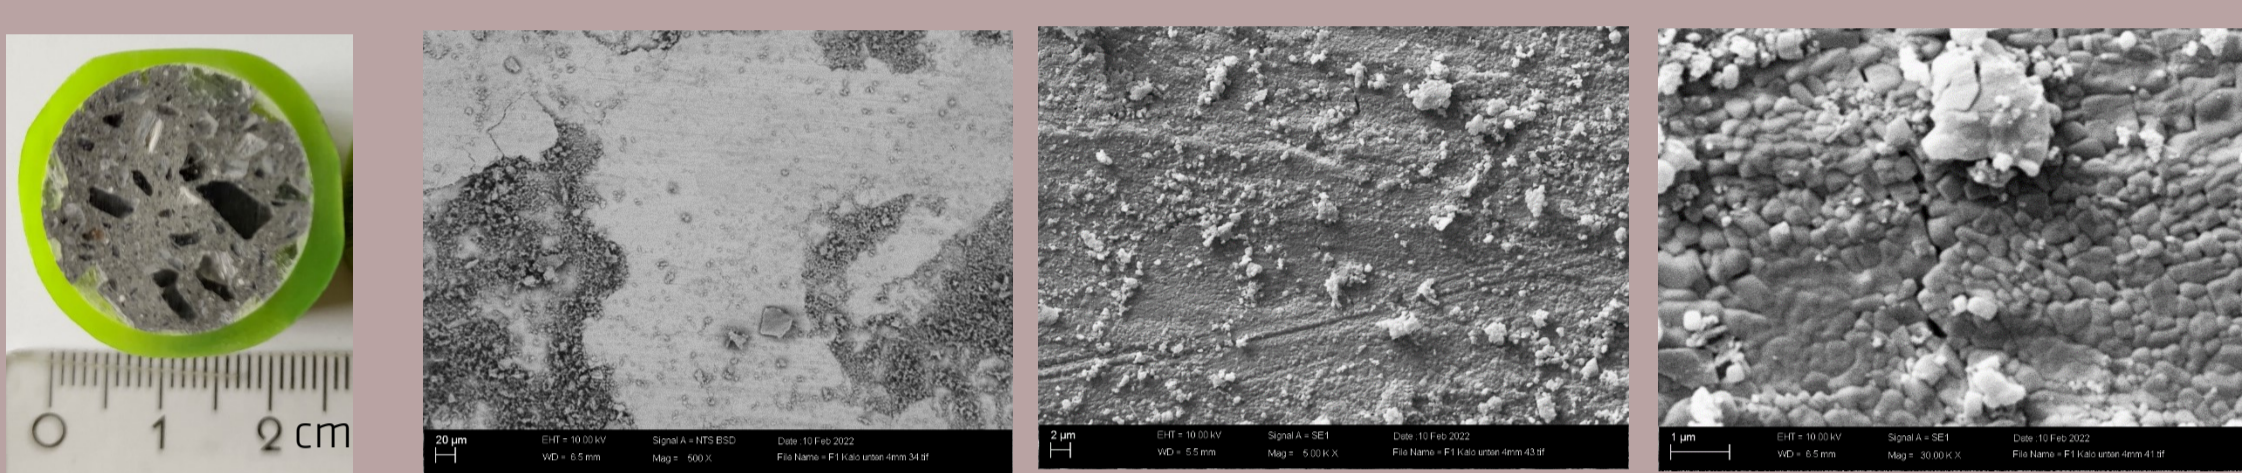
Photography and scanning electron microscopy images of AAM F1 (from left to right becoming more detailed)

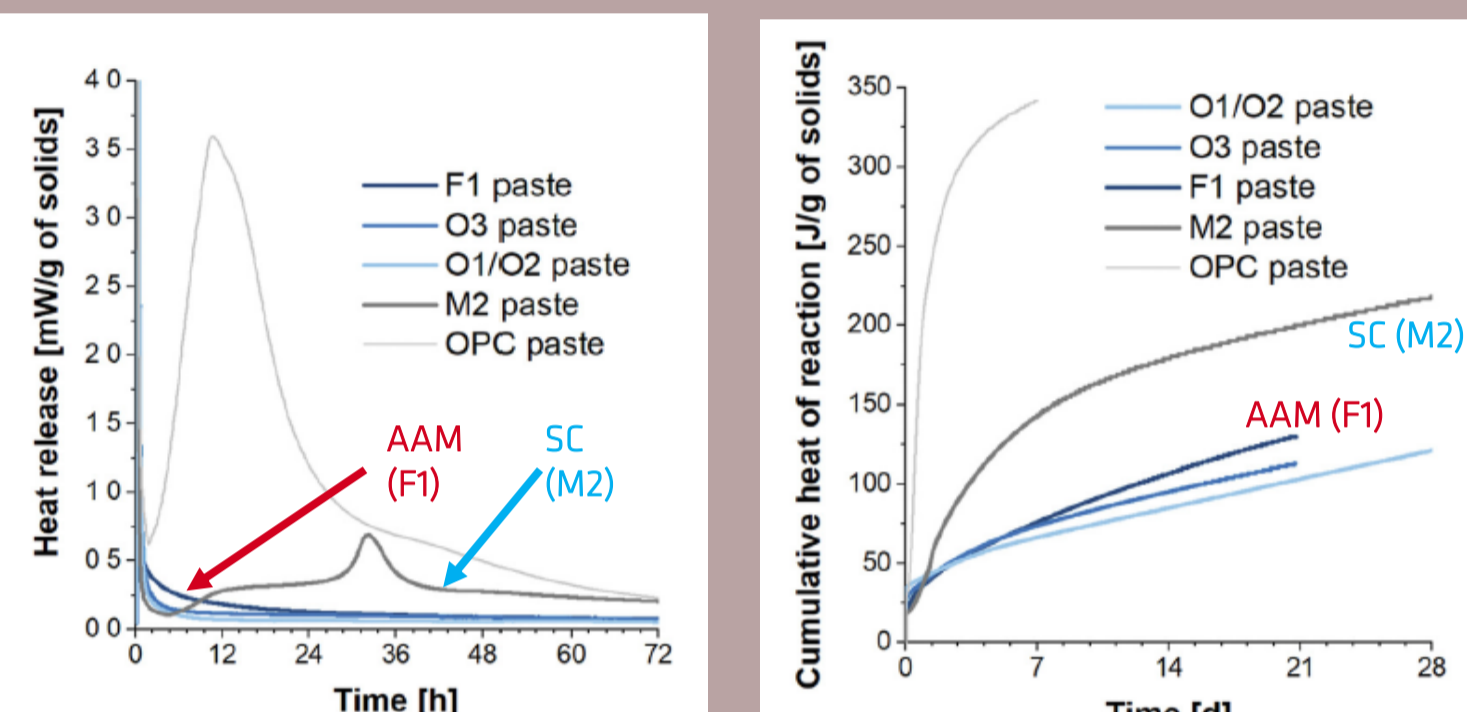
Heat release and cumulative heat of reaction showing less heat of reaction for AAM (F1) in comparison to salt concrete [1]. Thus, AAM has a potential for less cracking during hydration.

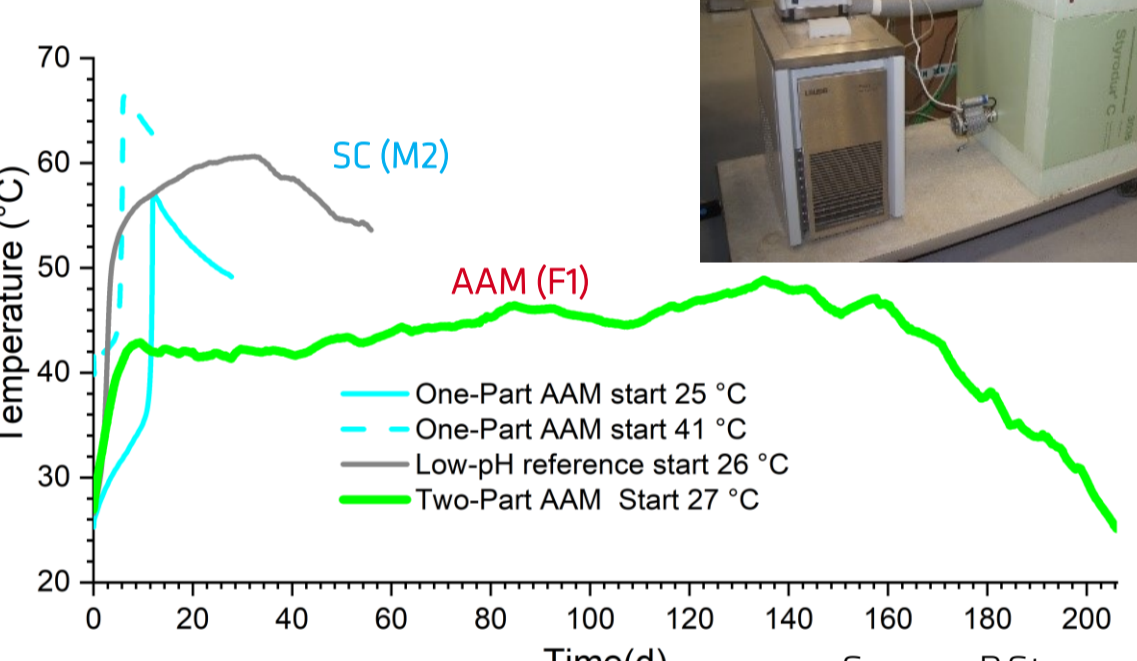
The semi-adiabatic temperature measured in a concrete calorimeter (photo, simulating in-situ conditions) shows significantly lower temperatures for the AAM in comparison to the SC.

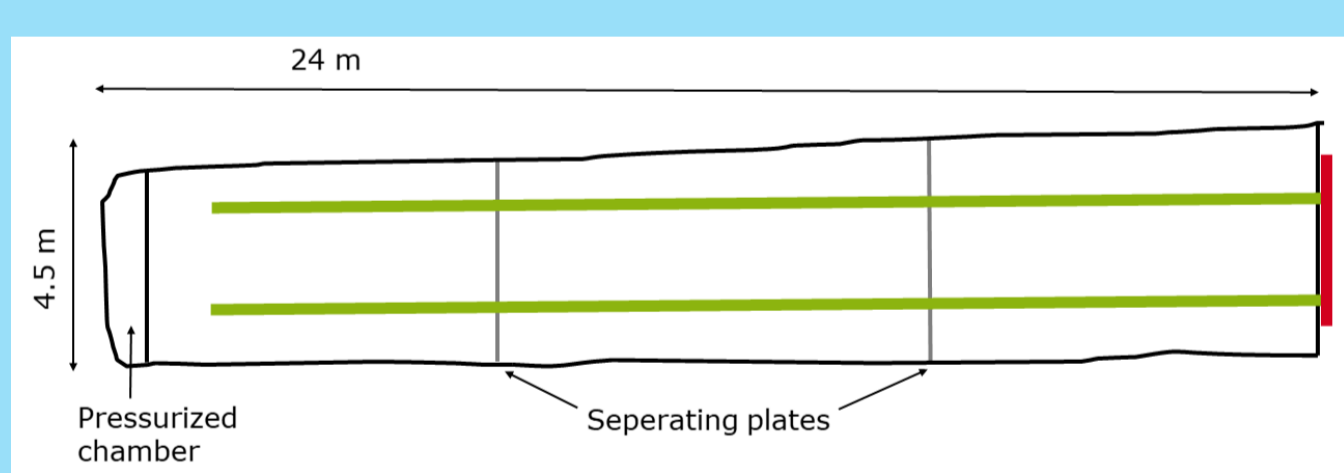
Sketch (side view) of an engineered barrier sealing a gallery with the location of ultrasonic echo inspection from with boreholes [5] and from the front [6,7].

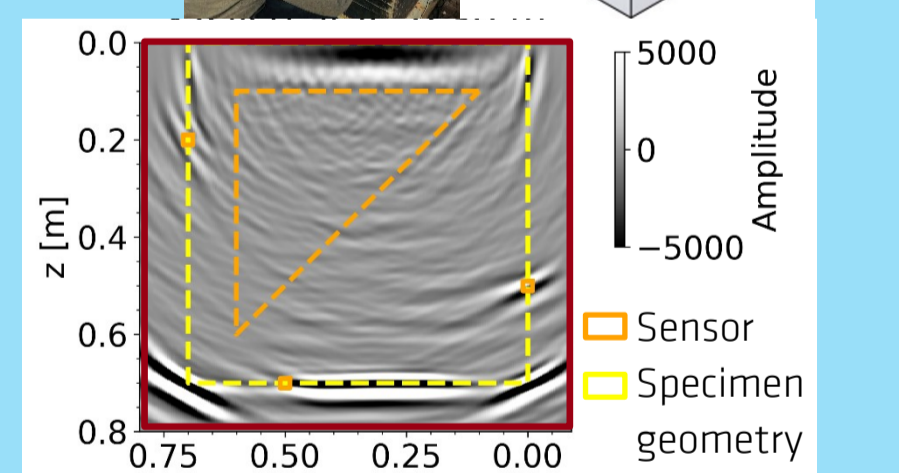
Ultrasonic images at the cuboid specimen (AAM) clearly identify sensor locations and specimen geometry. No major cracks are imaged. Slightly less reflectivity for AAM than for SC.

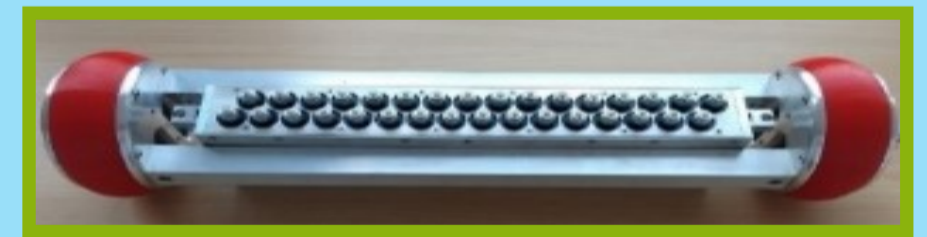
Left: new borehole probe

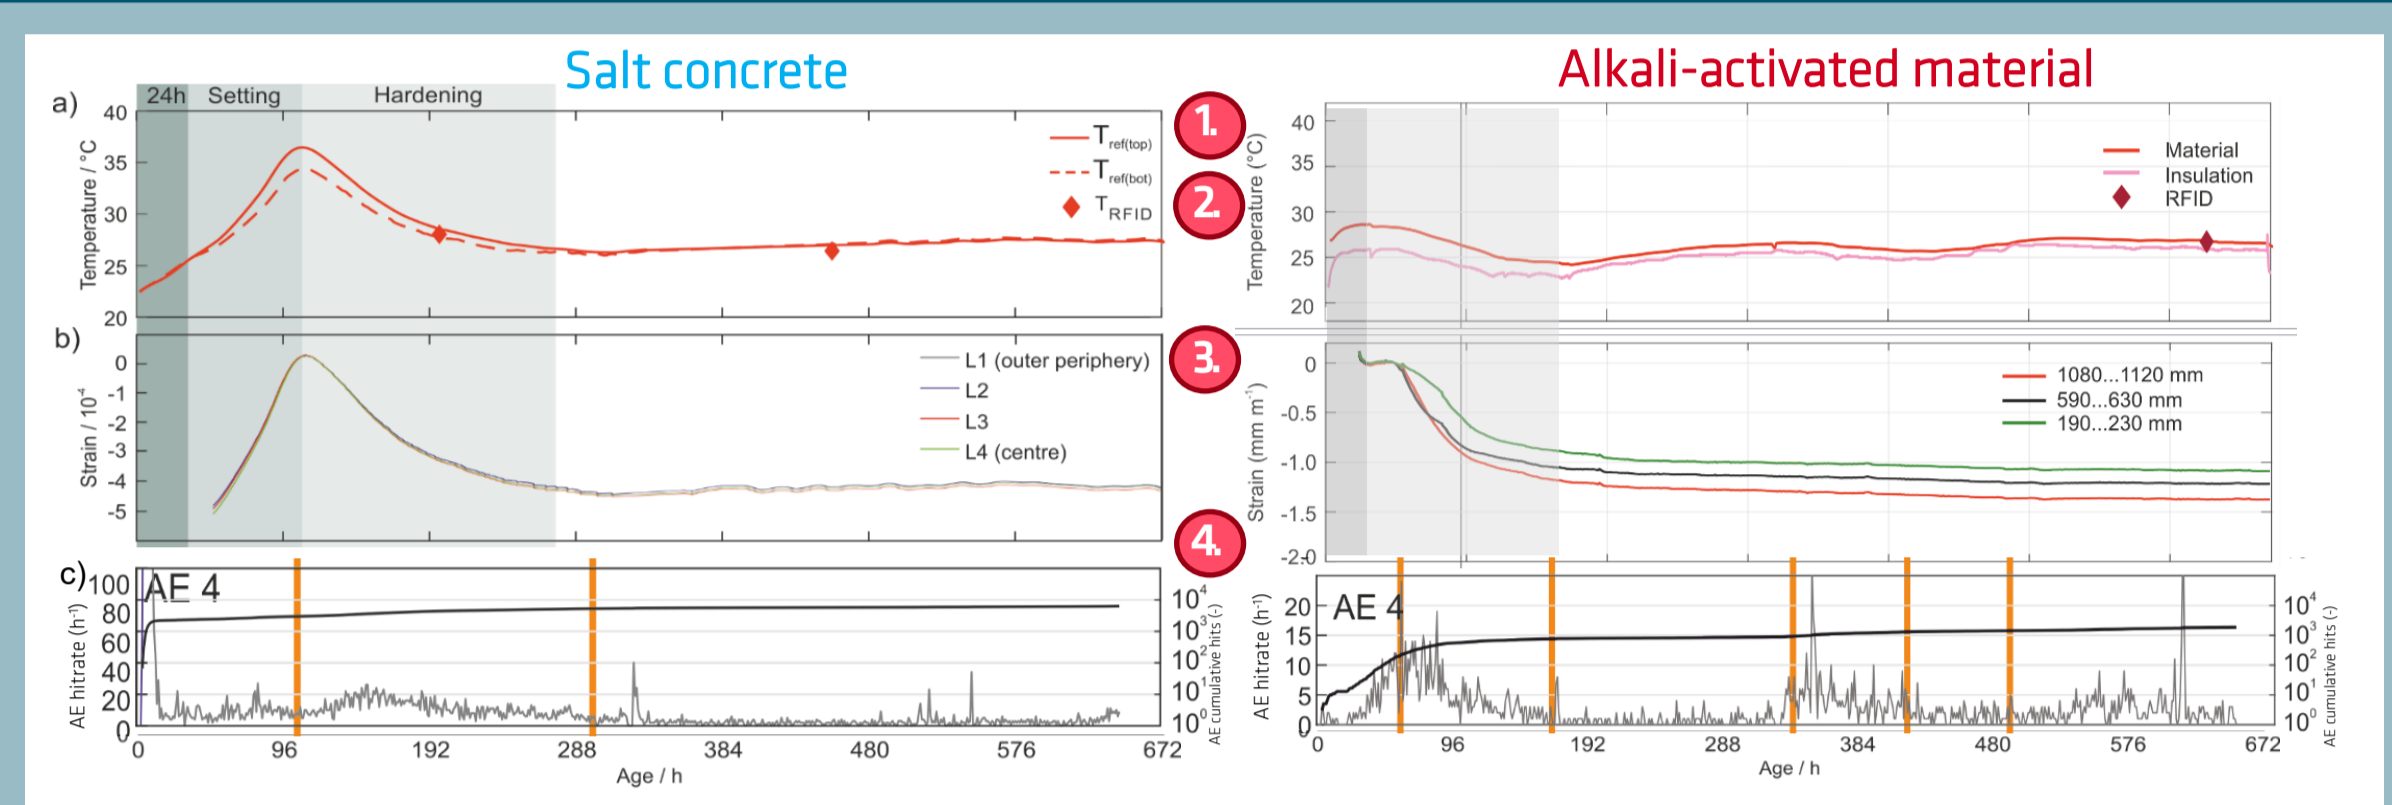
Multi-sensory hydration monitoring (28 days, cylindrical specimens) for salt concrete (left) and AAM F1 (right). a) temperature, b) strain from fiberoptic sensing, c) acoustic emission hitrate at sensor AE4. Strain and temperature indicate slower reaction kinetics for AAM, AE hits imply less cracking for AAM [3].

- 1 Temperature and humidity as reference (T,H)
- 2 Radiofrequency identification (RFID) based sensors (T,H)
- 3 Fiberoptic sensing (FOS) (strain)
- 4 Acoustic emission (AE) sensing (crack activity)

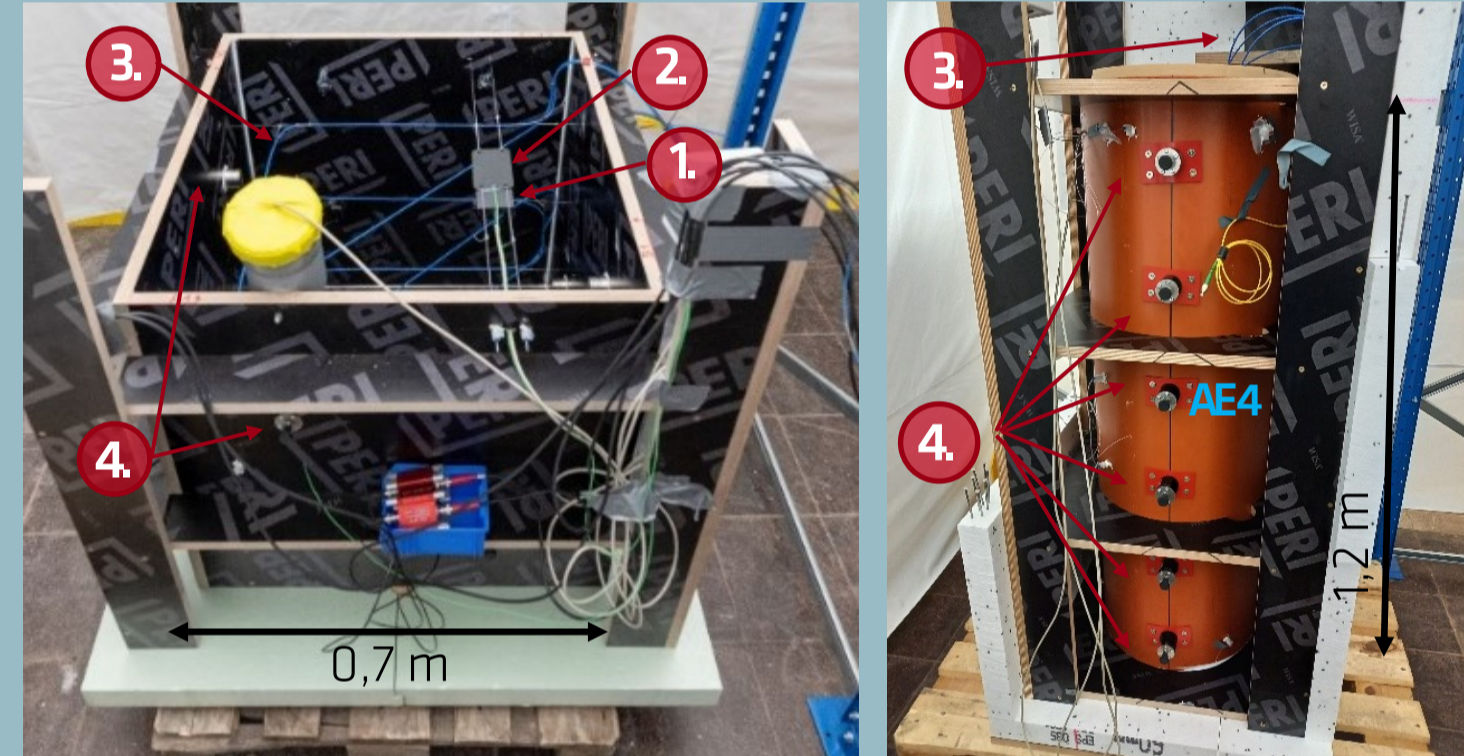
Test specimens with sensors before concreting

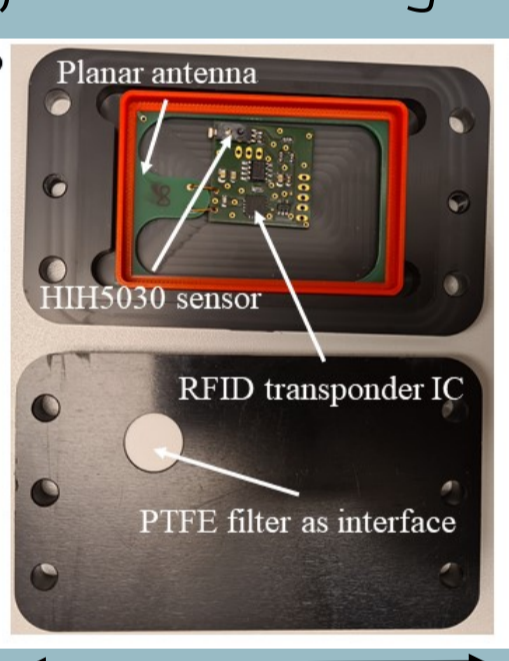
RFID-based sensor [3,4]

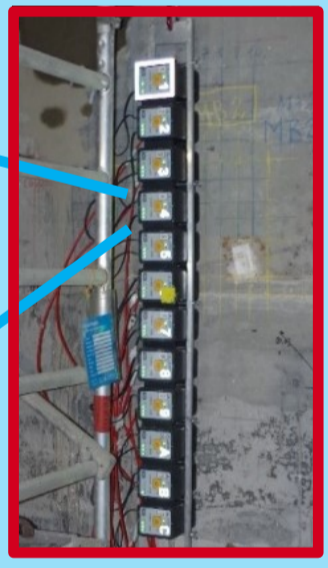
Left: Large aperture ultrasonic system LAUS measuring at the front of a test sealing structure in Morsleben [6].

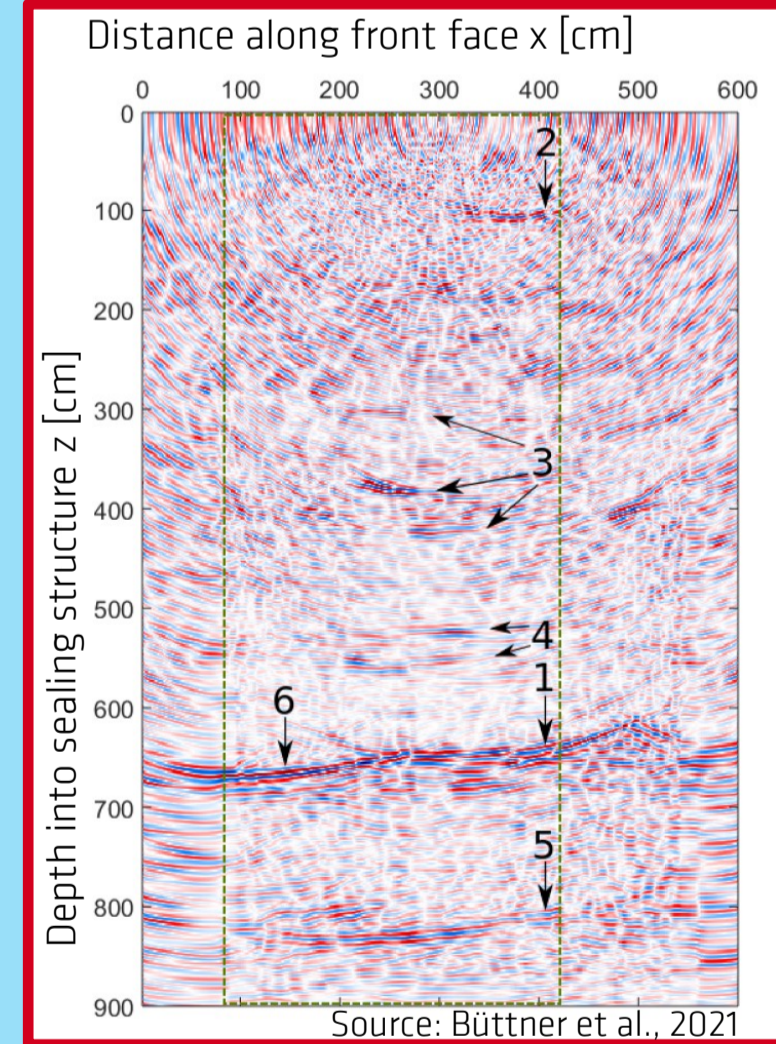
Left: Reconstructed image (using Reverse-Time-Migration) non-destructively reveals internal structures at an engineered barrier [7]. The identified features were verified by subsequent drilling and show built-in monitoring devices (2,4), the separating plate (5) and air-filled cracks (3,6).
