## DELIVERABLE 8.1 OF MODULE 4 WORK PACKAGE 3.2

### Report on Short Plug Test Results

Mod4-WP3.2-D8.1– Report on Short Plug Test Results

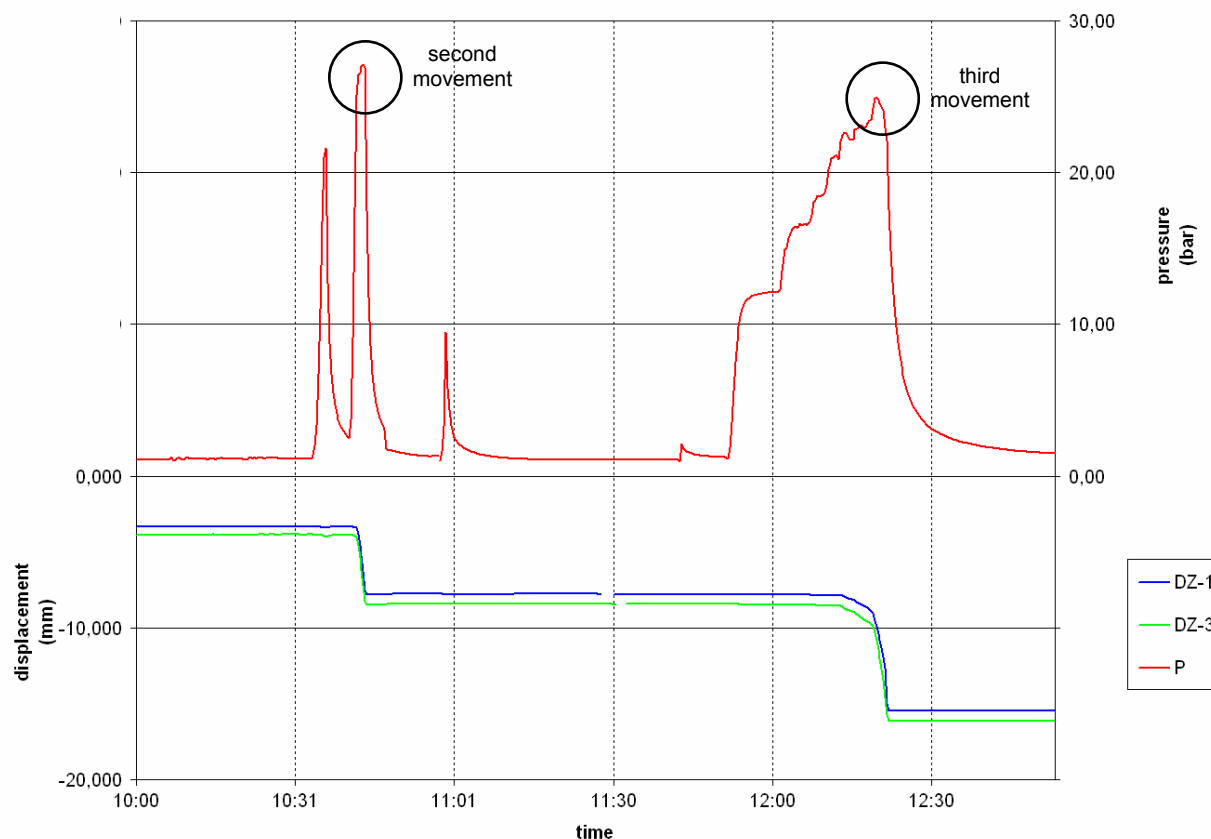
- At 11:52 the pump was connected, using doped water, and the pressure increased in a step-wise controlled manner (Figure 16).
- The third out-of-equilibrium movement of the plug took place at an applied pressure of 24.9 bar (at 12:19). Many hits per second were again registered by the acoustic emission sensors during this displacement.
- The pump was shut off at 12:22 (three minutes later) when the plug movement had increased from 8.419 mm to 15.718 mm (7.3 mm).
- At 12:55 the pressure had decreased to 1.48 bar.

Despite the plug movements recorded during the loading tests described above, two additional hydraulic pulses were performed coinciding with a technical meeting held at Äspö during 28-29 March 2006. In each one of the pulses the plug moved again, when the hydraulic pressure reached about 20 bars, with a total displacement of 19 mm, which added to the 16 mm recorded in the previous movements gives a total uniform displacement of the plug of more than 3.5 cm.

*Figure 16: Loading and displacements during March 3, 2006*

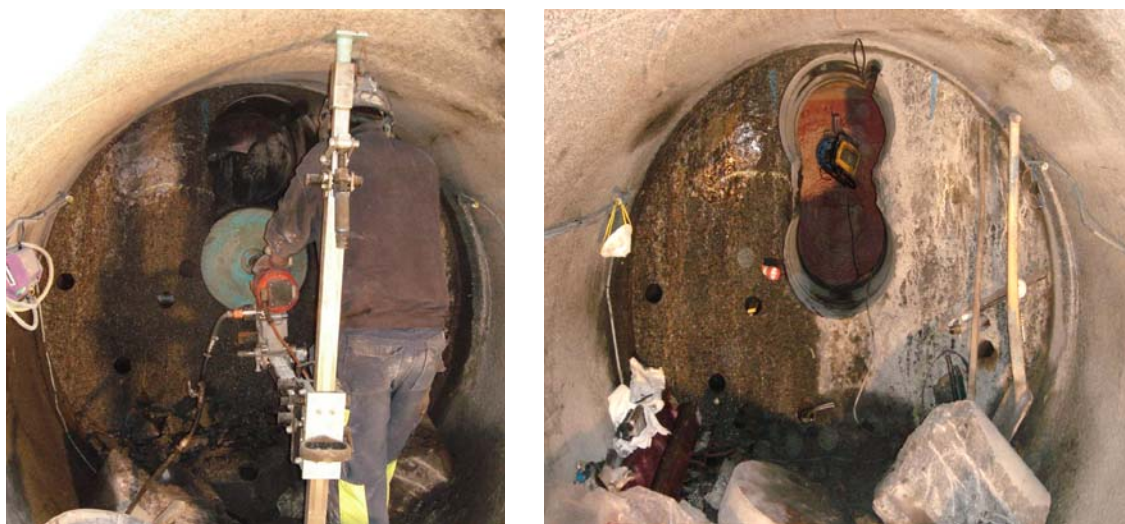
A penetration passing through the plug to the wooden support of the water chamber was excavated by drilling two horizontal channels measuring 500 mm in diameter. The first was drilled in the upper part of the plug at 4 cm from the rock, and the second immediately below (Figure 18). The connection between them was hammer drilled. To access the water chamber the wooden support was cut with a jig saw. This opening allows for both personnel access to the water chamber and the subsequent inspection of the behaviour of the system during the test and a detailed mapping of the inner part of the plug along its entire length.

*Figure 18: Drilling of penetration (left) and open access (right)*

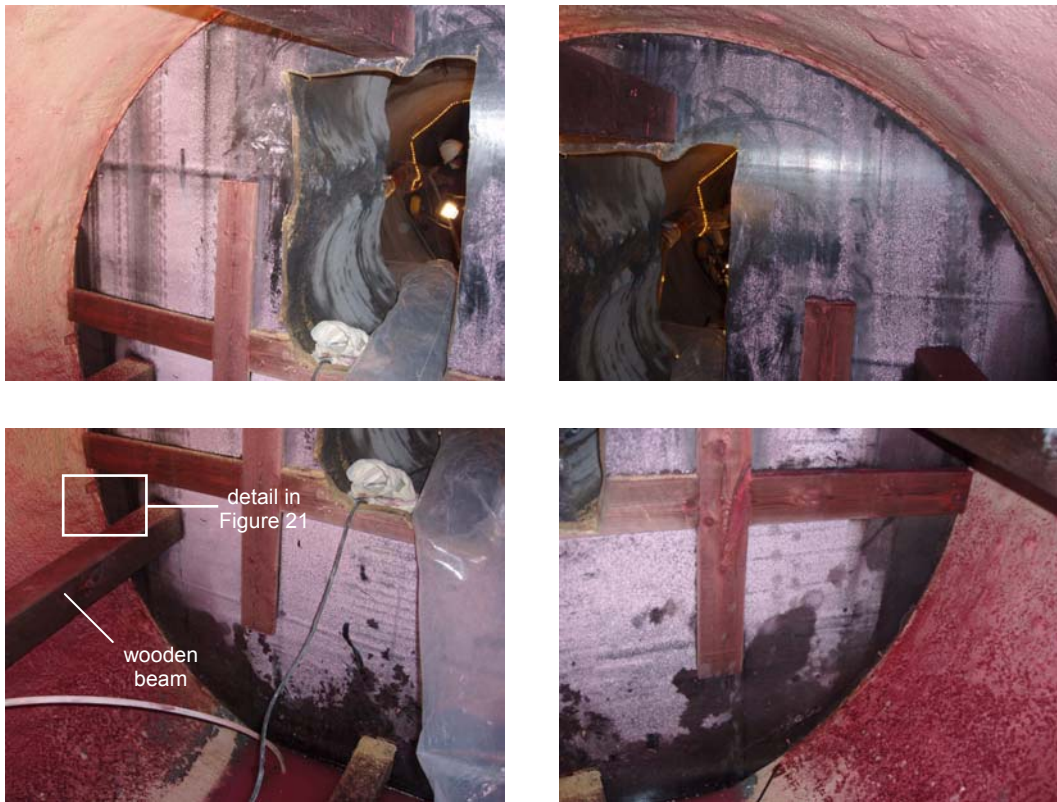
*Figure 20: Water chamber as found (view from inside)*

- The contact between the wooden support and the watertight membrane seemed to be intact, except for the lower left-hand part facing towards the entrance. In this zone the membrane presented a fissure (Figure 21).
- No signs of displacement could be observed at the anchoring points of the four beams that supported the wooden frame when these were removed.
- The membrane seemed to be intact and well bound along the entire rock surface of the chamber.

1. The fissure observed in the membrane at the contact with the plug in its lower left-hand part facing towards the entrance (Figure 20 and 21) most likely allowed water to enter into contact with the concrete at the start of the water chamber pressurisation process, producing the water leakage at the lower part of the plug (probably favoured by the existence of more permeable zones caused by shotcrete rebounds) (Figure 41). This leakage grew with increasing pressure, and perhaps with the wash out of the concrete in that part of the plug,

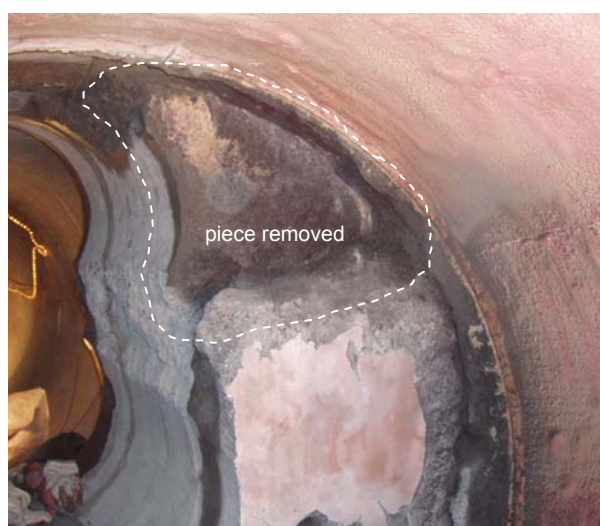
**Figure 25: Concrete piece removed from layer 1**

The inspection finished with the removal of a concrete piece from layer 1 (Figure 25). The penetration of the Rodhamine doped water may be clearly observed in the rock (Figure 26), as well as on the exposed surface of the concrete.

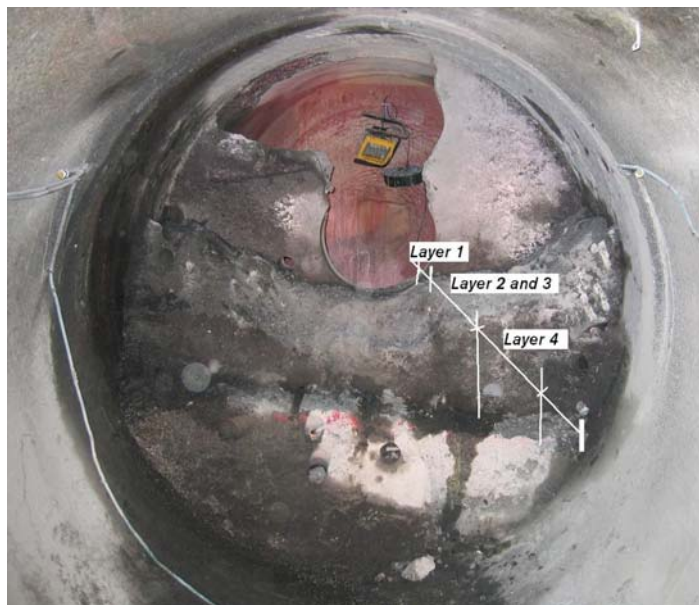
*Figure 27: Demolition of upper part of the plug*

Even with this controlled demolition method it was not possible to leave layer 2 intact (Figure 27). The demolition continued until only layer 1 and the bottom part of the plug were left in place. Then the vertical drilling was carried out as described in paragraph 6.3.4.

After removal of the concrete, numerous slickenside surfaces were observed in the granite in contact with the concrete. The slickensides were produced by the displacement of the plug, which indicates a tight concrete-rock contact, even after the failure episode during the successive horizontal movement of the plug.

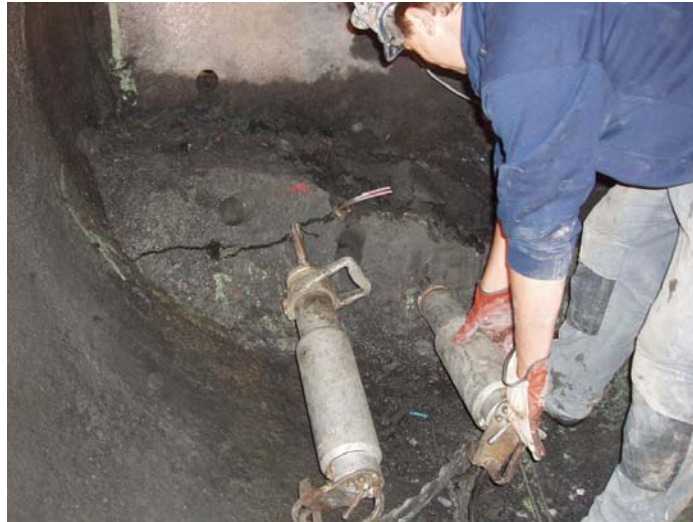
*Figure 29: Demolition of the bottom part of the plug with hydraulic splitter*

No noticeable variations in the porosity or noticeable heterogeneities in the bottom part of the concrete were observed either during breaking with the splitter or upon close inspection of the pieces of concrete removed. No clear signs of flow paths with Rodhamine were observed in the bottom part of the plug. Figure 30 shows the marks of Rodhamine along the entire contact between layer 1 and the rock, which did not progress through layer 2.

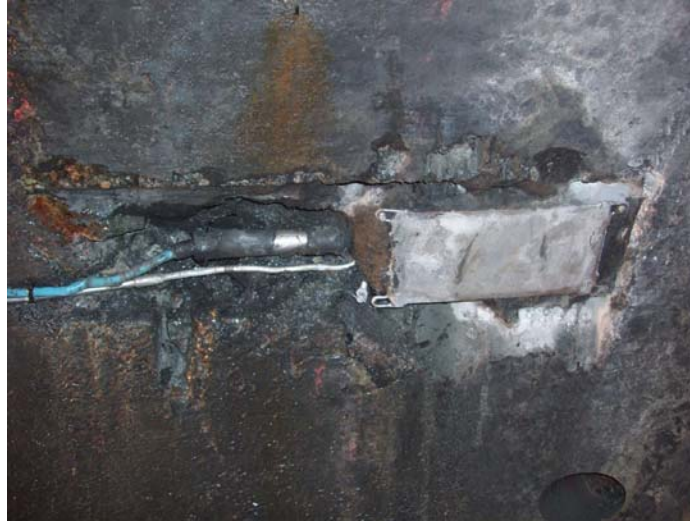
The total pressure cells were removed from the slots where they were embedded in mortar (Figure 31). It was observed that the slots had been well filled with mortar, with no air bubbles.

*Figure 31: Removal of TPC-3 at left-hand side*

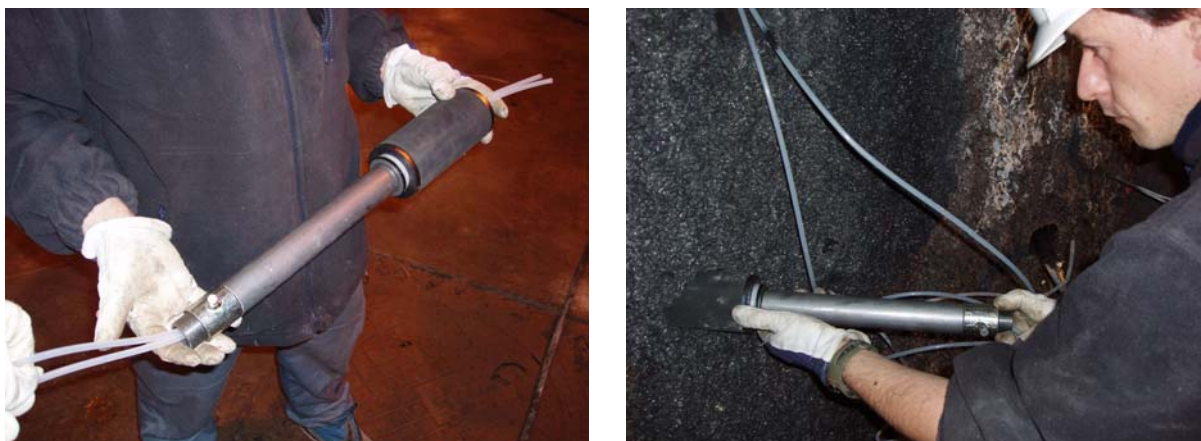
Four inclined boreholes measuring 75 mm in diameter were drilled from the plug surface to intersect the rock at different points. Mechanical packers were installed at the bottom of the boreholes (Figure 37) to isolate the concrete/rock interface and allow for the injection, at low pressure, of Sikadur 53 resin. The goal was to identify potential gaps between the concrete and the rock by drilling nearby boreholes parallel to the injected resin sections, which might have been intruded by the resin. The location of the boreholes is shown in Figure 32.

*Figure 37: Introduction of packers into the inclined boreholes*

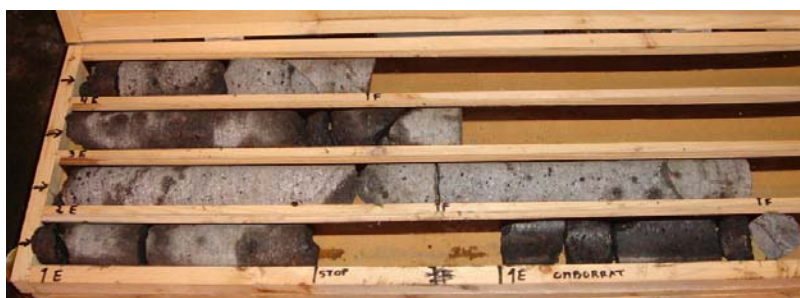
Resin was injected in the inclined boreholes 1.I to 4.I. After three days of resin hardening, boreholes 1.E to 4.E (parallel and very close to I holes) were drilled and cored in search for traces of resin intruded in potential gaps at the rock/plug interface. No resin was found in any of the cores extracted.

The absence of resin in any of the cores extracted cannot be interpreted as an indication of the absence of gaps, since it was observed that the space sealed with the packers was not completely filled by resin, probably due to the high density of the resin used, thus hindering the injection under pressure of resin in any possible existing gap.

*Figure 38: Inclined cores for resin checking*

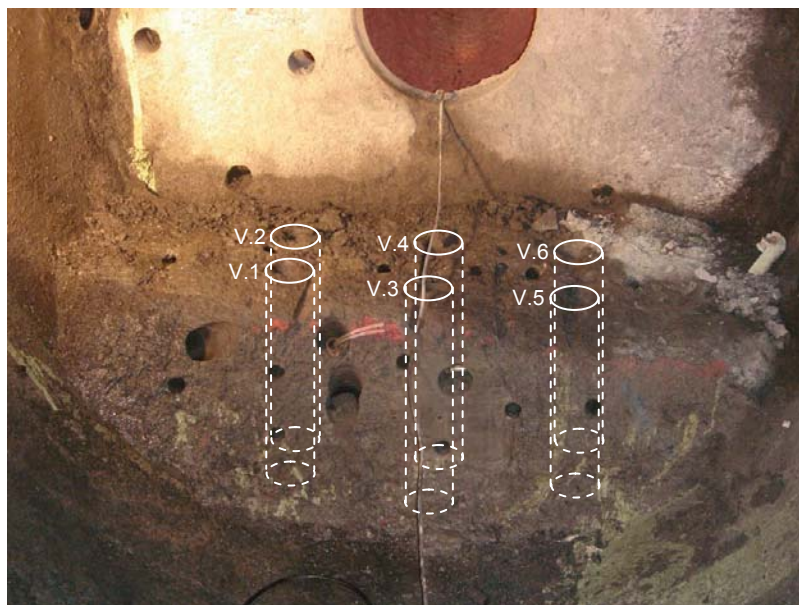
*Figure 40: Vertical sampling*

Boreholes V.1, 3 and 5 were drilled in concrete layer 3, while V.2, 4 and 6 were drilled in concrete layer 2. In the cores from layer 2 a more heterogeneous and porous zone was observed at a few centimetres from the rock. Apart from this, no significant variation may be observed between the bottom and top parts of the cores.

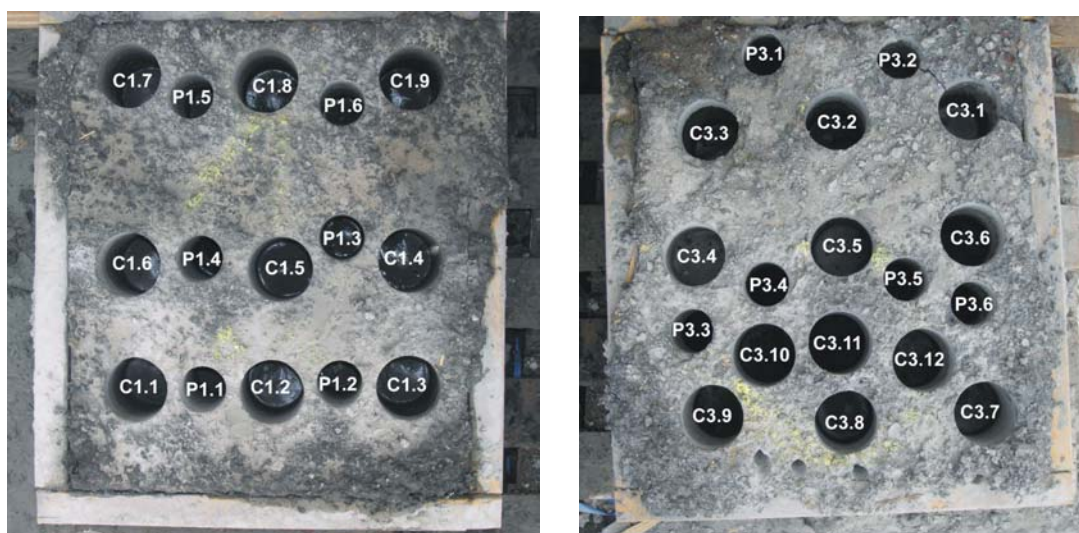
*Figure 42: Cores from sample panels of layer 1 (left) and layer 3 (right)*

The compressive strength and elastic modulus of the cores from the layer 1 panel are within the required limits (over 10 MPa and below 20 GPa, respectively). Three cores from this panel were analysed also by the Madrid School of Mines, for cross-checking. The values obtained are of the same order as those provided by the Torroja Institute, although one of the values for elastic modulus is over 20 GPa. The results obtained may be found in Table 4.
