**DELIVERABLE (D-N°:D4:03)**  
**KBS-3H Preparations, assembly and installation of  
the Multi Purpose Test**

Author(s): Magnus Kronberg, SKB

Date of issue of this report: **01/09/2015**

### **P-14-27 KBS-3H Preparations, assembly and installation of the Multi Purpose Test**

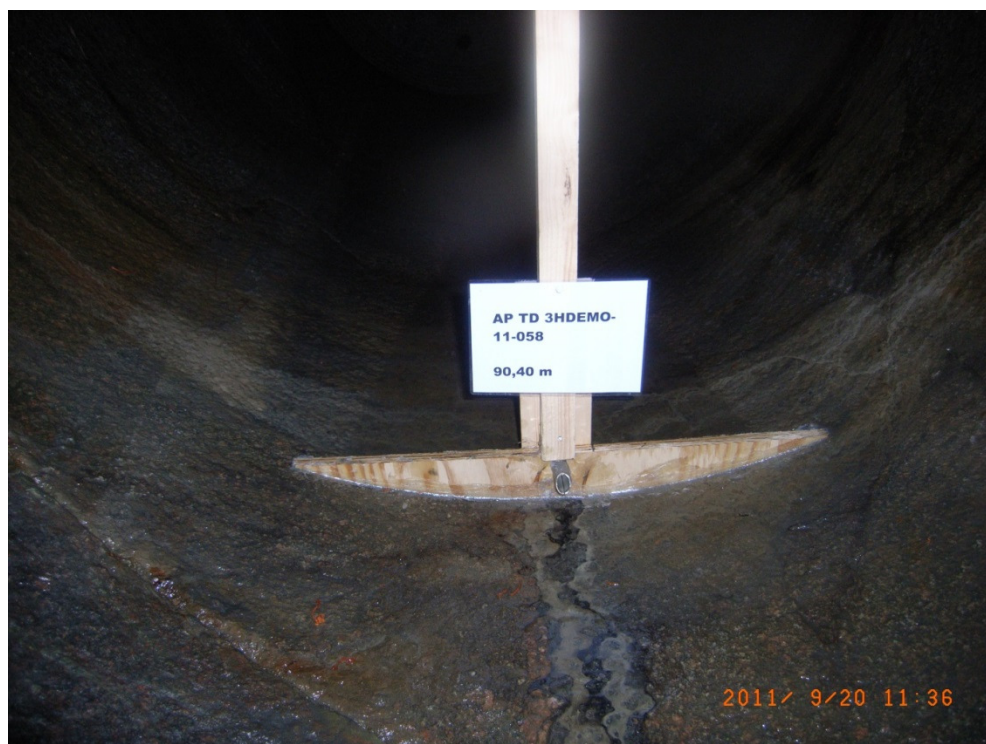
**Figure 3.1.** Wooden weir used to section off and measure the distribution of groundwater inflow in the MPT section.

In order to obtain a good view of the inflow conditions in the MPT section, a set of wooden weirs were installed, Figure 3.1. The weirs were placed where the rock conditions allowed so, but they matched up quite well with the components positions. Detailed inflow data are presented in Table 3.1

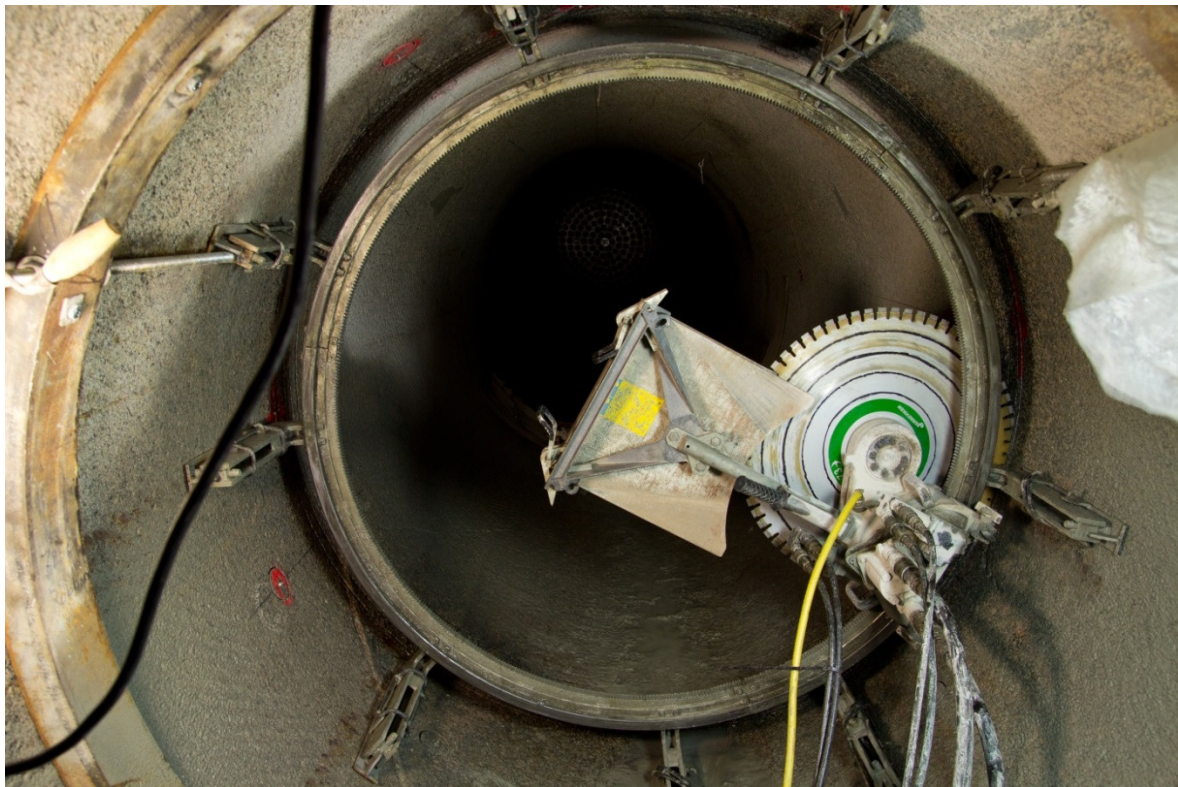
**Figure 5.1** Rail and saw installed inside the drift. The reference ring towards which the rail is pulled in 45 mm steps can be seen to the left in the picture.

A circular saw, mounted on a circumferential rail is used to cut out a slot for the compartment plug, c.f. Figure 5.1. It total 14 parallel cuts were made, with approximately 45 mm between each cut and extending to a depth of 283 mm which allows for an effective depth of approximately 263 mm when the slabs of rock are broken loose. The rock is broken manually using wedges, starting at the highest point, with rigid precautions taken to ensure worker's safety. The fastening ring has 12 positioning bolts around the periphery of the slot for which 12 cored holes ( $\varnothing$  80 mm) were drilled radially to a depth of 180 mm prior to the sawing. Figure 5.2 illustrates the cutting pattern and visualises two of the cored holes. The drilling step can most likely be excluded in the future by making the two outermost parallel cuts slightly deeper using a hand held saw at the corresponding positions, thus enabling sufficient space for the fastening ring's positioning bolts.

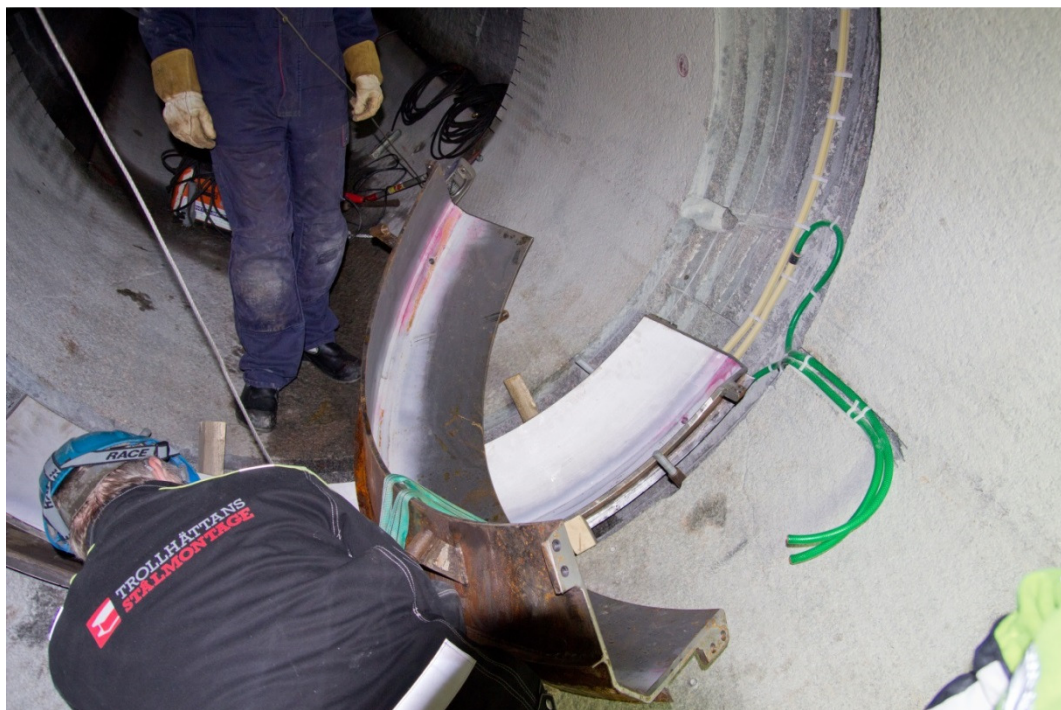
**Figure 5.3** Installation of the fastening ring, the contact grouting tube in the rock-casting interface can be seen to the right in the picture.

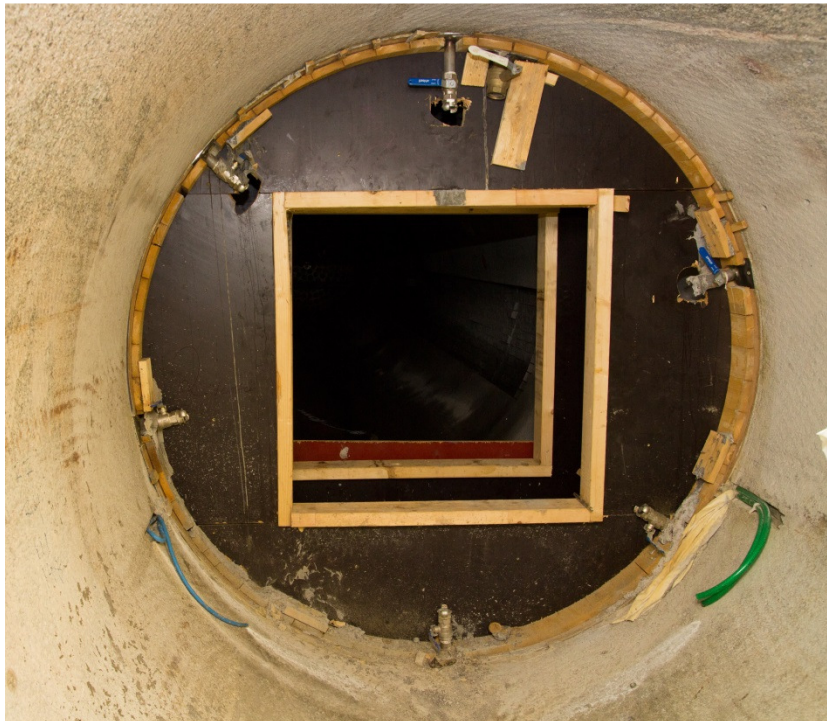
**Figure 5.4** *Form-work for the casting of the fastening ring.*

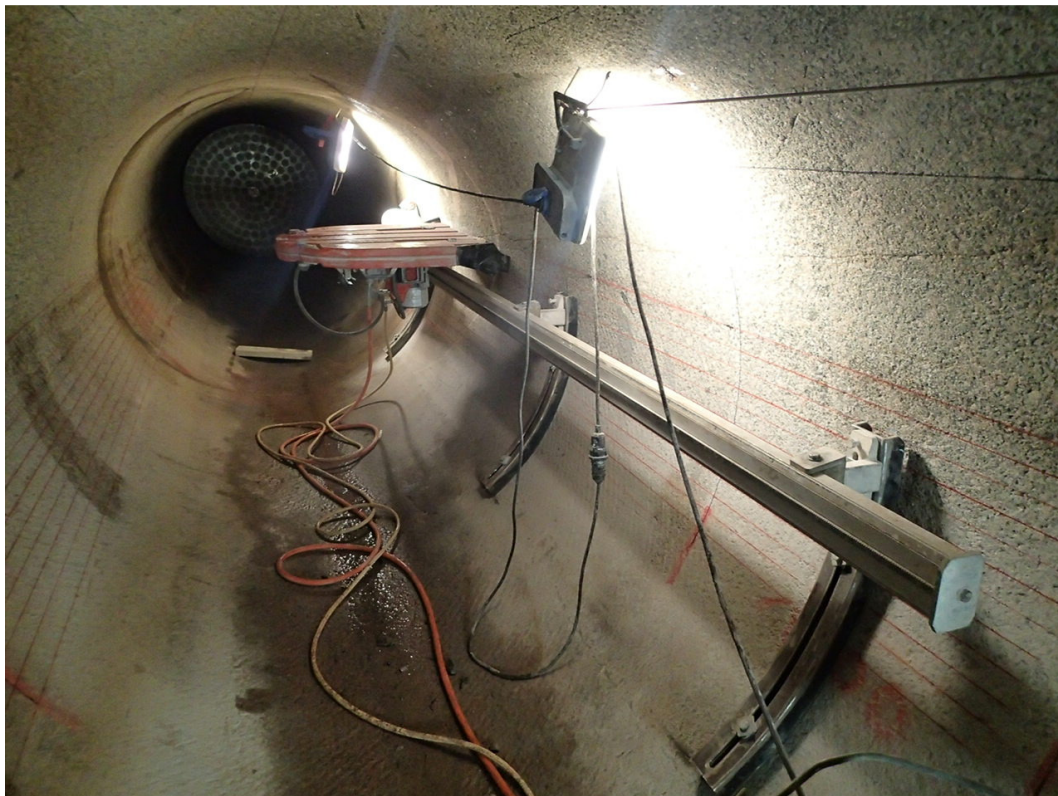
**Figure 5.5** Saw fitted on rails with anchoring's that allow for cutting of parallel cuts along the drift sides. Slices of rock were later broken off starting at the highest point and continuing downward.

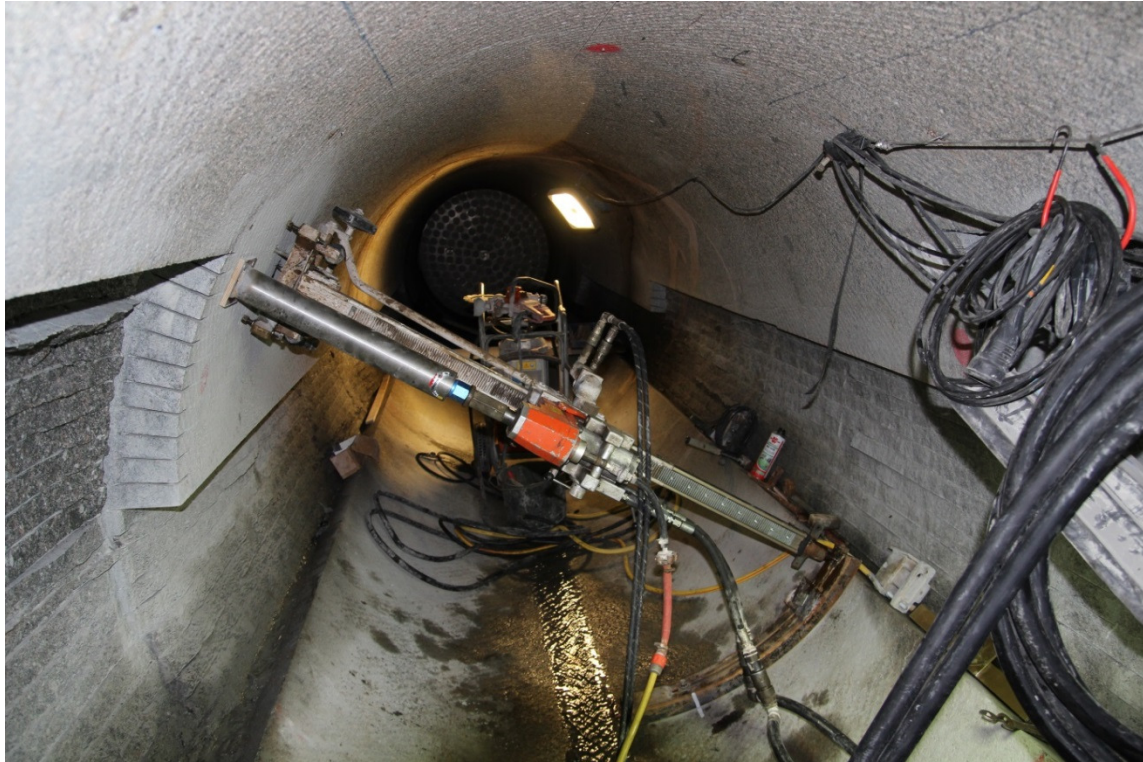
**Figure 5.6** Core drilling of 10 m long boreholes inside the MPT test section. The picture also visualises the cable notches. Note that the Supercontainer vaguely seen at the end of the drift is the concrete dummy used during deposition machine testing; it was removed prior to the main MPT installation.

The cores were photographed and tentatively mapped for rock types and fracture frequency. The dominant rock type seen in the boreholes is Äspö diorite with minor occurrences of fine-grained granite. In the overview mapping the broken fractures of the cores were all interpreted as possibly open fractures (containing fracture fillings). The total numbers of fractures in the boreholes are: KA1619A03 = 7 fractures, KA1620A01 = 13 fractures and borehole KA1619A04 = 5 fractures.

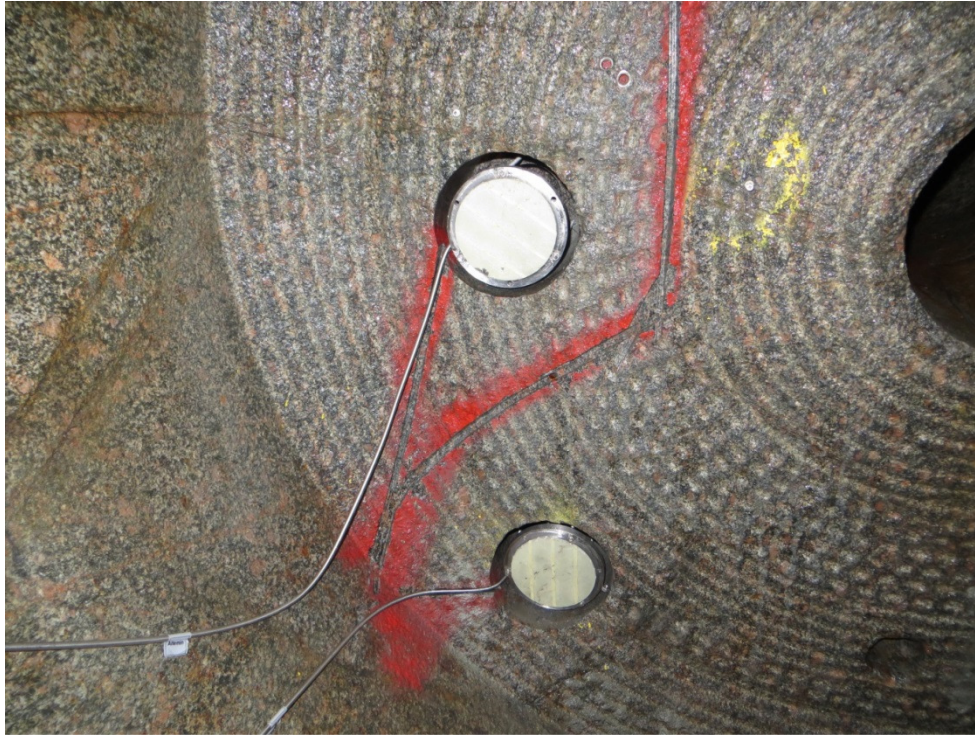
**Figure 5.7** Total pressure sensor position in their holes prior to casting. The picture, which is taken at the drift end, also illustrates the shallow cutouts in which the sensor cable pipes were placed (red spray on the wall).

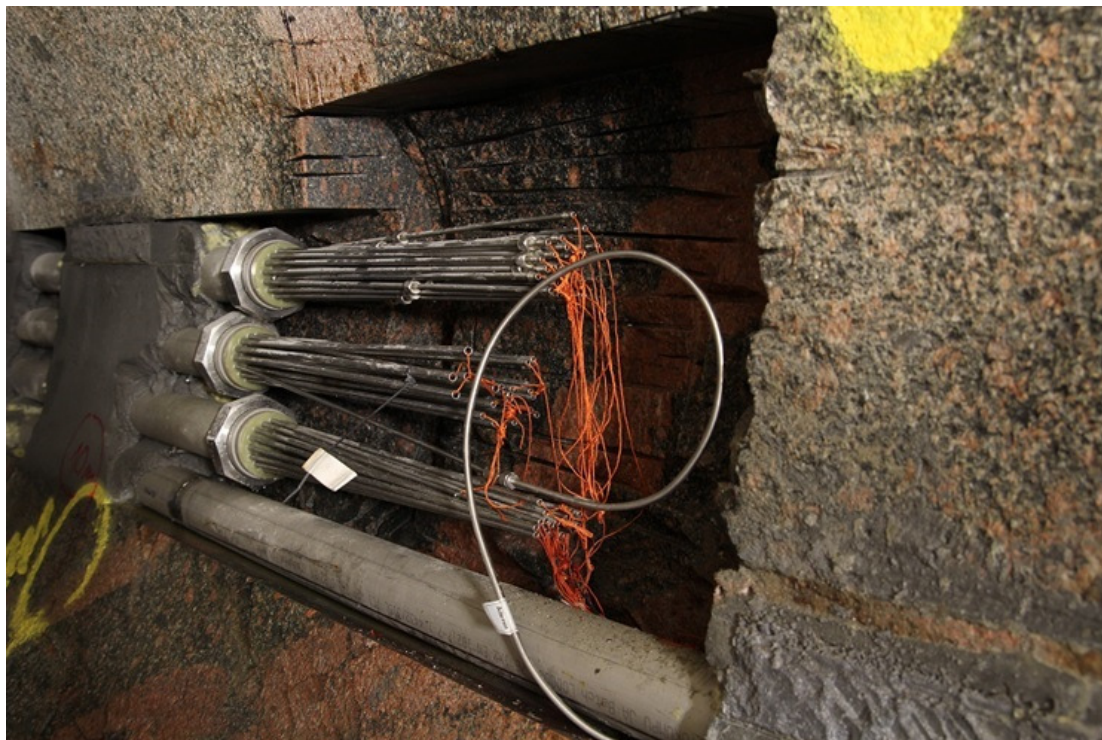
**Figure 5.9** 'Hedgehog' connectors at the Supercontainer position, in this case three 'hedgehogs' due to the numerous sensors inside the Supercontainer. The pipe passing by at the bottom carries the sensor cables from the innermost distance block. The small pipe in a loop and already connected is from one of the rock-sensors.

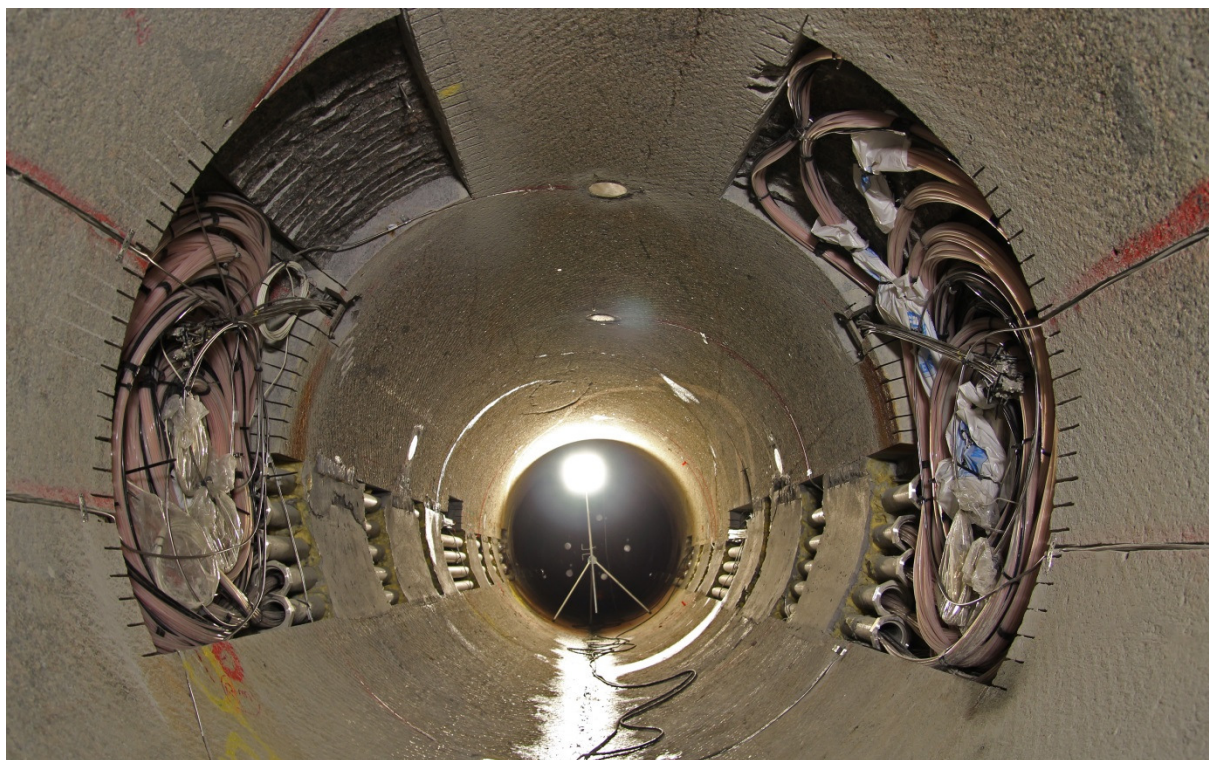
**Figure 5.10** The MPT drift prepared for installation, note the partial low-pH casting around the larger pipes. Also visible is the cable storages where tubes and cables are placed during installation.

All larger pipes ended in the cable storage, Figure 5.10, where tecalan tubing and cables were stored during installation. Once the plug was subsequently built these tecalan tubes with cables inside were taken through large flexible stainless steel pipes and out through the plug.

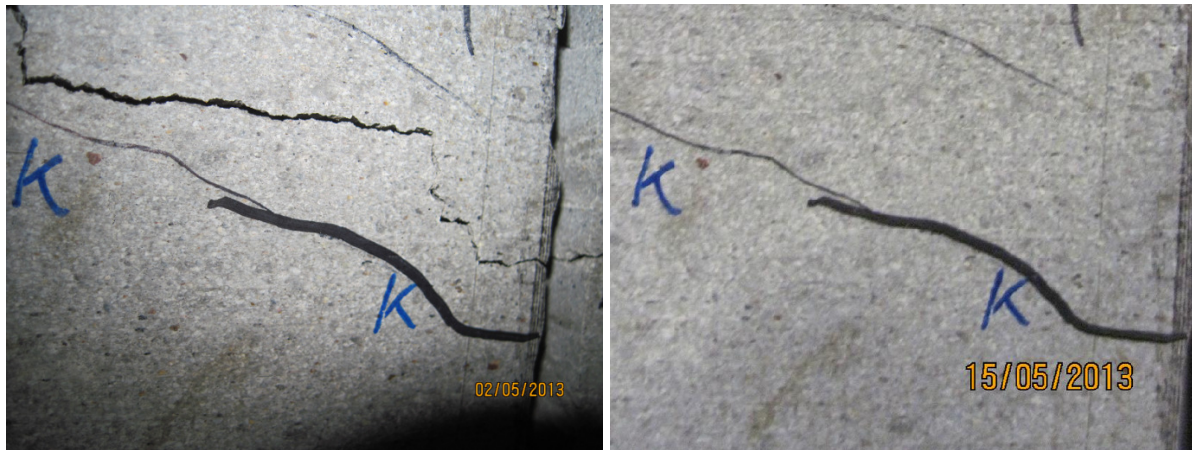
**Figure 7.1** *To the left, one of the worst drying cracks noted on the distance blocks, several centimetres long and in the order of 1 mm wide. To the right a picture of the same area once the block had been stored for some days in a RH corresponding to its equilibrium state, the closing of the crack is apparent.*

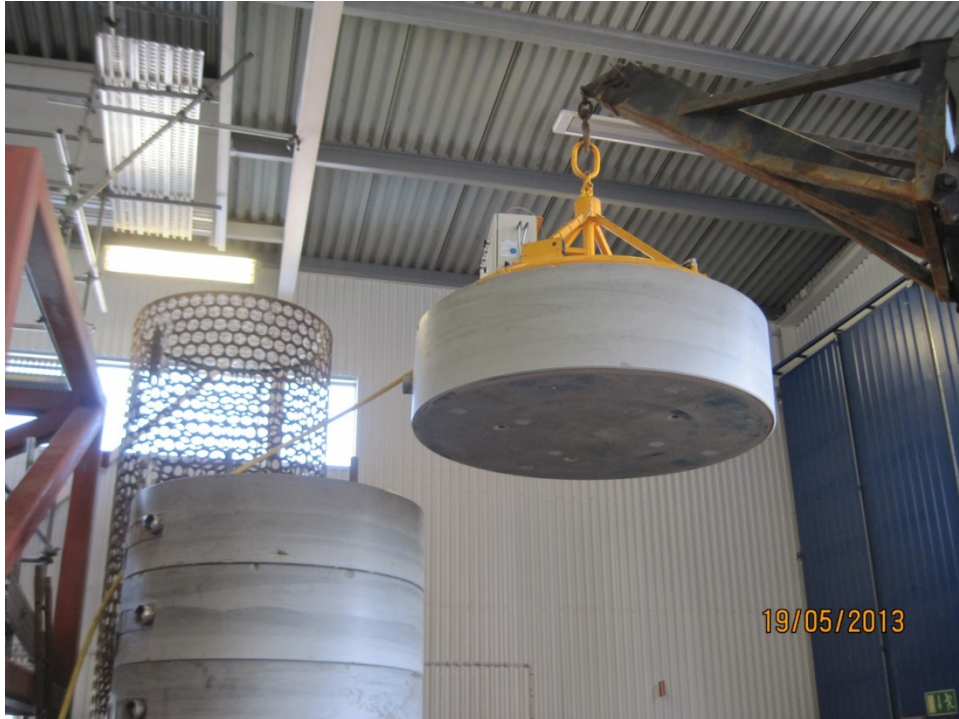
**Figure 7.2** A Distance block segment being placed using a wheel loader and a vacuum tool in the controlled environment of the assembly facility. The distance block feet can be partially seen to the left on the stack of blocks.

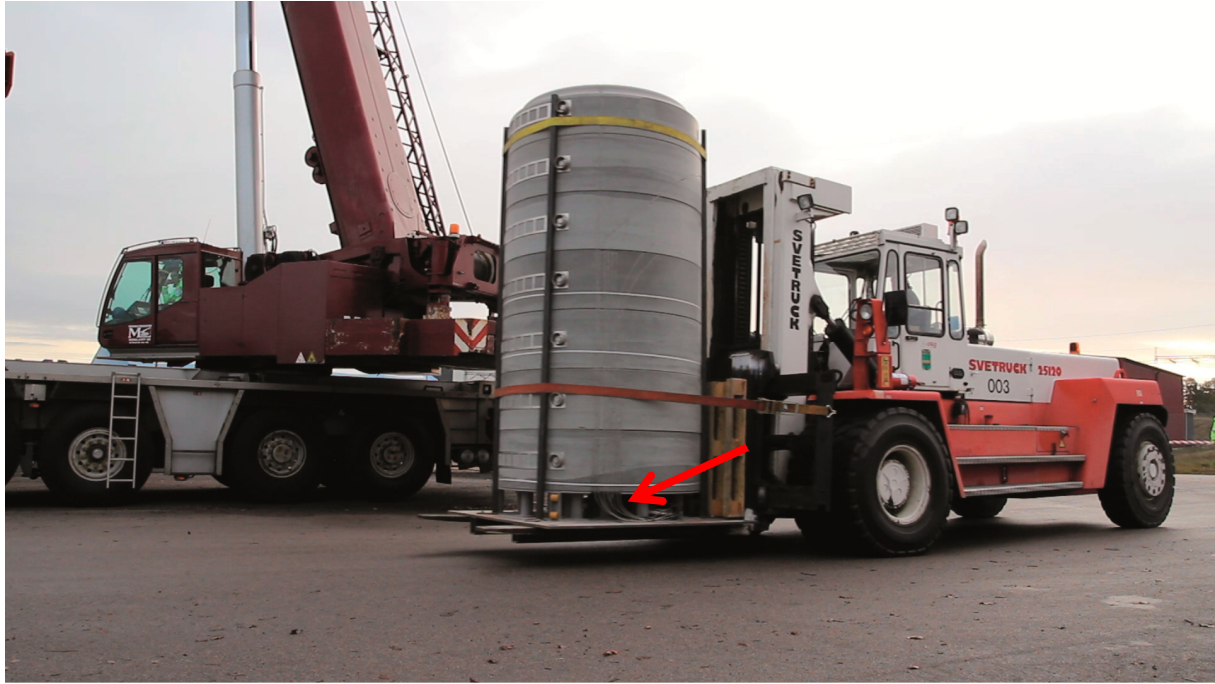
**Figure 7.3** Test distance block being moved out from the assembly facility. The red arrow marks the cable block placed on the stacking plate.

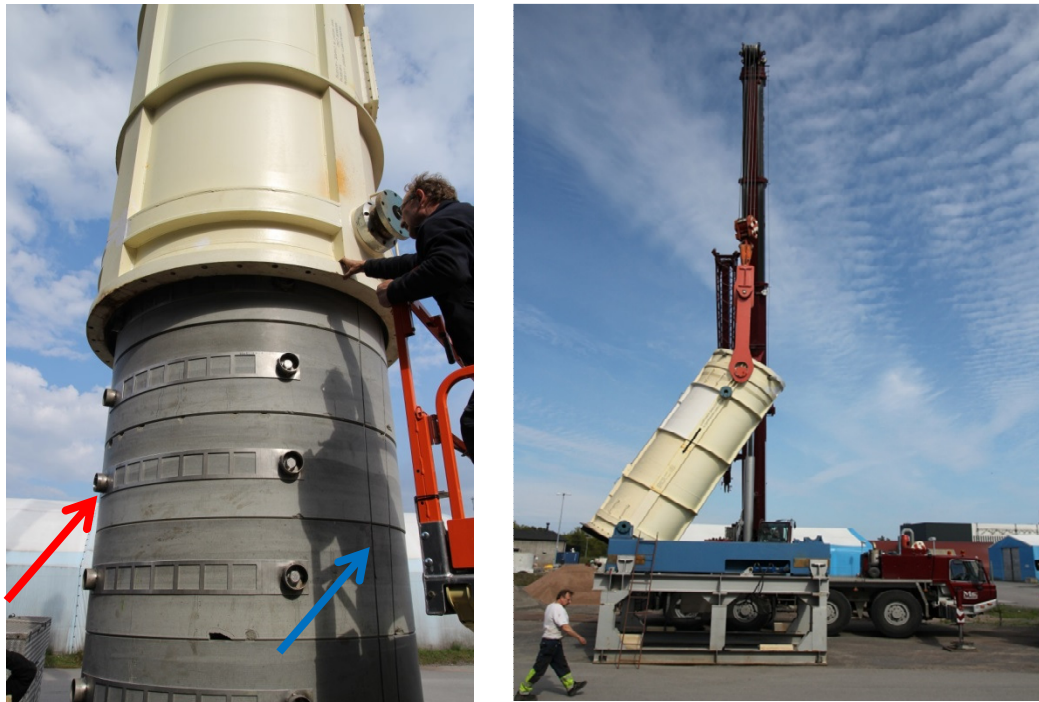
**Figure 7.4** The transport tube is being lowered over the distance block (left). The feet placed on each distance block segment are clearly visible (red arrow) and two cable pipes milled into the block surface can be seen to the right of the component (blue arrow). The transport tube is being lowered on to its transport cradle (right).

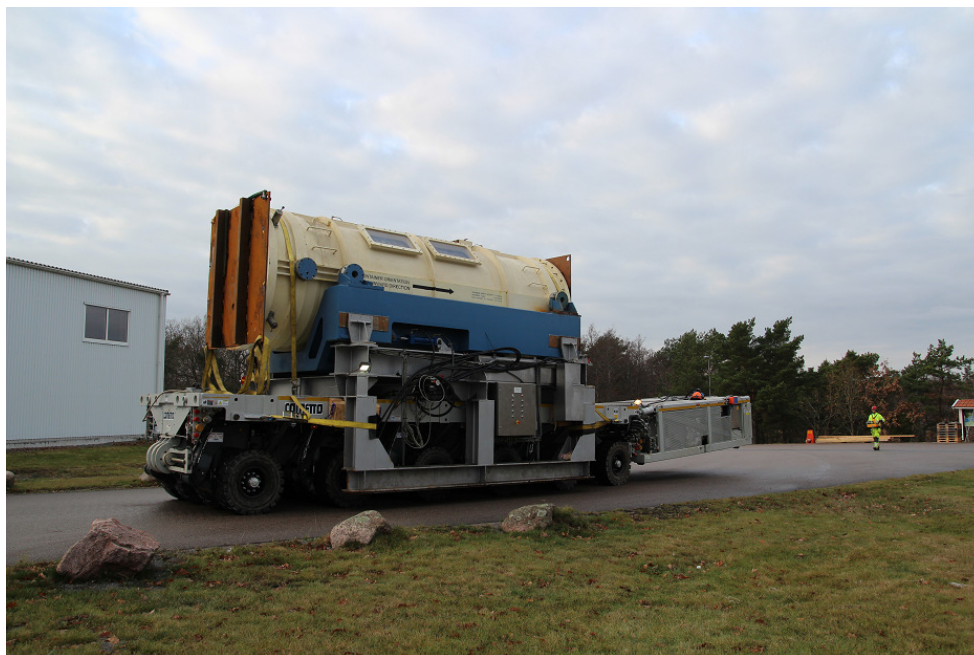
**Figure 7.5** Transport tube secured to MODE transport vehicle being ready for transport down to the deposition drift at -220m.

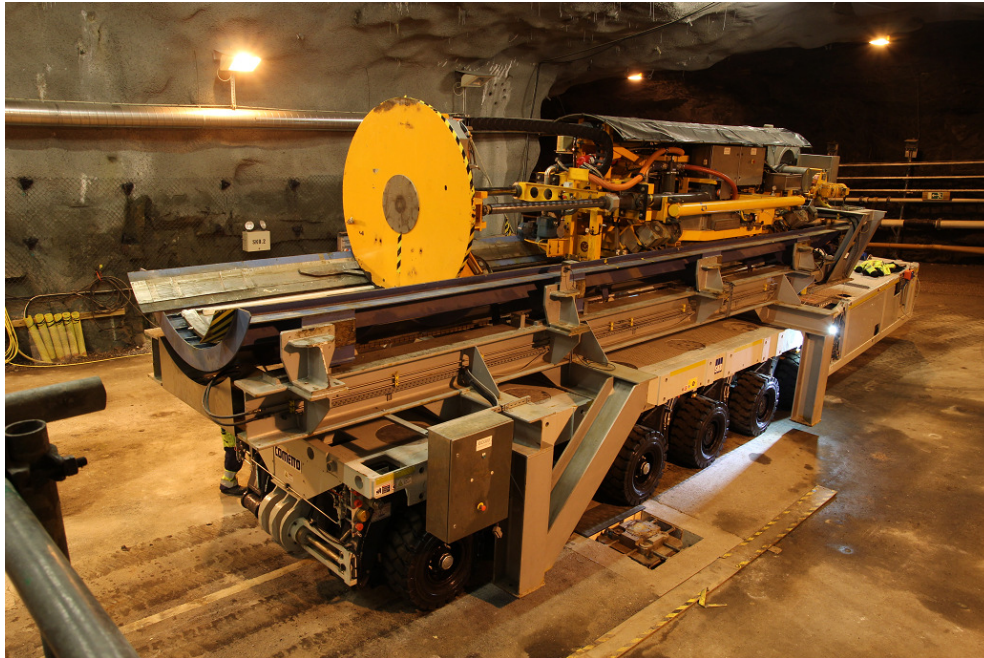
**Figure 7.6** Starting tube with the deposition machine being moved into position by MODE.

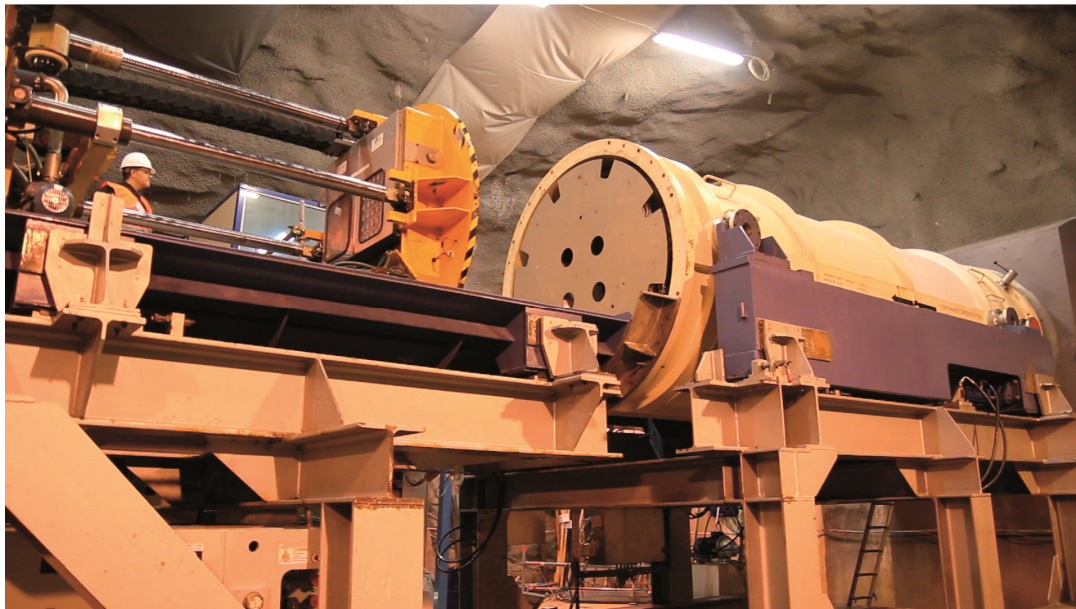
**Figure 7.7** Starting- and transport tube aligned in front of the drift, being ready for deposition. The test distance block is inside the transport tube with only the bottom of the cable block visible.

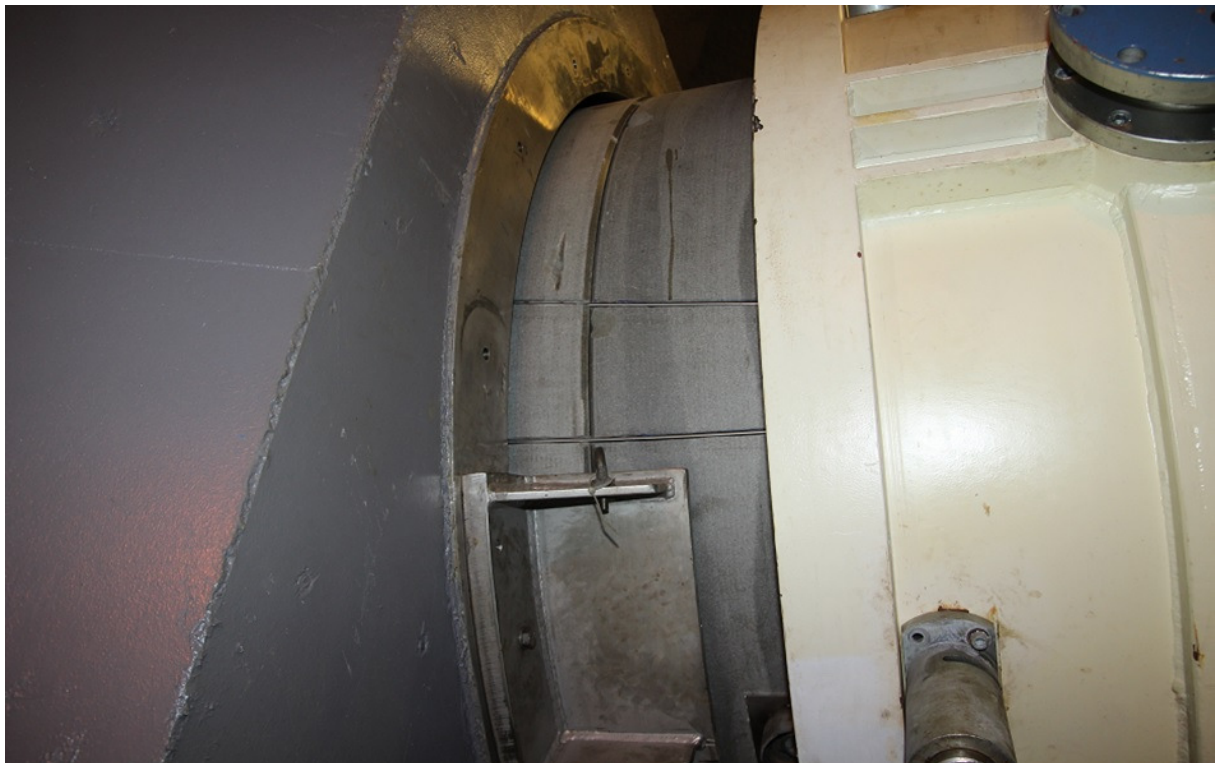
**Figure 7.8** Distance block driven in to the drift from the transport tube. The tight fit between the component and drift wall when it is lifted can be seen in the top part of the picture.

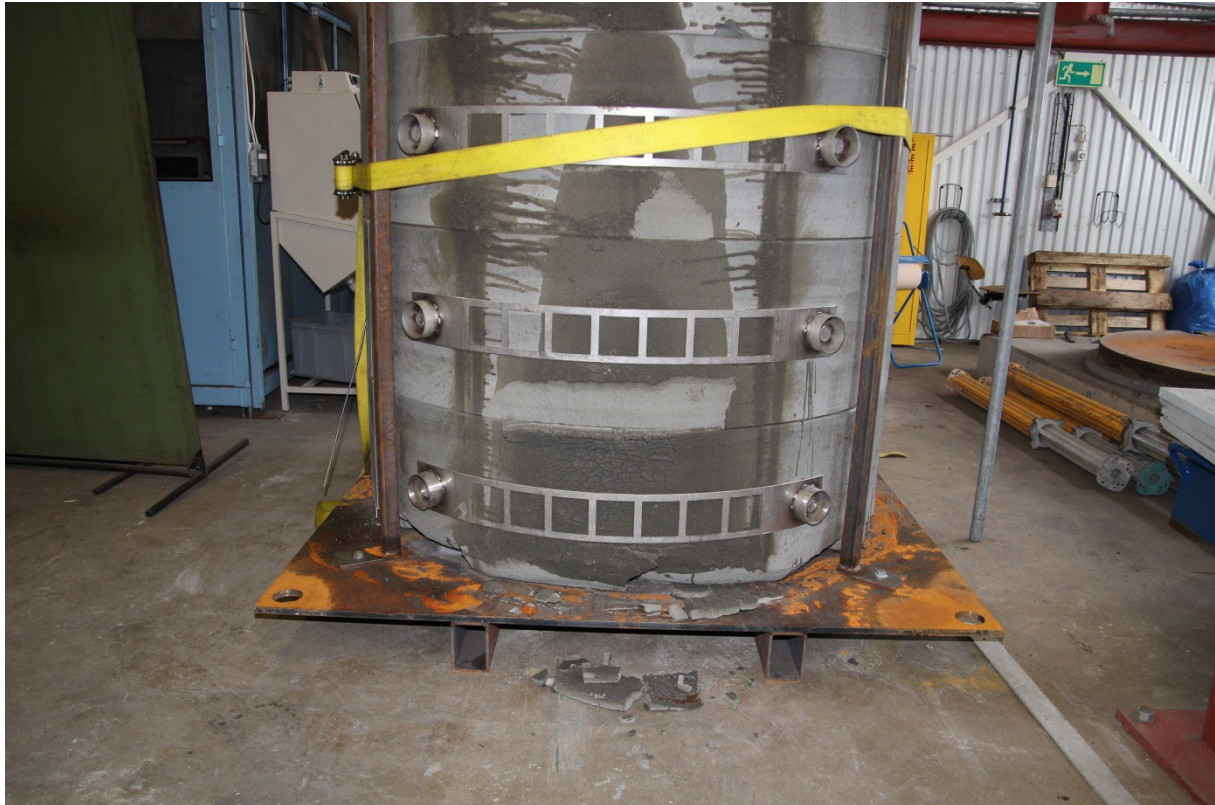
**Figure 7.9** Test distance block back in the assembly facility, the effects of splashing is evident.

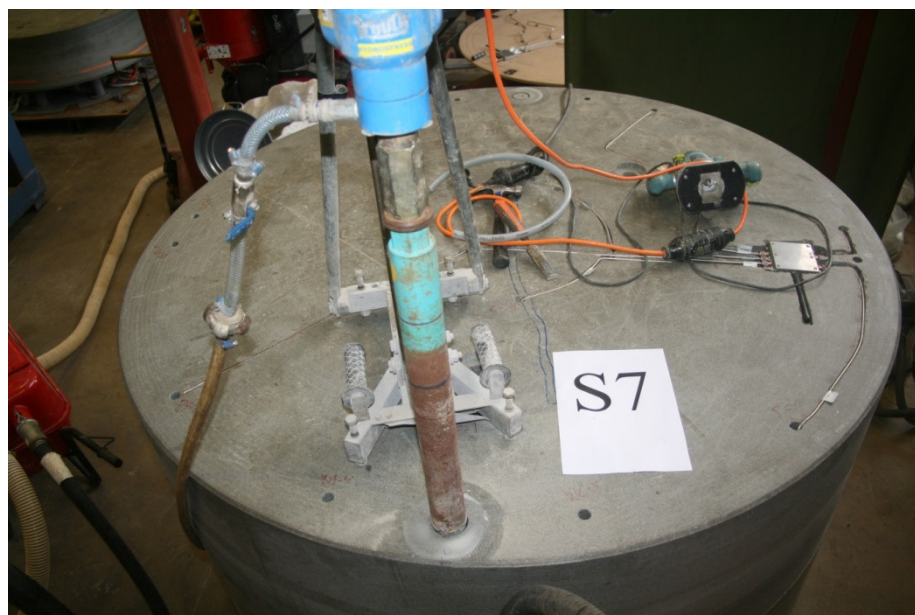
**Figure 8.2** Drilling for placing sensors in section 7, one of the wireless transmitters and its sensors has already been placed, to the right.

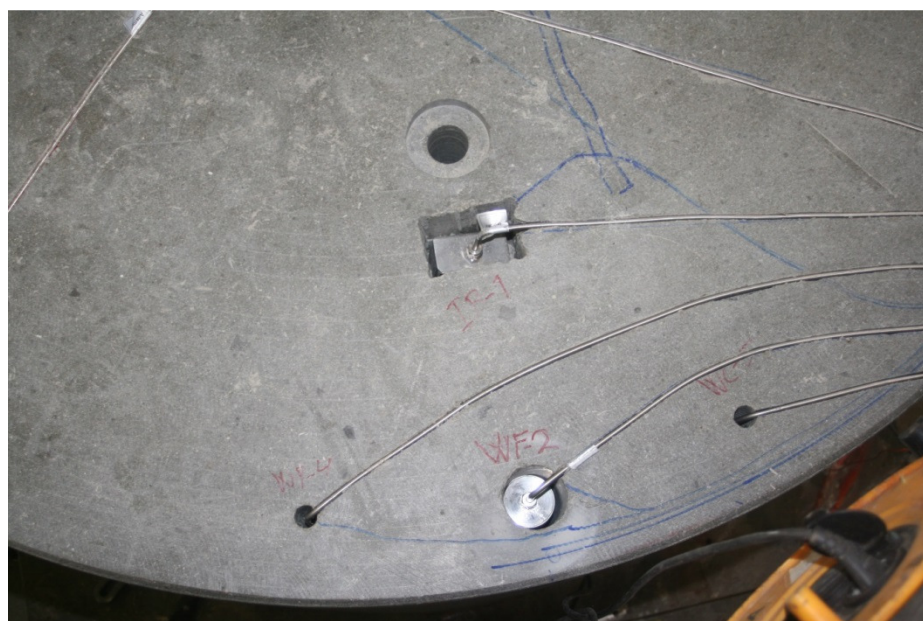
**Figure 8.3** Sensors in place and ready for filling of bentonite powder around and on top of them. The hole in the upper part of the picture is one of the holes for the segmented lengthwise rods.

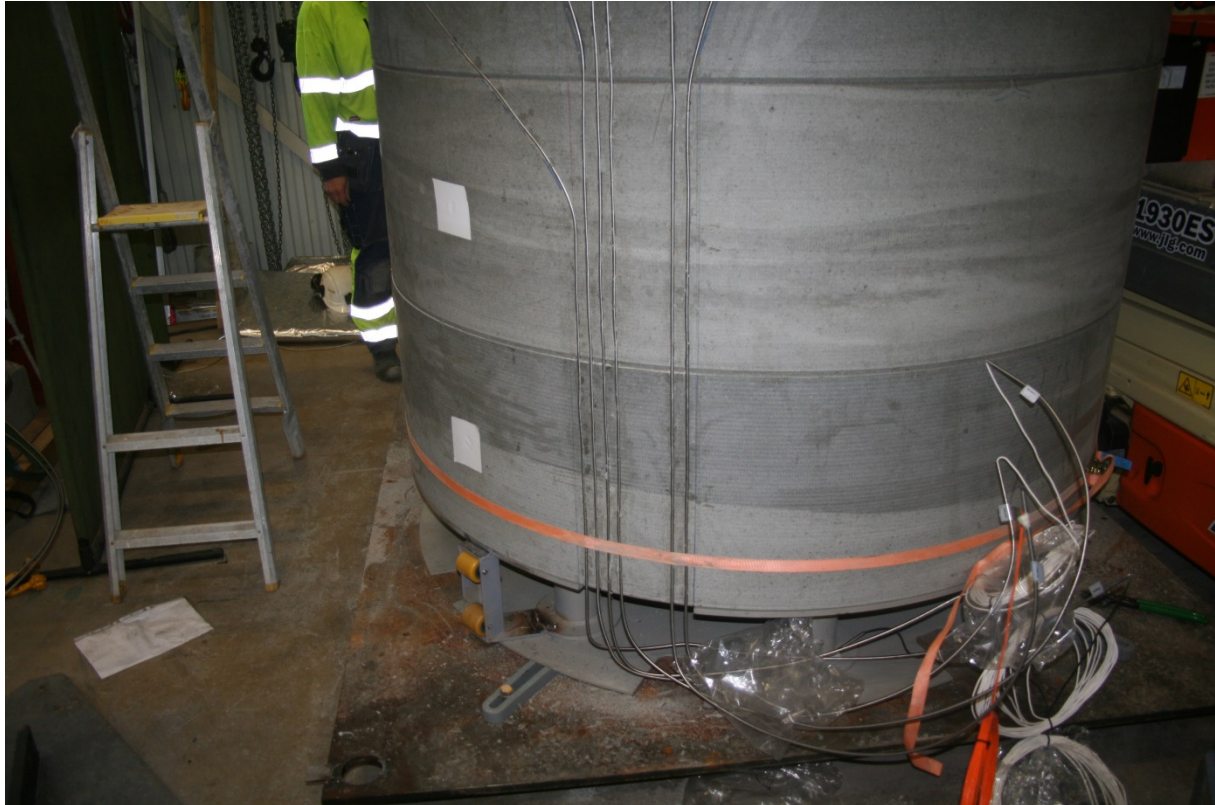
**Figure 8.4** *Lower part of one of the composite components, with the cable piping milled into and running along its periphery to the cable block. The pipes and cable rolls were later secured inside the cable block.*

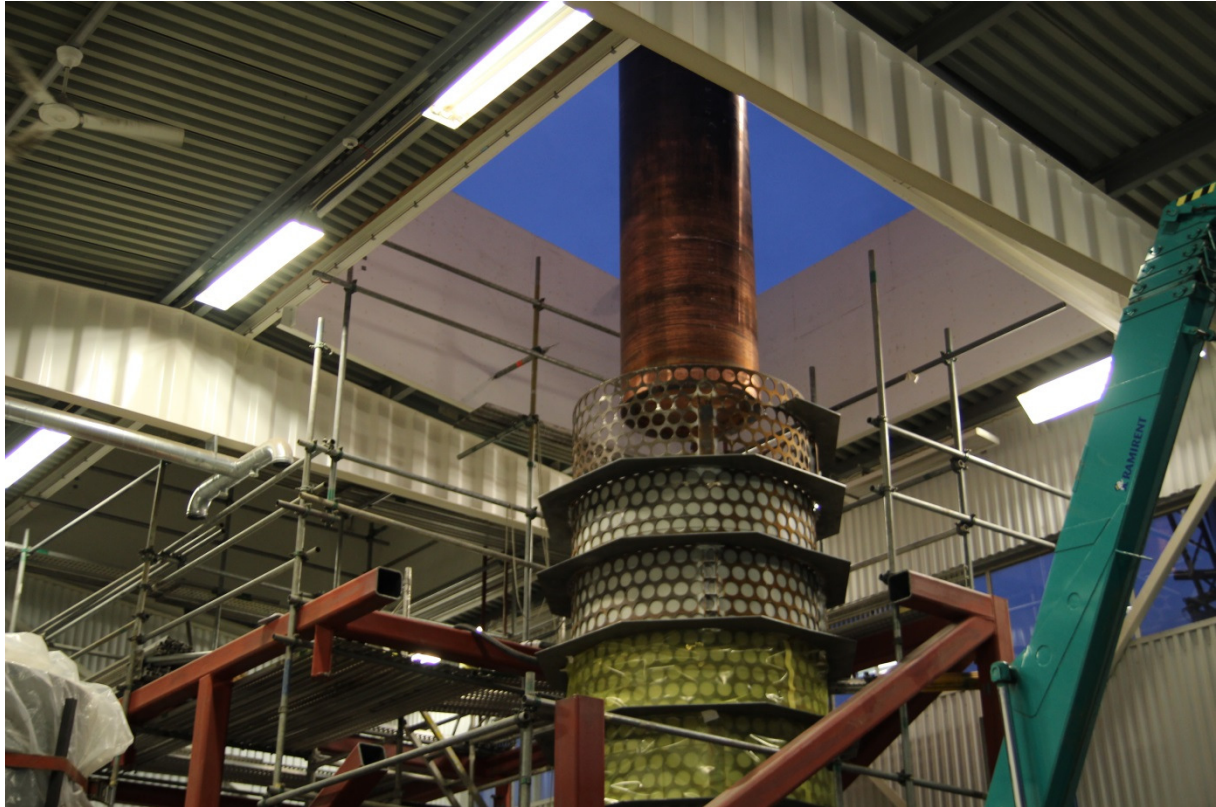
**Figure 8.8** *Canister being lowered into the Supercontainer. The stiffening plates for straightening the shell can be seen on its outer periphery.*

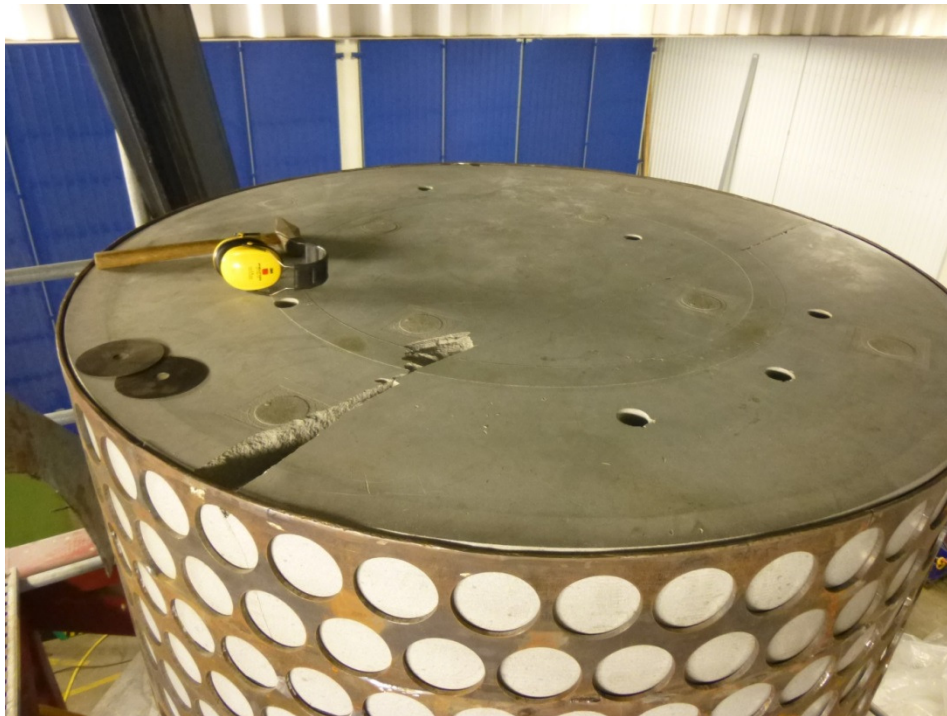
**Figure 8.9** *Top block placed inside the Supercontainer. The three pieces could be lifted individually by the mechanical lifting tool and positioned with tight fit, like a jigsaw puzzle. Machining of the height of the final ring ensured a total buffer height corresponding well with the height of the shell.*

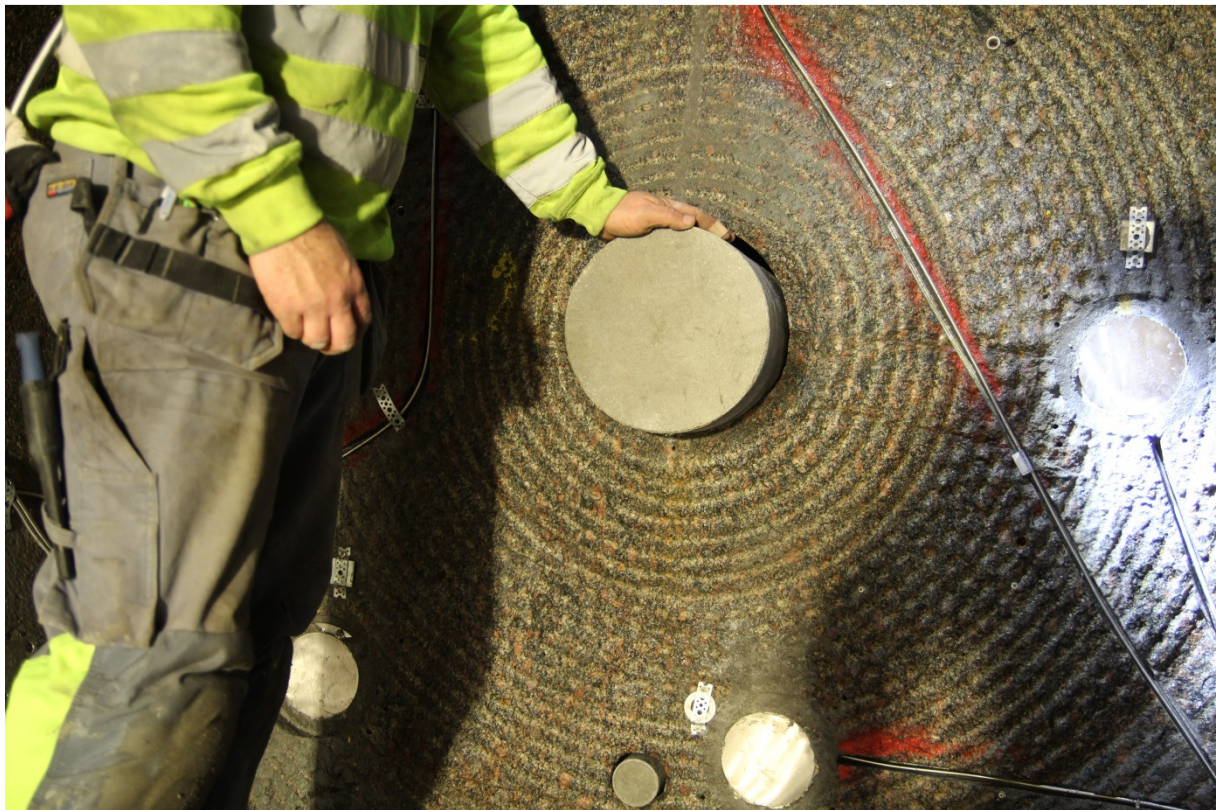
**Figure 9.2** Bentonite filling components placed in the remainder of the main pilot hole, centre of picture, and in the 76 mm characterisation hole seen at the bottom of the picture. Also seen are three of the drift front total pressure sensor with their piping sawed into the rock and by their side a small distance placed to ensure that the first distance block would not crush them.

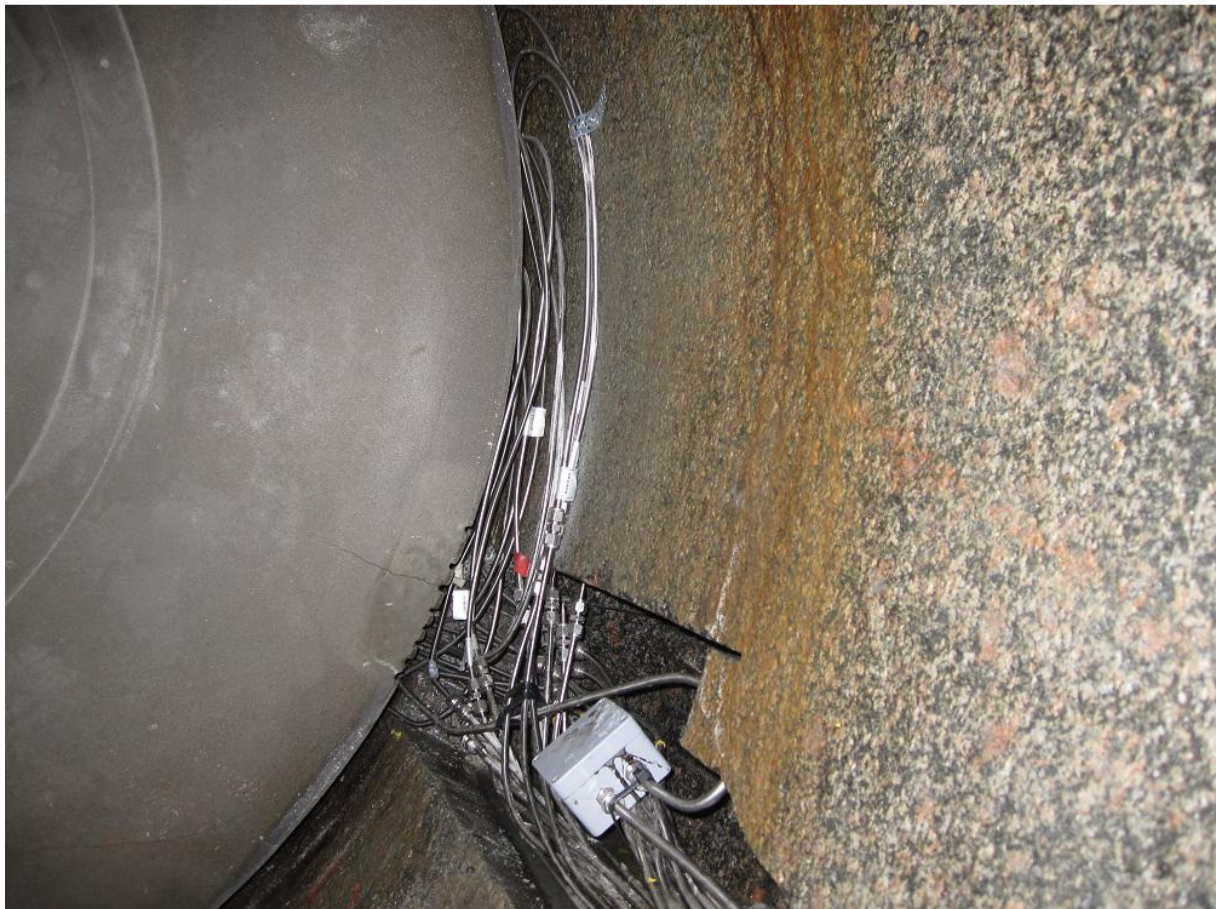
**Figure 9.4** One of the sides of the inner distance blocks with all cables connected and the cable block removed.

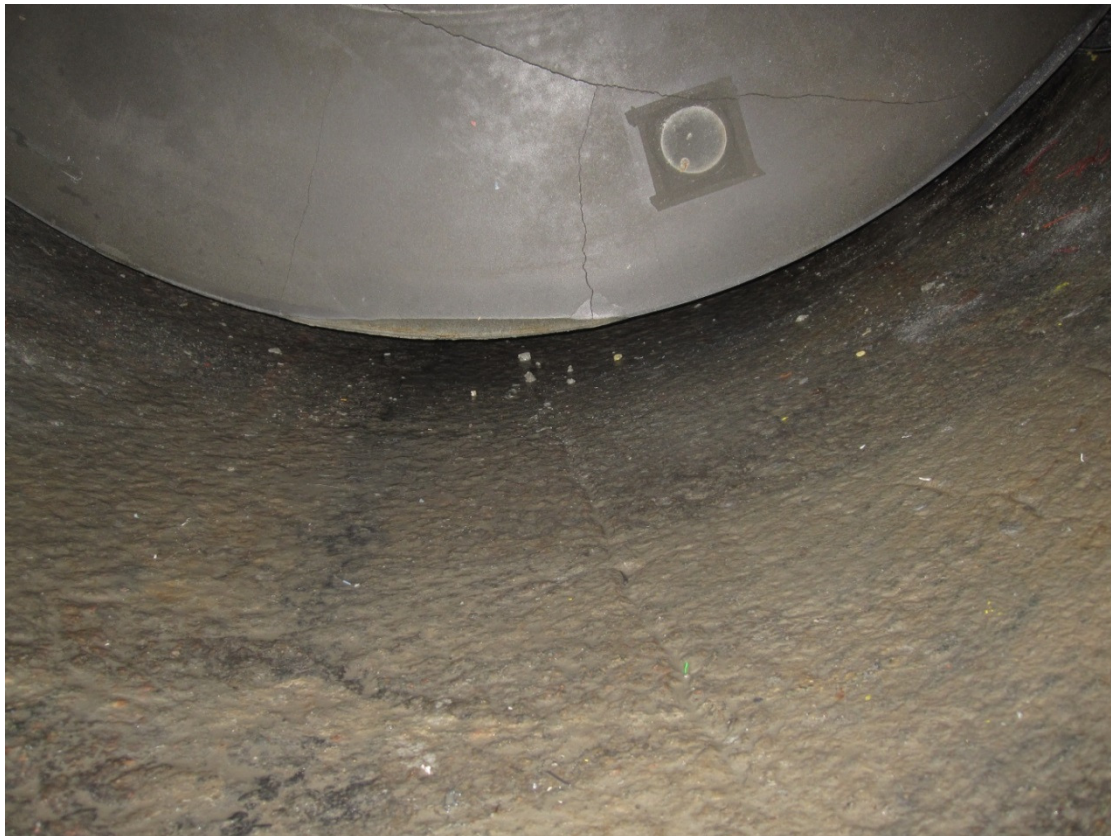
**Figure 9.5** Crack on the inner distance block which was noted when the cable block was removed.
