**DELIVERABLE (D-N°:D4:03)**  
**KBS-3H Preparations, assembly and installation of  
the Multi Purpose Test**

Author(s): Magnus Kronberg, SKB

Date of issue of this report: **01/09/2015**

### **P-14-27 KBS-3H Preparations, assembly and installation of the Multi Purpose Test**

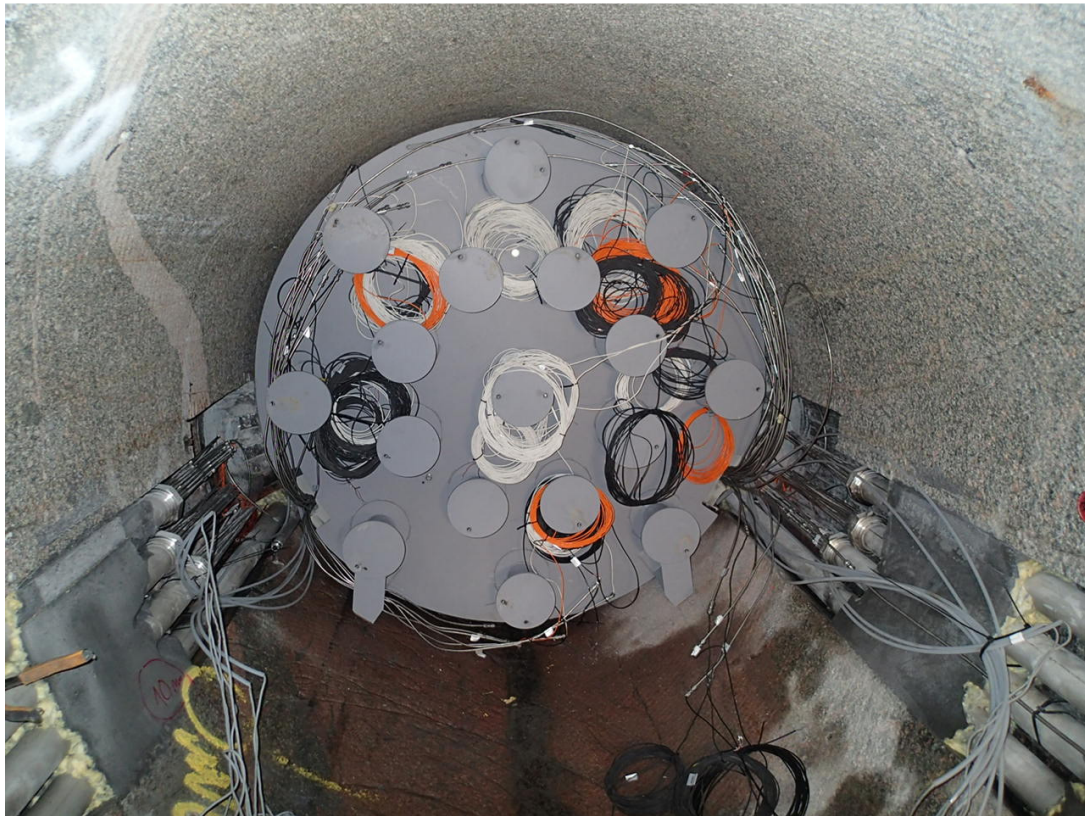
**Figure 9.6** *Pulling of cables from the Supercontainer to the main piping in the drift walls and to the cable storage, c.f. Figure 5.10.*

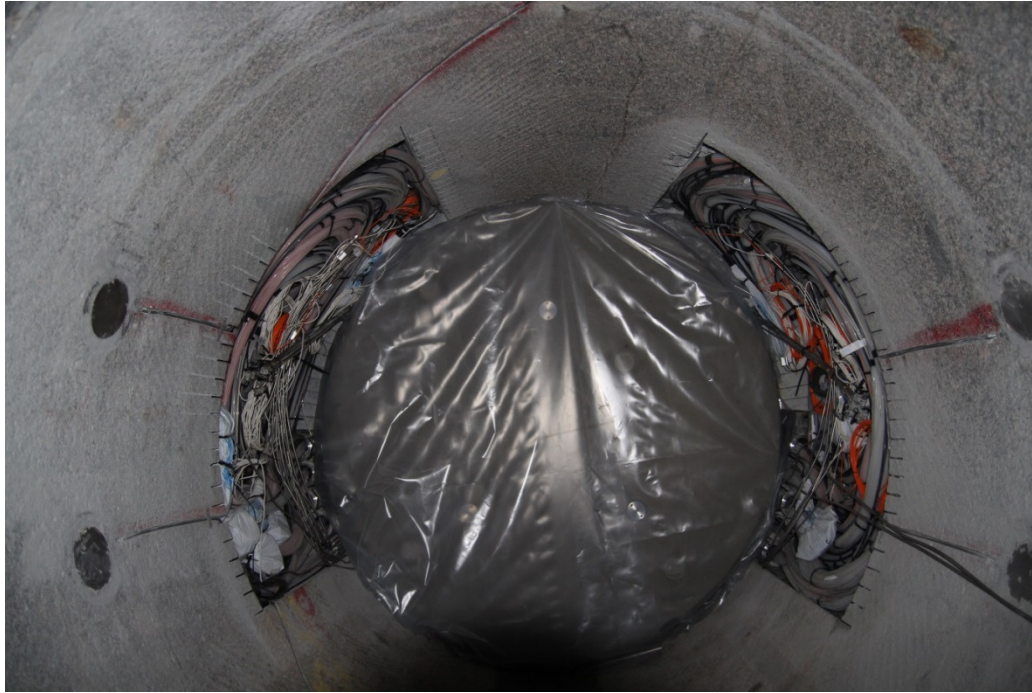
**Figure 9.9** Transition block deposited and protected by plastic film awaiting installation of the plug. Note that the cable storages (left and right flanking walls) are now filled with all the cables from the various components.

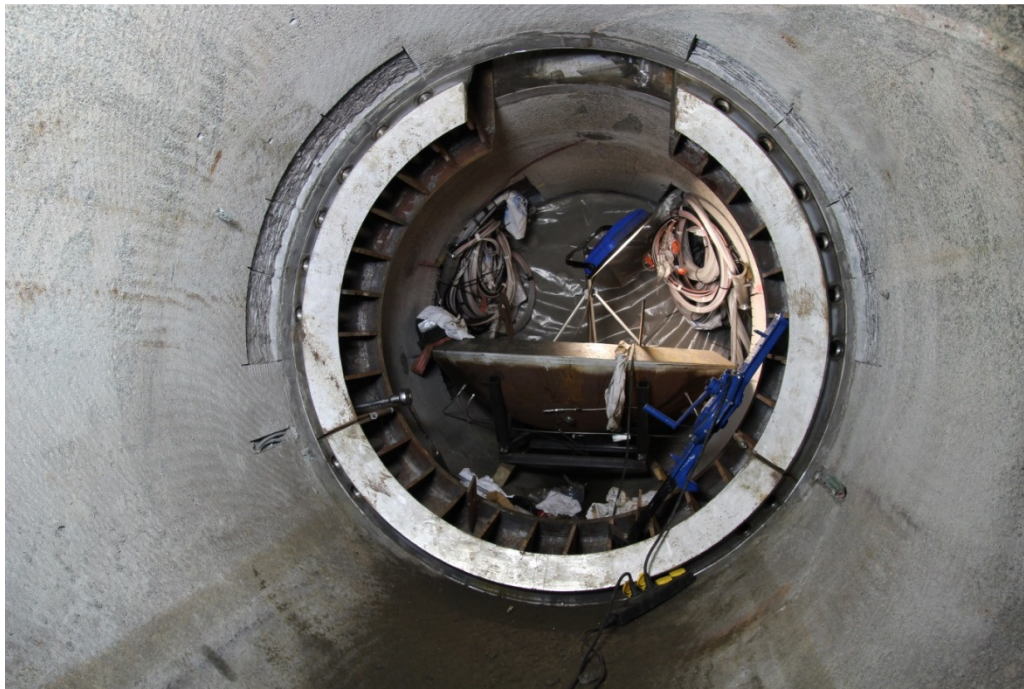
**Figure 9.10** *Three of the collar segments placed with only the fourth smaller top segment remaining. The plug cap, leaning on its steel support can be seen between the collar and the transition block.*

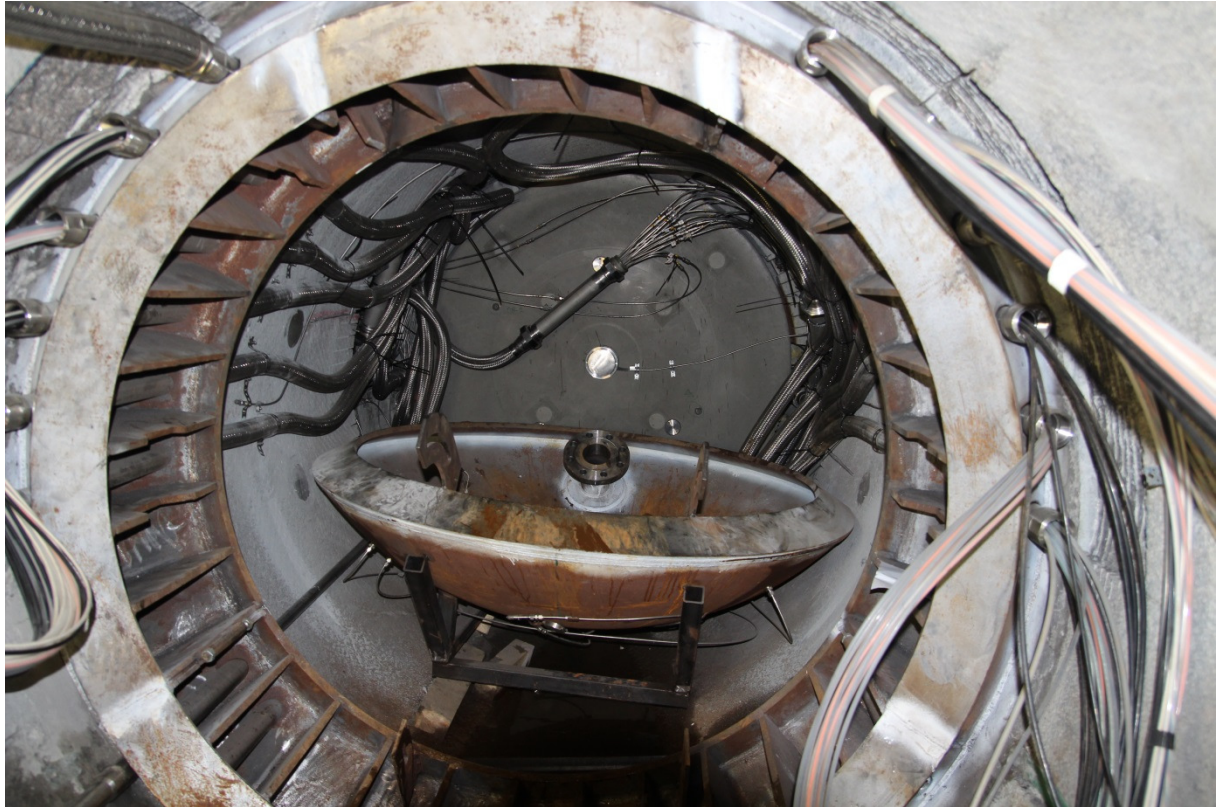
**Figure 9.11** *The flexible pipes between the collar and the main wall pipes can be seen attached on the drift wall between the collar and the transition block.*

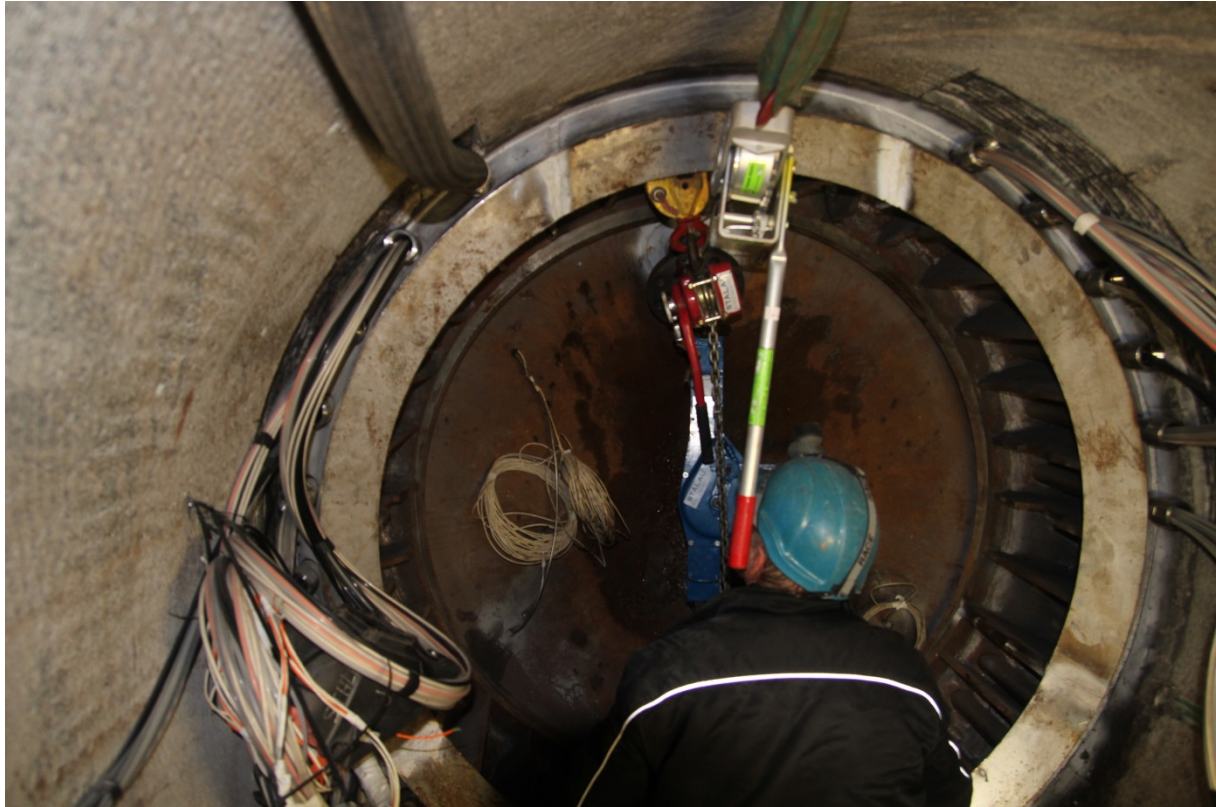
**Figure 9.12** *Raising of the cap by use of chain pulleys.*

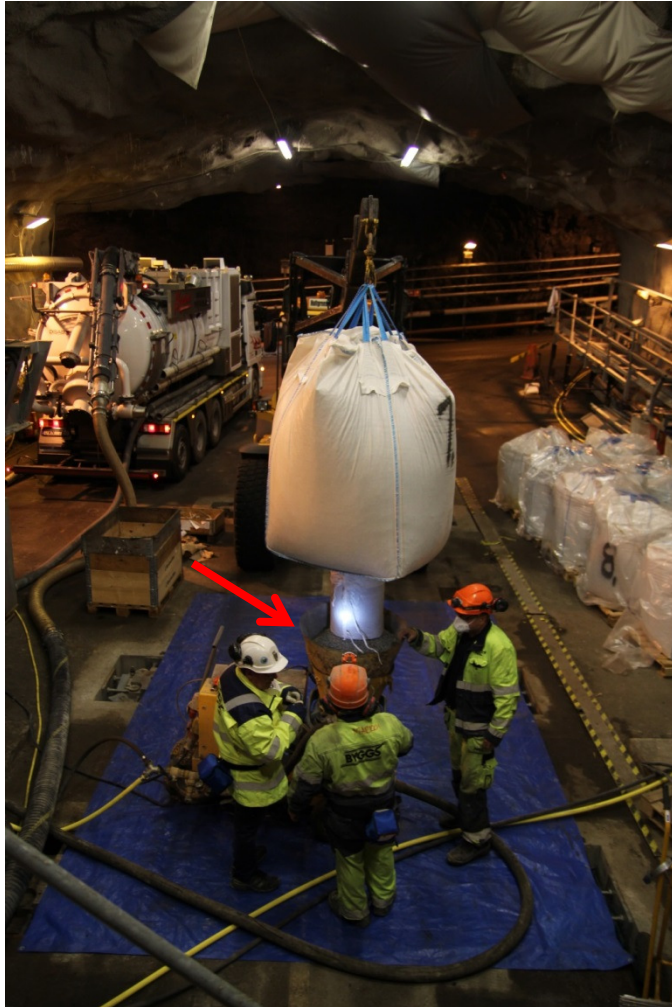
**Figure 9.13** Pellets blower (red arrow) placed immediately outside the drift with pellets being filled. In the background, to the left, is the sewage truck used to suck out air and dust from the compartment.

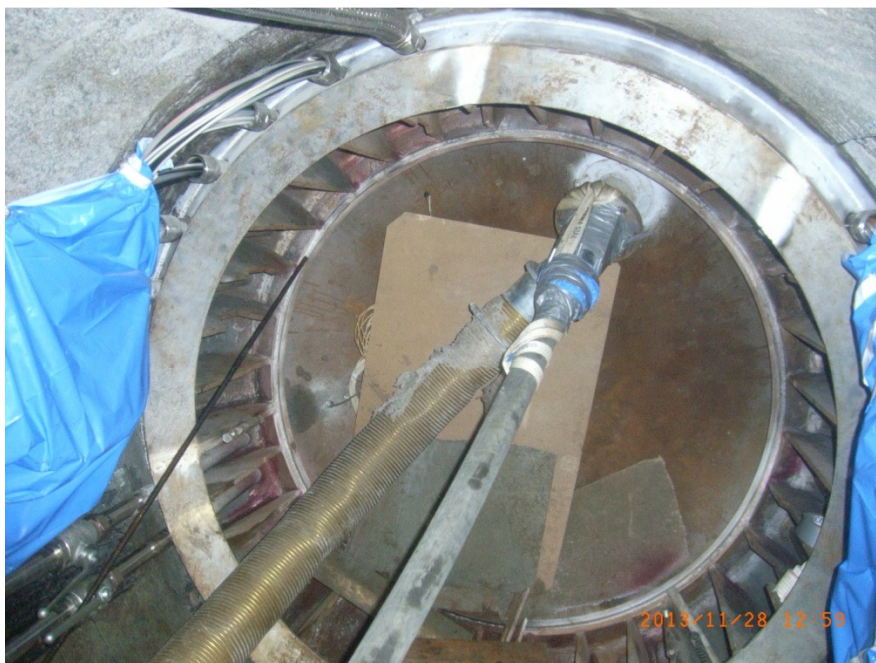
**Figure 9.14** T-connector connected to the pellets filling hole in the plug.

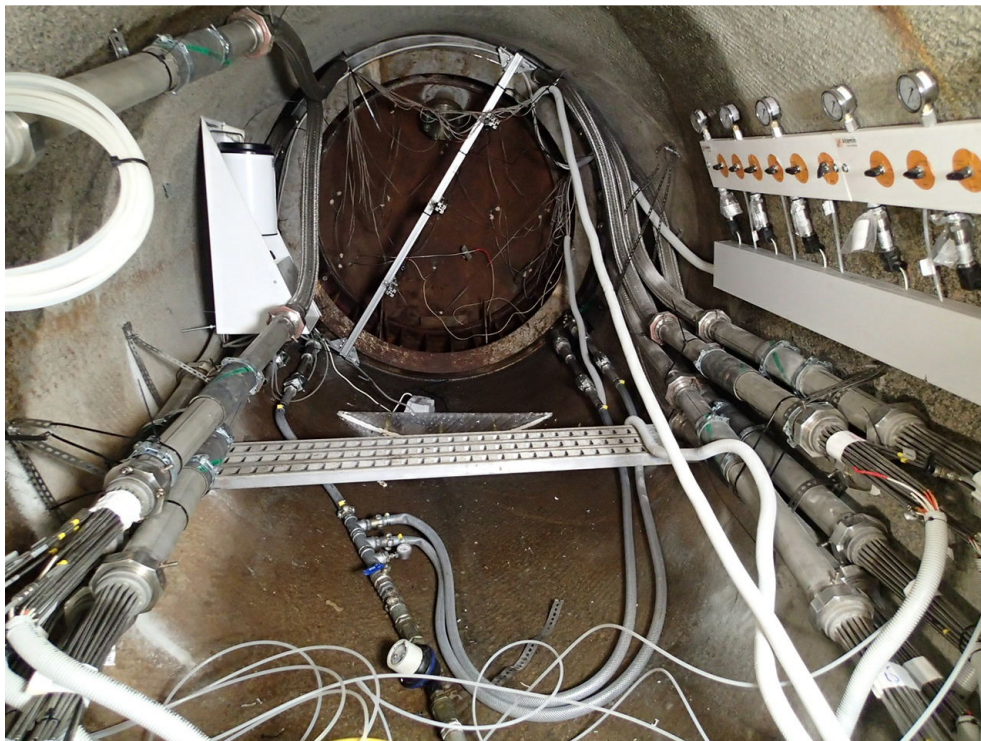
**Figure 9.15** Flexible piping and outer ‘hedgehogs’ with the cabling inside. The picture was taken during the DAWE procedure.

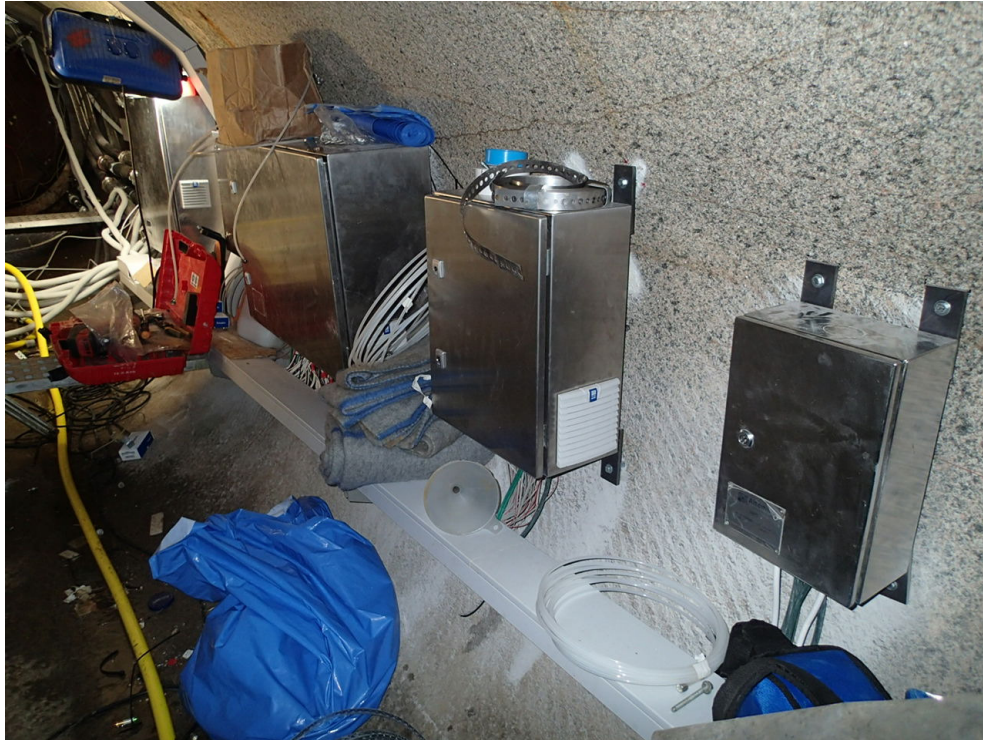
**Figure 9.16** *Connection cabinets placed on the drift wall immediately outside the plug.*

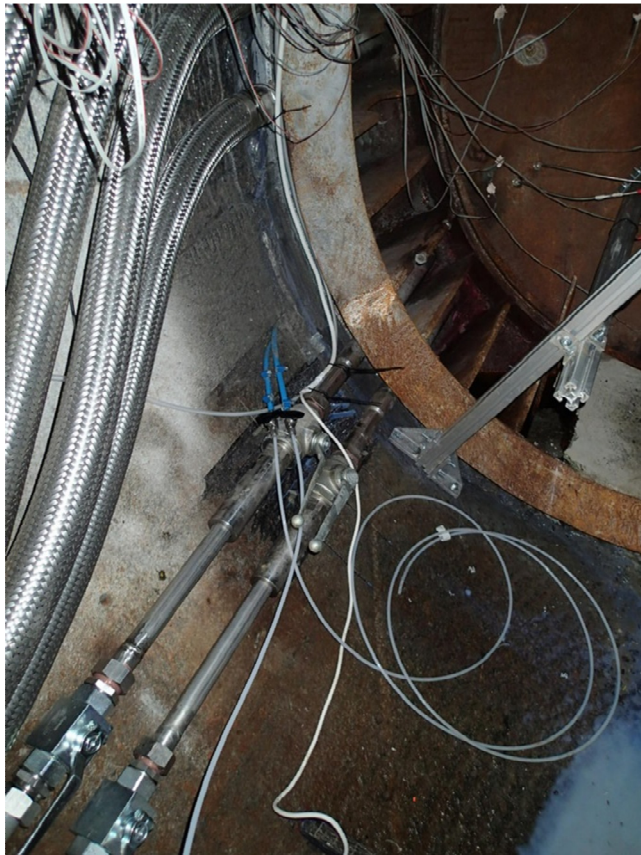
**Figure 9.17** Contact grouting in the blue tubes, corresponding to the casting-steel interface. The silica sol seen down to the right is from flushing prior to starting the grouting. The silica sol leaking out at 9 and 4 o'clock was much less.

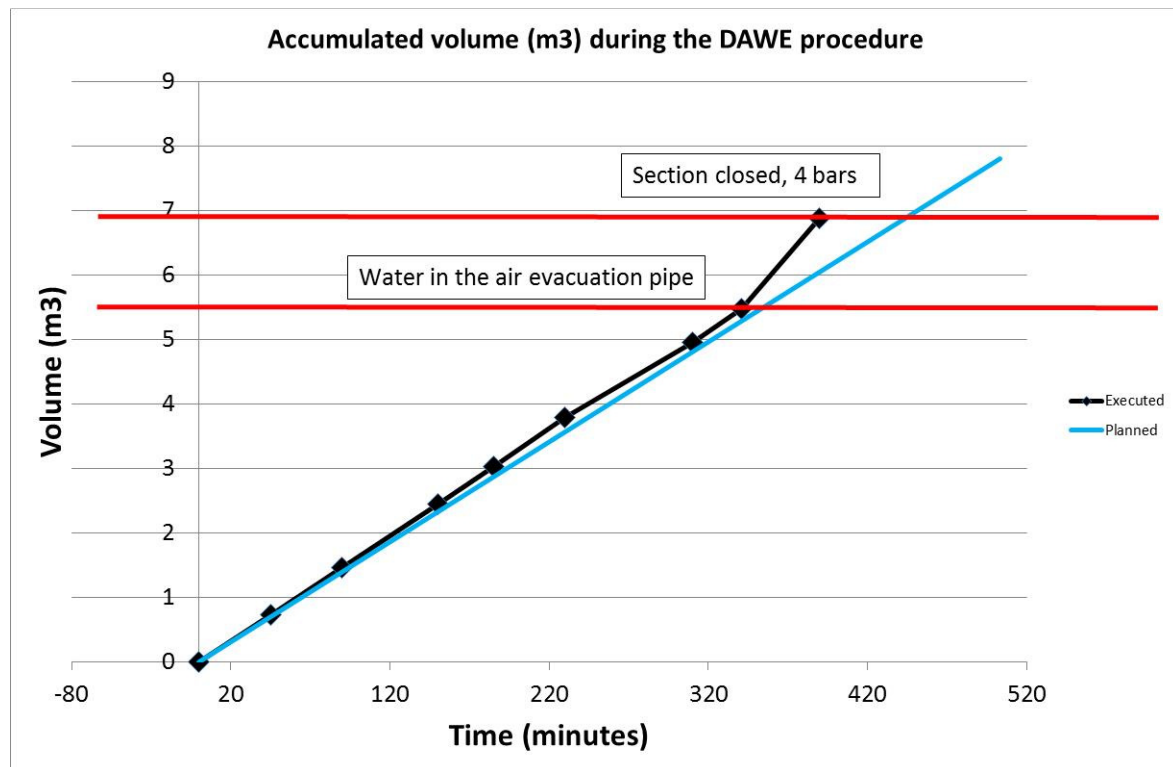
**Figure 9.18** MPT water filling procedure. The actual flow rate was 17.6 l/min on average and the filling was stopped at 6876 litres after 6 hours and 30 minutes.

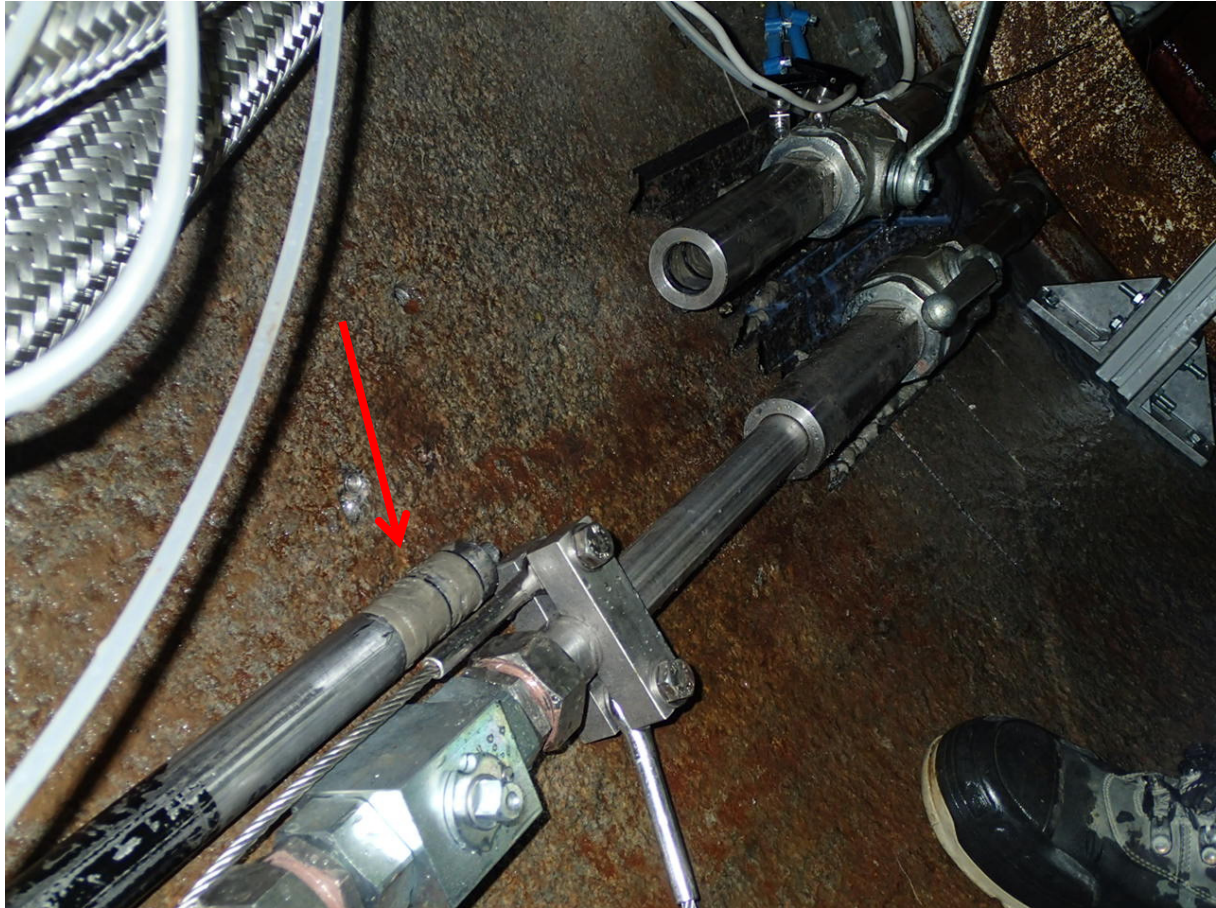
**Figure 9.20** *The air evacuation pipe has just been pulled out and the first water filling pipe is connected with a wire to be pulled out. Bentonite can be seen stuck to the valve part of the air evacuation pipe (red arrow).*
